Topic	Pre Delivery Inspection (PDI) Coolant fan operation check (SC24/08)
Market area	United States E05 Bentley USA and rest America (6E05)
Brand	Bentley
Transaction No.	2073357/2
Campaign number	ED01
Note	
Type	
US code

### New Continental GT / GTC and New Flying Spur - W12 only

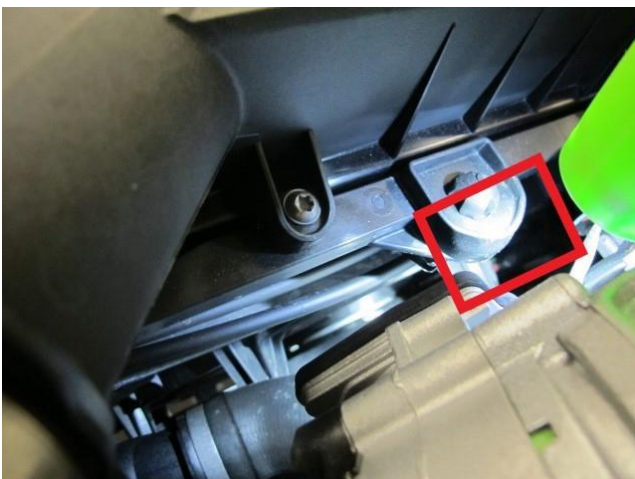
- 5) Referring to Figure 3 (Rear of radiator cowl) - Whilst the engine running - Visually check the cooling fan is spinning / operating

Whilst the engine is running the operative should observe the operation of the fan for a total of 60 seconds Hint: The fan will start and stop depending on engine coolant temperature

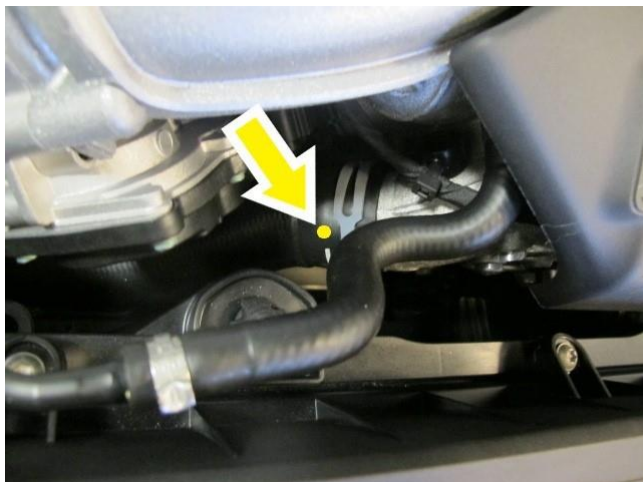
Figure 4

Yellow paint completion mark on the radiator top hose confirms the fan is spinning / operating (Figure 4)

**Yes the fan is spinning / operating whilst the engine is running** - Apply a yellow paint completion mark on the radiator top hose (Figure 4) no further action is required

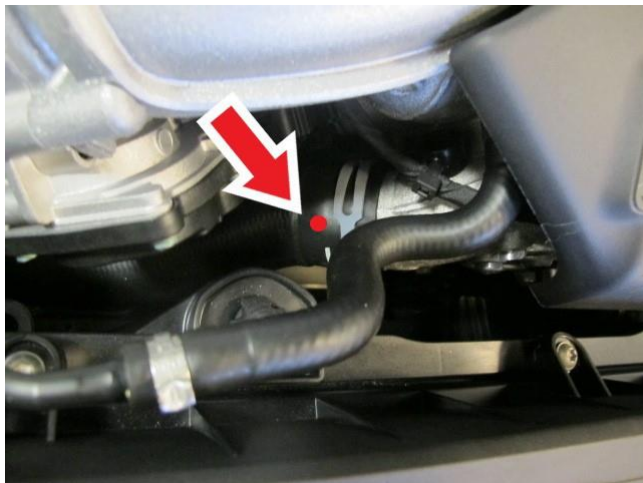
Figure 5

Red paint completion mark on the radiator top hose confirms the initial fan operation check and the software update were both conducted (Figure 5)

- 8) Conduct the repair instructions (once received from Product Support via the open DISS query)
- 9) Confirm the fan is spinning / operating to specification whilst the engine is running - Repeat steps 1 through to 5
- 10) Apply a red paint completion mark on the radiator top hose (Figure 5)
