TECHNICAL SERVICE BULLETIN

Water Entry Into The Front Foot Wells

24-2090

Ford 2024 Mustang

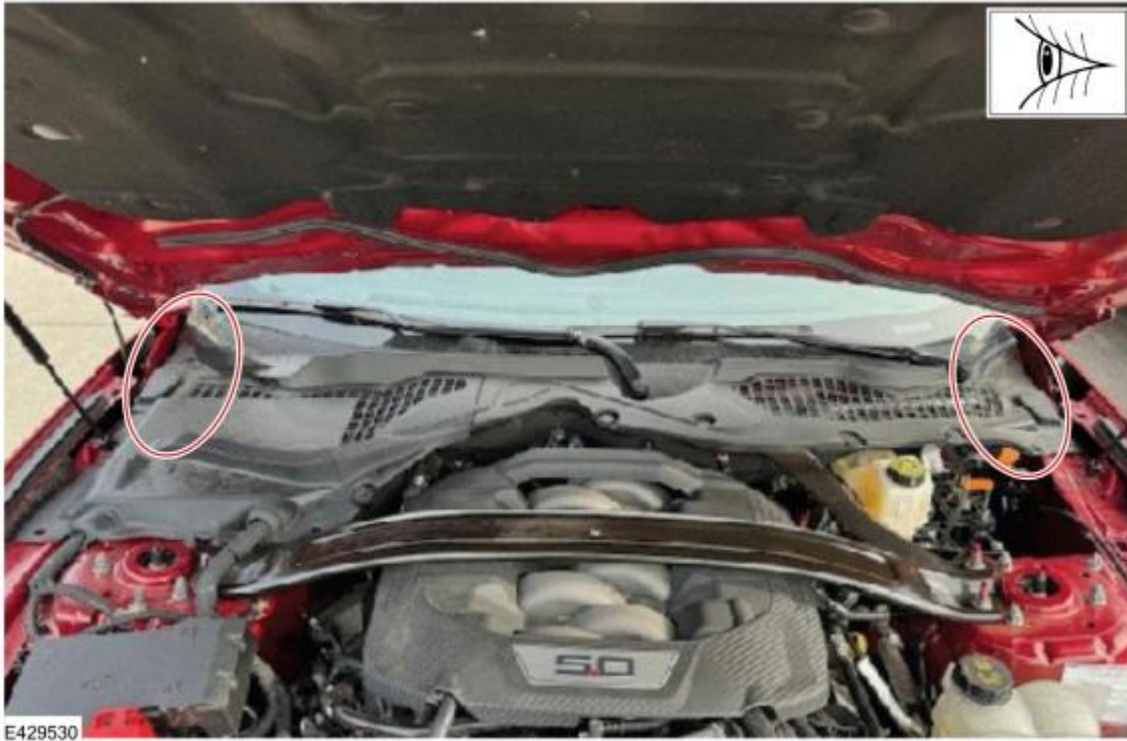
Figure 1

1. Remove the wiper linkage assembly. Refer to WSM, Section 501-16.
2. Remove the rear bumper cover. Refer to WSM, Section 501-19.
3. Pressurize the cabin of the vehicle. Refer to WSM, Section 501-00 > Diagnosis And Testing > Body Systems > Dust And Water Leaks.
4. Spray the areas shown in Figures 1-3 (driver side shown passenger side similar) with soapy water.

5. Are bubbles present indicating a leak?

6. Thoroughly clean and dry area, removing any dirt, debris, and water that may be present.

7. Apply Motorcraft® Seam Sealer to fill any gaps found between the metal panels to eliminate the water entry.
