Seat Fixings Torque Check

Bulletin type: Service Campaign
Reference number: N/A
Campaign reference: SCB 00 N 003
Attention: Retailer Aftersales Managers, Retailer Service Managers, Retailer Service Advisors, Retailer Technicians
Affected vehicles: McLaren Artura, McLaren 750S
Situation: Seat fixings/bolts torque check
Procedure: Action affected vehicles on first opportunity (immediately if already on site or during next Retailer visit if not already on site). Please refer to the information outlined in this document to complete the required work
Date: 06 March 2024

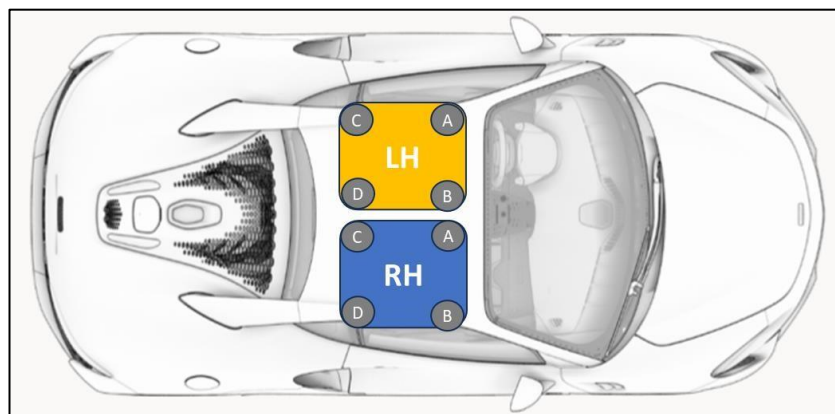
Through continuous product quality monitoring, McLaren Automotive has identified an inconsistency in seat tightening torque on some seat fixings of certain McLaren vehicles.

Image 1: Seat bolt locations (vehicle interior cabin)

With immediate effect, McLaren Automotive is instructing Retailers to check the torque, retorque if needed and report the results for all fixings of both driver and passenger seats of all vehicles within the supplied VIN range.
