Technical Service Bulletin

SUBJECT:		No: TSB-20-23-001REV4
POTENTIAL TRANSMISSION SHUDDER/SURGE WITH POSSIBLE DTC (CVT-8) - REVISED		DATE: March 2024
		MODEL: See below
CIRCULATE TO:	<input type="checkbox"/> GENERAL MANAGER	<input checked="" type="checkbox"/> PARTS MANAGER
<input checked="" type="checkbox"/> SERVICE ADVISOR	<input checked="" type="checkbox"/> SERVICE MANAGER	<input checked="" type="checkbox"/> TECHNICIAN
	<input checked="" type="checkbox"/> WARRANTY PROCESSOR	<input type="checkbox"/> SALES MANAGER

Certain vehicles with F1CJC/W1CJC (CVT-8) transmissions may exhibit a shudder or surge condition possibly caused by poor reaction of the hydraulic pressure circuit. With continued driving under these conditions, the CVT belt may slip repeatedly when accelerating, and abrasion powder may enter the hydraulic pressure circuit, causing a warning light to turn on with one of the following DTCs: P0776, P0730, P0741, P084A, P0969, P2719. The shudder/surge condition may also be described as engine flare, lack of acceleration, and/or car shake.

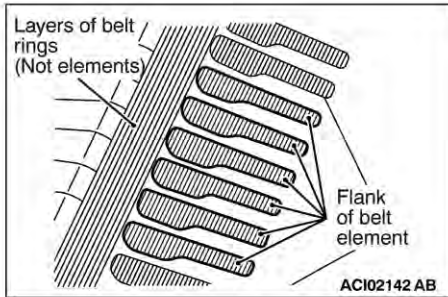
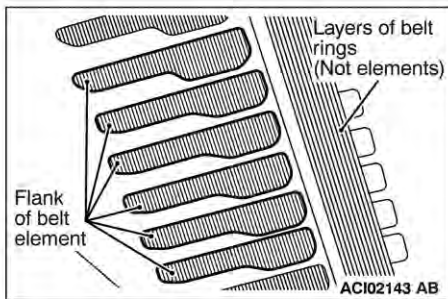
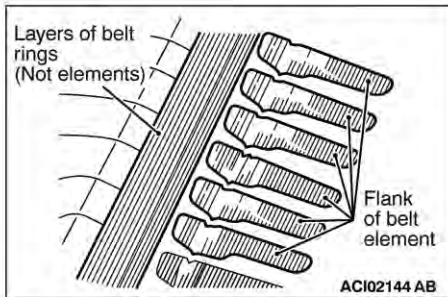
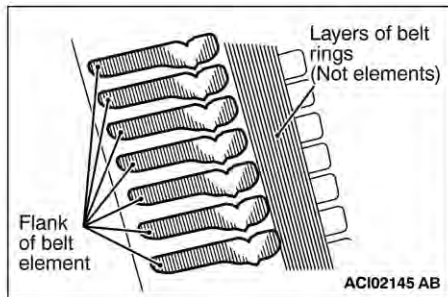
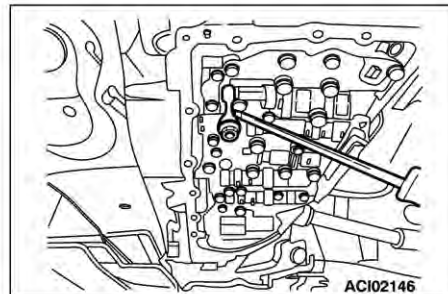
- No damage is observed on flanks (grooved surfaces) of belt elements.

- Damages to grooves are observed on flanks of belt elements.

- If damage is found on either side of mating surfaces of the belt, CVT assembly replacement is required.
- If no damage is found on mating surfaces of the belt, a new valve body installation is required. Follow next steps.
