# Service Bulletin

Bulletin No.: 17-NA-216

**Subject:** Convertible Top Back Glass Separation from Top Cover Material

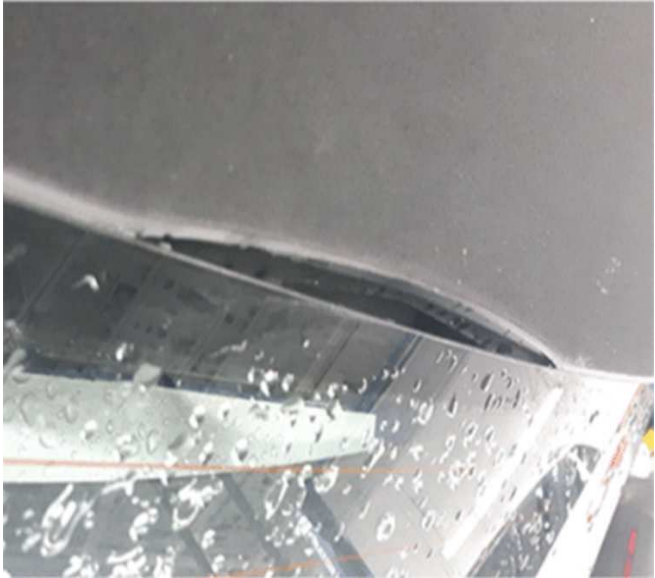
<p>4794660</p>

Involved Region or Country	North America, Argentina, Brazil, Bolivia, Chile, Colombia, Ecuador, Paraguay, Peru, Uruguay, Europe, Middle East, Israel, Japan
Condition 1	<p>Some customers may comment on seeing the back glass separating from the convertible top cover material.</p> <p>Several examples of the separation are shown in the graphic examples below:</p>

<p style="text-align: right;">4794112</p> <p>It will be necessary to replace the convertible top cover (1). Refer to <i>Folding Top Cover Replacement</i> in SI.</p>

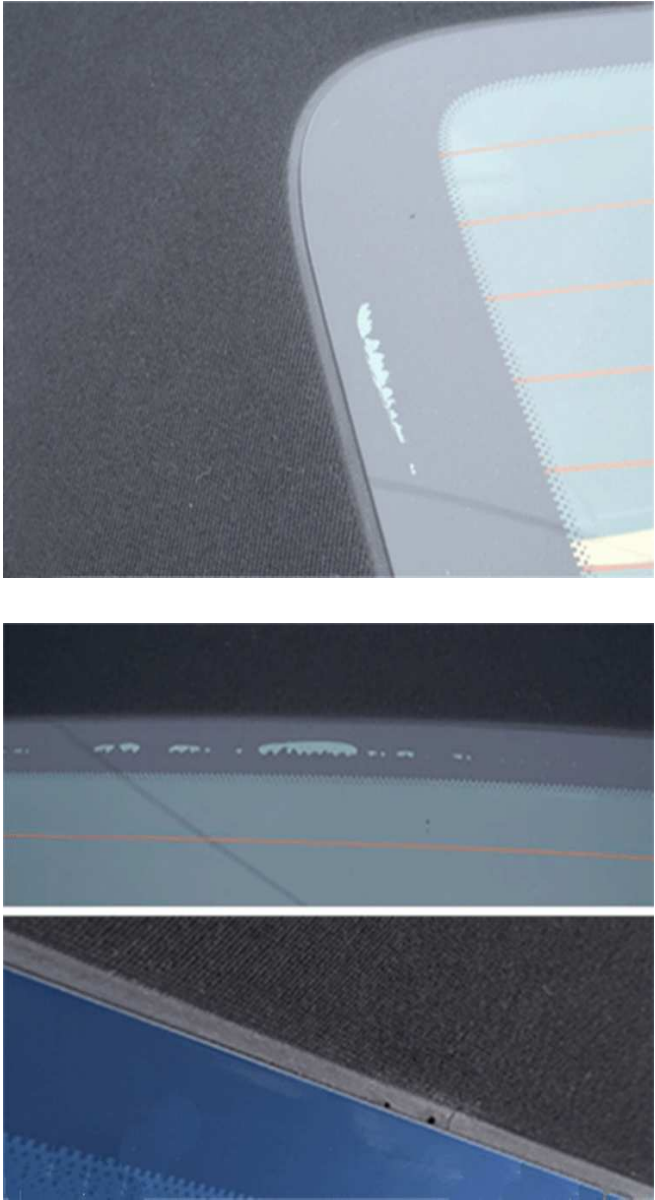
<p>4794670</p> <p>4794682</p>
<p><b>Cause 1</b></p>	<p>The cause of this condition may be an insufficient amount of primer used during the assembly process, which creates stress points allowing the material to separate from the glass.</p>

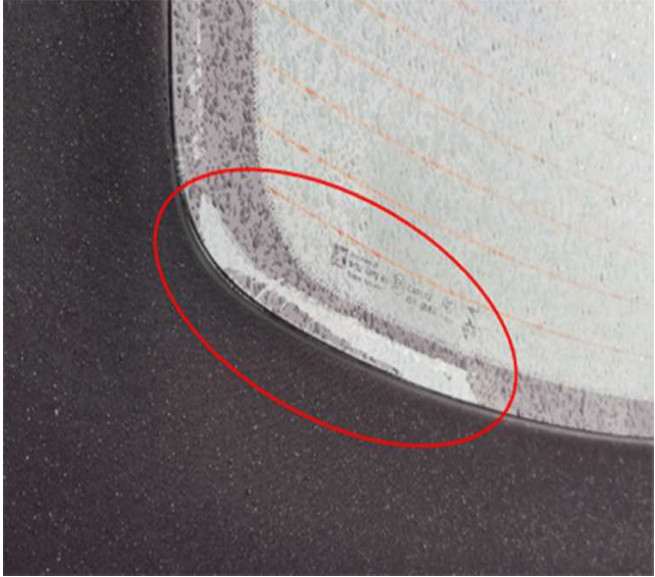
<p style="text-align: right;">5049793</p> <p>Some customers may comment that the vehicle may exhibit a condition where the back glass is separating from the top. This condition will typically start in the corner of the back glass.</p>
<p>Cause 2</p>	<p>The cause of this condition may be the back glass separating from the bond.</p>
<p>Correction</p>
