Service Bulletin

Bulletin No.: 18-NA-063

Subject: Multiple Electrical Issues, Dead Battery, Start/Stop Inoperative, Instrument Cluster and Switch Backlighting Remain Illuminated, Battery Draw

Brand:	Model:	Model Year:		VIN:		Engine:	Transmission:
		from	to	from	to		
Cadillac	XT5	2017	2017			All	All
GMC	Acadia (VIN N)						
	Acadia	2018	2019				
Holden	Acadia	2019	2019

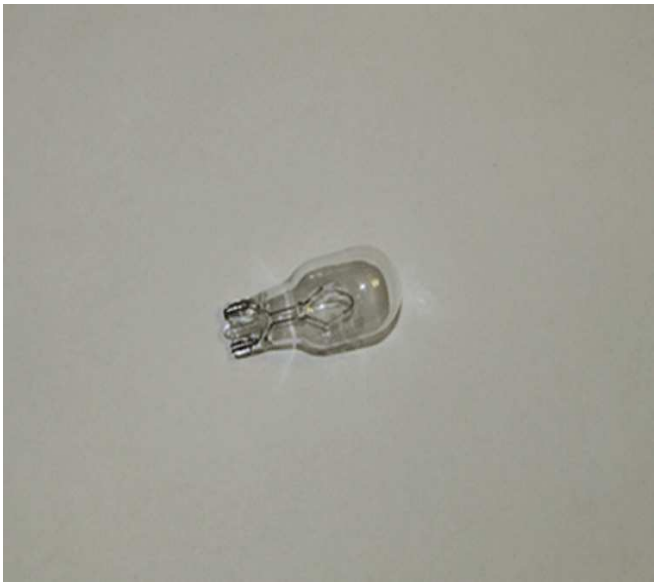
</div> <p style="text-align: right; font-size: small;">4977973</p> <p>The cause of the condition may be that the wrong bulbs may have been installed in the backup lamps. Incandescent bulbs (example shown above) should have been used, but LED's may have been incorrectly installed in their place.</p> <p>Note: The BCM evaluates the Reverse Lamp circuit to determine bulb outages by applying and monitoring a low voltage signal. Because LED lamps have different electrical properties than Incandescent bulbs, the circuit does not operate as expected. The BCM is calibrated for incandescent lamps and may stay awake after key off, if LED's are used. The BCM will continuously monitor the circuit, resulting in the symptoms identified above.</p> <p>Note: Unplugging the lamps will not remove a battery draw, the correct bulbs need to be installed for the BCM to see the proper resistance and go to sleep.</p>

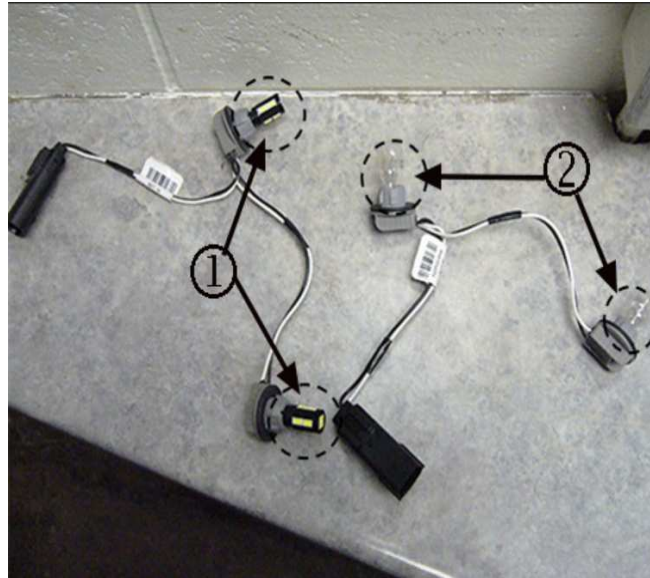
On vehicles that exhibit the above conditions or other electrical abnormalities, check the bulbs in the back up lamp locations.

- If the bulbs are found to be LED (1), the incorrect bulbs have been used and they need to be replaced with Incandescent bulbs.
- If the bulbs are found to be the proper incandescent bulbs (2), refer to SI for further diagnostic recommendations.

For backup bulb replacement, refer to the appropriate *Backup Bulb Replacement* procedure below.
