Service Bulletin

Bulletin No.: 21-NA-245

Subject: Shift to Park Message Displayed in Driver Information Center (DIC)

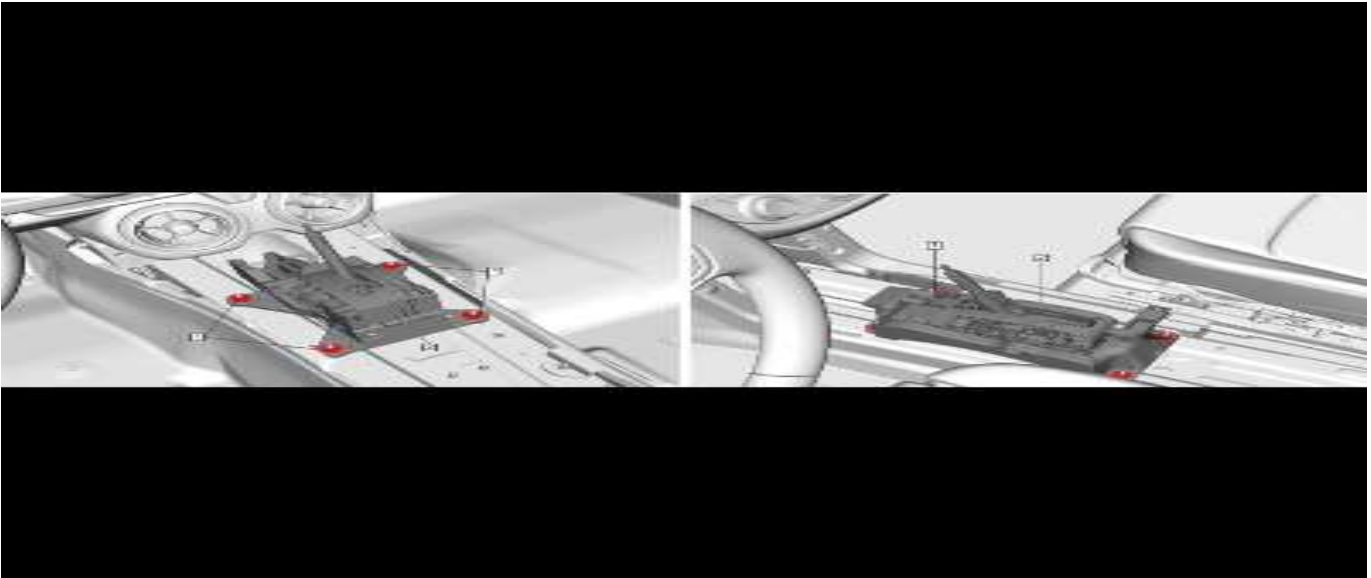
6595991

Note: Camaro shifter shown on the Left. Regal shifter shown on the right.

1. Remove the transmission control assembly from the vehicle (2). Refer to *Transmission Control Replacement* in SI.

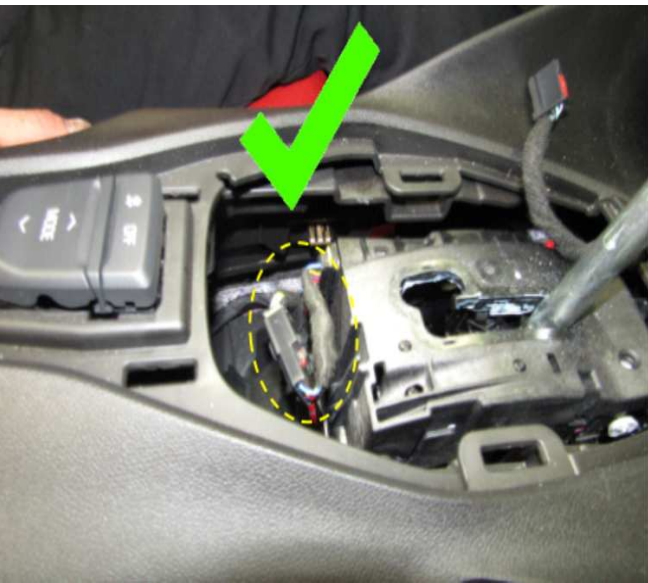
5404694

Note: Ensure the jumper harness is not twisted or kinked.

2. Install the jumper harness between the shift control and the console body harness connector.
