## Field campaign

Topic	Pre Delivery Inspection (PDI) Coolant fan operation check (SC24/08)
Market area	United States E05 Bentley USA and rest America (6E05)
Brand	Bentley
Transaction No.	2073357/3
Campaign number	ED01
Note	
Type	
US code

### New Continental GT / GTC and New Flying Spur - W12 only

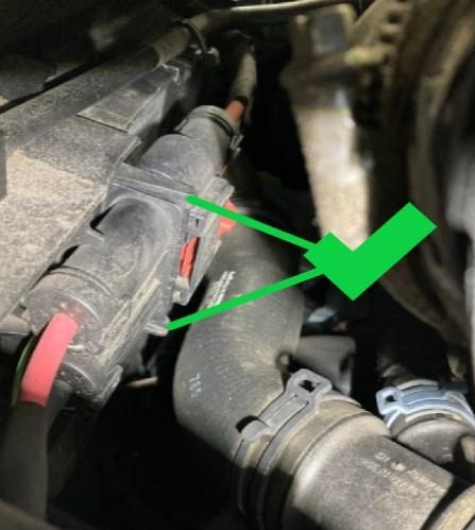
1) With the ignition switched off - Check the coolant fan connector is located correctly within the keeper as shown in Figure 1

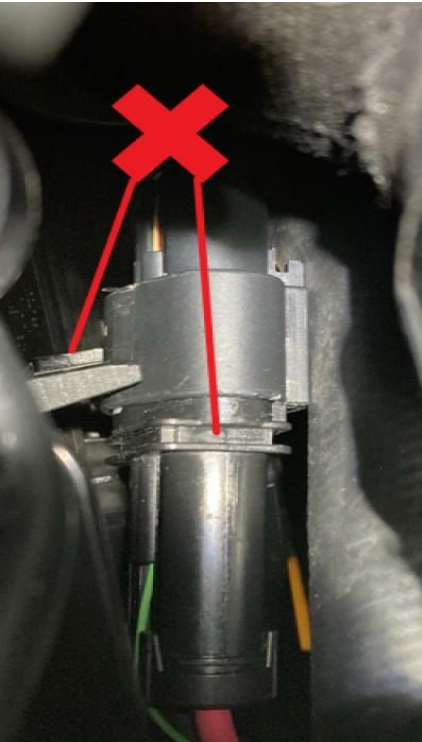
Hint: Figure 2 shows the connector not located correctly within the keeper, in this scenario the connector must be fitted into the keeper as shown in Figure 1

In the event the connector was not located within the keeper please raise a technical DISS query ensuring a photograph of the issue is attached

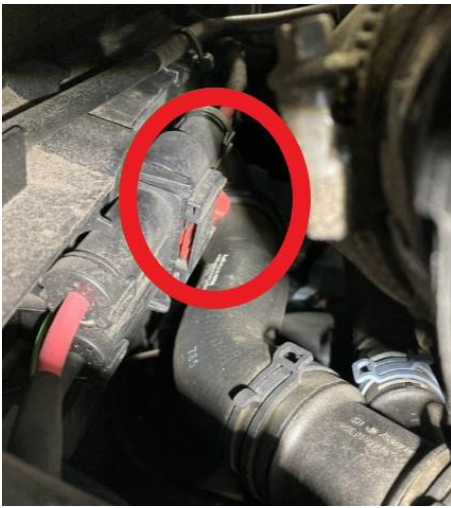
- Referring to Figure 3 - Check the coolant fan electrical connection is plugged in / connected

In the event the coolant fan electrical connection was not plugged in / not connected please raise a technical DISS query ensuring a photograph of the issue is attached - Continue with all remaining instructions

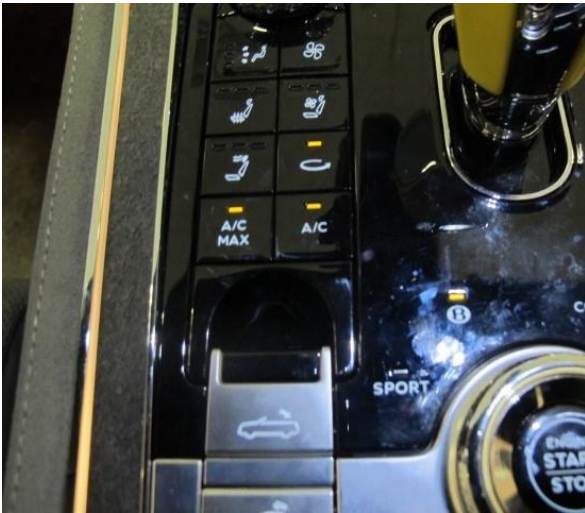
3) Referring to Figure 4 - Select A/C MAX as shown

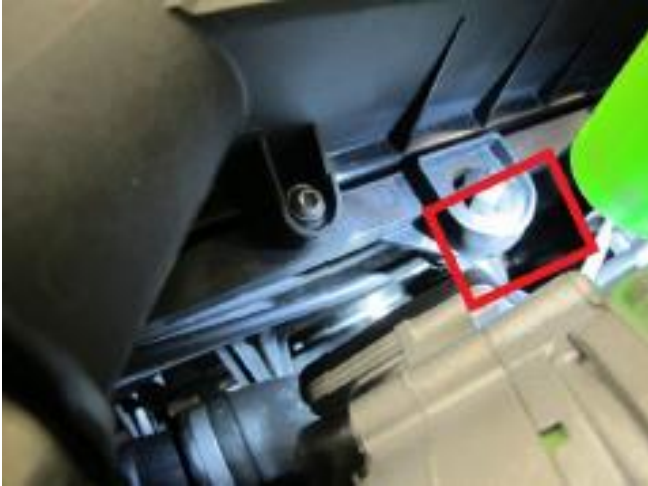
4) Referring to Figure 6 (Rear of radiator cowl) - Whilst the engine running - Visually check the cooling fan is spinning / operating

**NOTICE**  
Whilst the engine is running the operative should observe the operation of the fan for a total of 60 seconds Hint: The fan will start and stop depending on engine coolant temperature

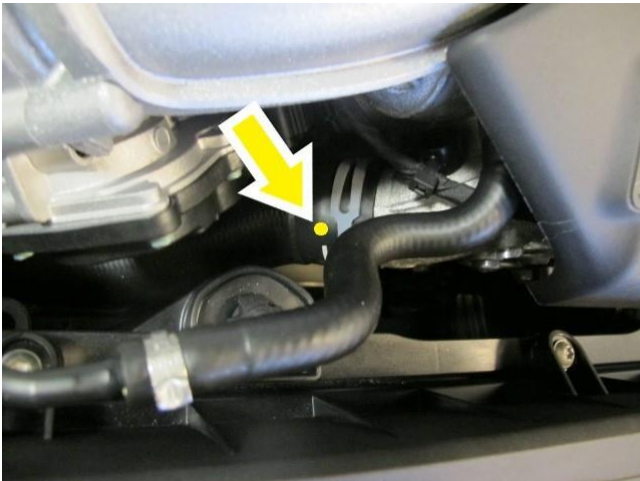
Figure 7

Yellow paint completion mark on the radiator top hose confirms the fan is spinning / operating (Figure 7)

**Yes the fan is spinning / operating whilst the engine is running** - Apply a yellow paint completion mark on the radiator top hose (Figure 7) no further action is required

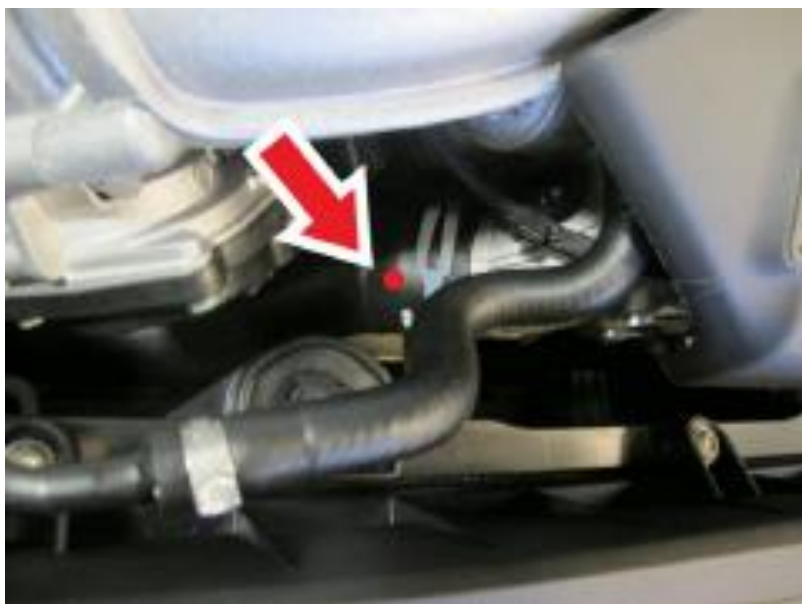
Figure 8

Red paint completion mark on the radiator top hose confirms the initial fan operation check and the software update were both conducted (Figure 8)

- 7) Conduct the repair instructions (once received from Product Support via the open DISS query)
- 8) Confirm the fan is spinning / operating to specification whilst the engine is running - Repeat steps 2,3 and 4
- 9) Apply a red paint completion mark on the radiator top hose (Figure 8)
