GROUP	MODEL
ELE	2023-2024MY Niro EV (SG2 EV)
NUMBER	DATE
332	April 2024

## TECHNICAL SERVICE BULLETIN

## EWP COOLANT HOSE REPLACEMENT

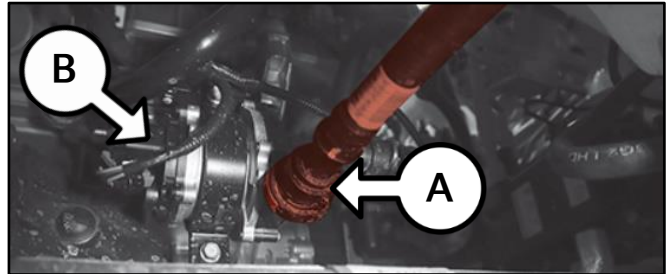
3. Disconnect the EWP coolant hose connector (A) from the EWP (B).

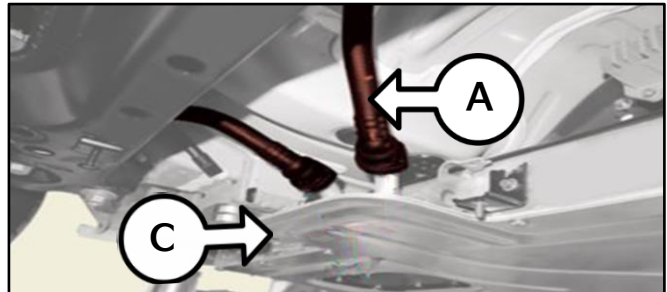
4. Disconnect the EWP coolant hose connector (A) from the high voltage battery (HVB) (C).
