CAMPAIGN BULLETIN

Left Front Drive Shaft

Reference: PMA35
Date: March 15, 2024

PMA35 – 2024-SENTRA LH FRONT DRIVE SHAFT

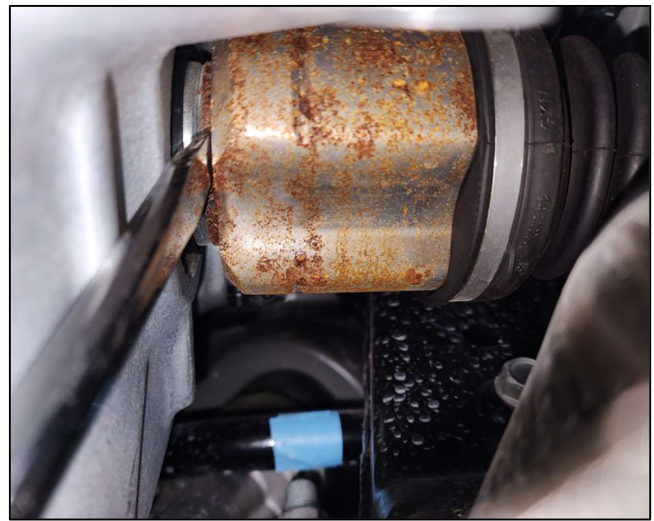
4. Verify the LH front drive shaft is fully seated in the transaxle.
- Place a long flat blade screwdriver between the front drive shaft and the transmission case as shown in Figure 3
 - Gently pry the front drive shaft outward (away from transaxle) while watching the drive shaft inner joint for movement

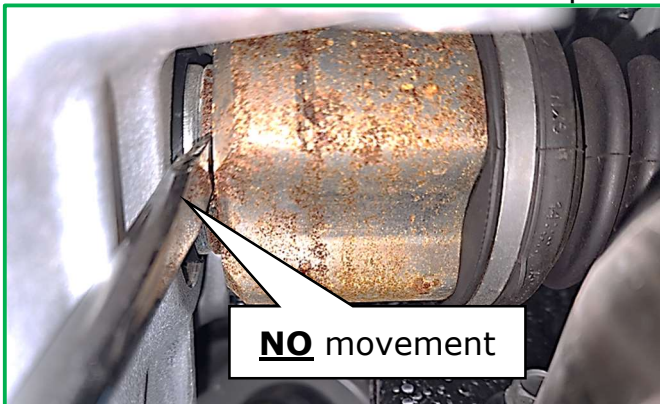
Good -
Drive shaft secured in transaxle with
NO movement

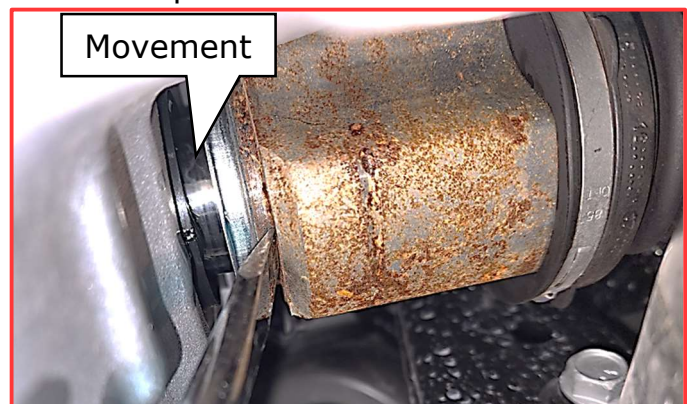
NO Good -
Drive shaft **NOT** secured in transaxle,
drive shaft moves out of transaxle

10. Remove the LH front drive shaft.

12. Replace the LH differential side oil seal (drive shaft seal).

13. Confirm the circular clip (C-clip) is correctly attached to the drive shaft.

- If the C-clip is present and not damaged, continue to Step 14 for reinstallation
- If the C-clip is missing or damaged, replace the C-clip (refer to parts section)

14. Reinstall the LH front drive shaft. Refer to the ESM section: **ESM section: TRANSMISSION & DRIVELINE - FRONT AXLE - REMOVAL AND INSTALLATION - FRONT DRIVE SHAFT - Removal and Installation (LH)**

- Torque the **NEW** wheel hub/front drive shaft nut to 165 N•m (17 kg–m, 122 ft–lb)
- Torque the lower ball joint to: 75 N•m (7.7 kg–m, 55 ft–lb)
