Technical product information

Topic	Bentayga V8 Kovomo - DTC P227900 evident within the engine control unit 0001
Market area	United States E05 Bentley USA and rest America (6E05)
Brand	Bentley
Transaction No.	2071575/3
Level	EH
Status	Approval
Release date

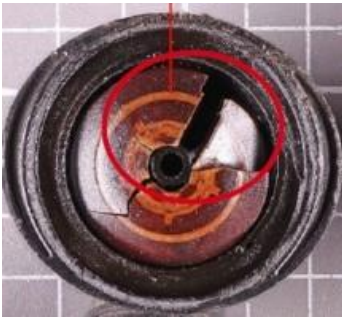
Figure 1

The issue described is due to a split breather diaphragm in one or both of the turbocharger full load pipes (Figure 1)

The diaphragm of the bank 1 turbocharger full load pipe is located at the end of the pipe and can be easily located however the diaphragm of the bank 2 turbocharger full load pipe is installed within the pipe and therefore will not be visible

Hint: the breather diaphragm could be split/damaged or missing

Hint: The diaphragm of the A,B and E suffix parts is orange (Figure 1)

1) Referring to Rep.Gr 21 - Replace the bank 1 (right) and bank 2 (left) turbocharger full load pipes

The operative should remove any debris belonging to the original diaphragm before fitting the new replacement pipes

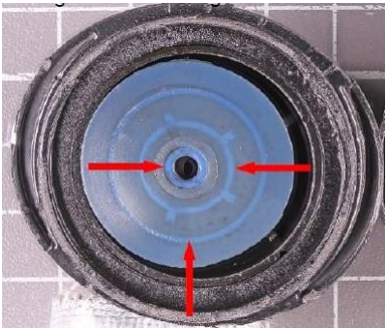
Figure 2

Hint: The diaphragm of 0P2 103 210G and 0P2 103 211H are blue (Figure 2)

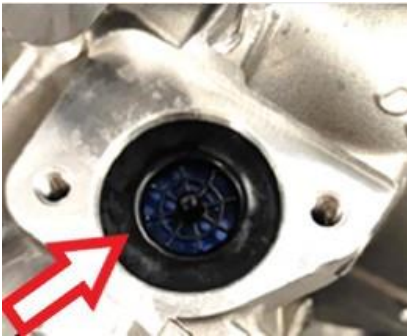
Figure 3

Production improvement was performed by fitting the diaphragm directly into the housing of the bank 1 and bank 2 turbochargers on all VINs post SJAAM2ZV3MC039237 (Figure 3)

VINs with this design are **not** subject to extended warranty

In the event the issue is evident post the suggested VIN the operative should raise a technical DISS query and await feedback before conducting any further work

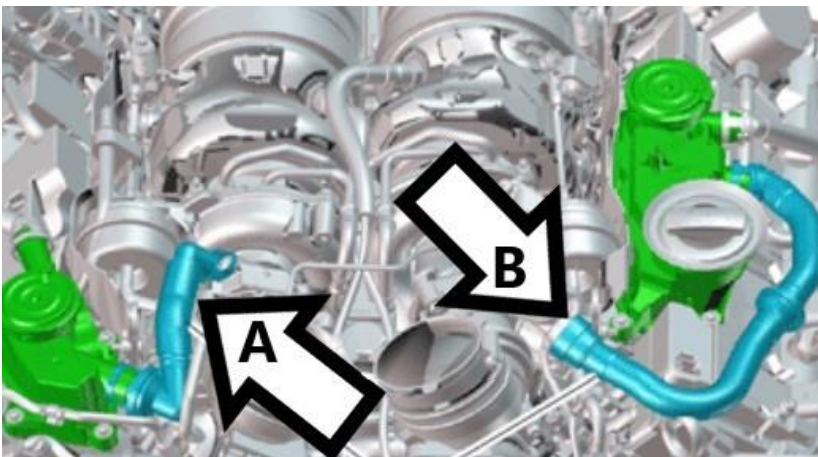
Figure 4

- Point A - Is the bank 1 (right) turbocharger full load pipe
- Point B - Is the bank 2 (left) turbocharger full load pipe

Note: when conducting the instructions within this TPI please ensure the bank 1 and bank 2 turbocharger full load pipes are replaced in pairs (during the same workshop visit)
