Service Bulletin

Bulletin No.: 24-NA-009

Subject: Loss of Forward Gear, Slipping, Malfunction Indicator Lamp Illuminated - DTC P2714 Set

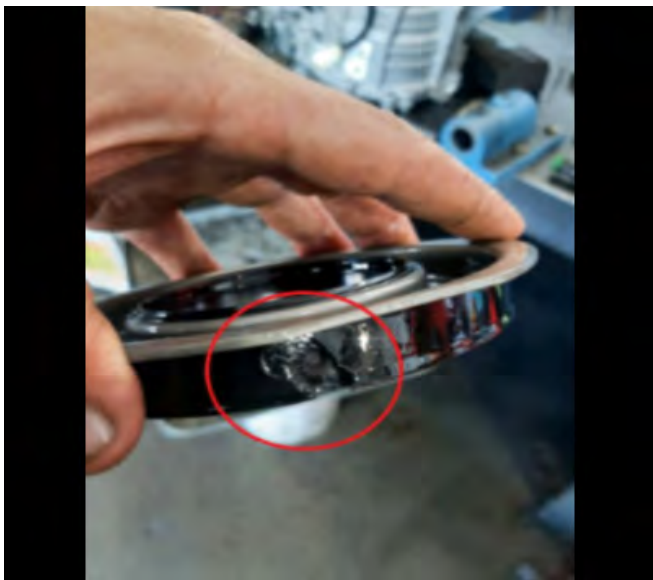
5896314

Inspect the Forward Clutch Piston for damage along the side.

If the Forward clutches are worn and there is damage seen to the Forward Clutch Piston, then replace the Forward Clutch Piston and Housing and the applicable apply components as needed.

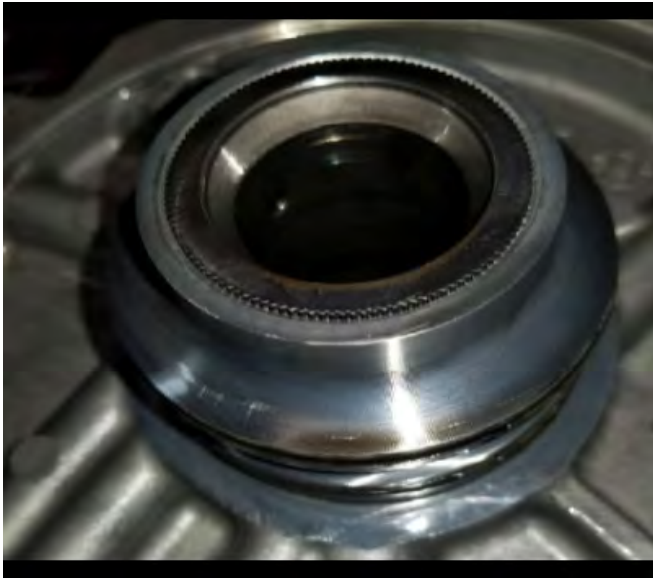
5892611

Note: The first 2 graphics show the outside of the pump, and the second 2 graphics show the wear that is found internal to the pump when wear to the Primary Pulley Bearing Bore is found.

If signs of wear are seen as shown, this indicates the Primary Pulley Bearing has spun in the bore and is allowing the Turbine Shaft to become off center. When this happens, it causes a pressure leak.

If this concern is found, the transmission will need to be replaced.
