WORK DESCRIPTION FOR FIELD MEASURE

Code: 23P7492005

Check right tailgate, rework if necessary

Model 254

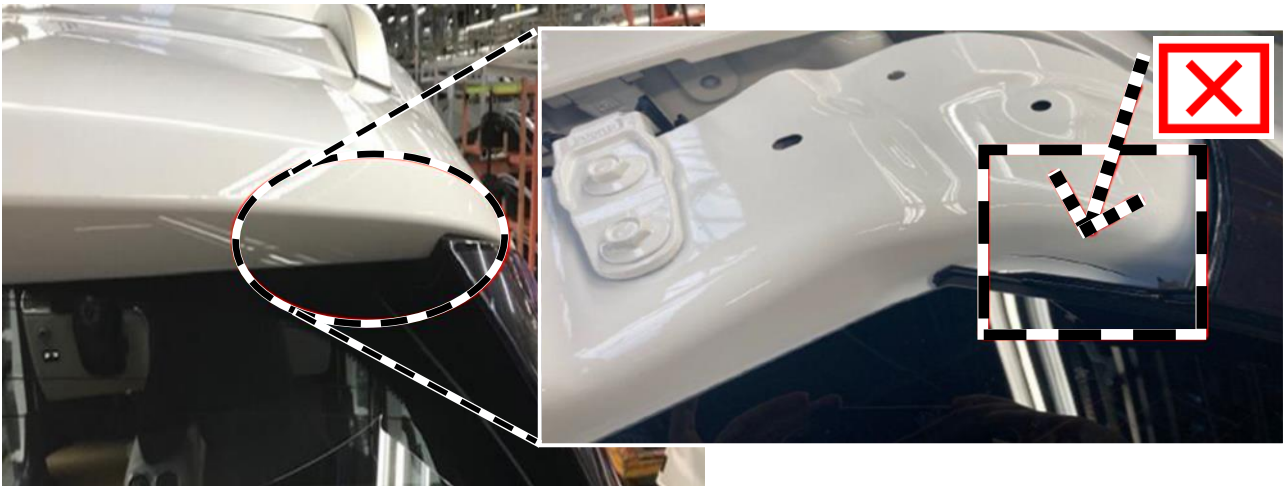
2. Check outer top right of rear-end door for constriction and crack formation (Figure 1).

Figure 1 (not OK)

- a. **No** crack or sheet metal constriction present on outer right of rear-end door: **End measure.**
- b. Crack or sheet metal constriction present on outer right of rear-end door: **Carry out work procedure.**

2. Drill off crack/sheet metal constriction on outer right of rear-end door at ends using a 2–3 mm drill bit.

3. Clean rear-end door in processed area, apply anticorrosion protection, and rework/seal the crack with seam sealant.
