| <b>Tesla, Inc.</b><br>Service Bulletin | | <b>Reroute RH Frame Harness</b> | |
| <b>SB-24-17-002</b><br>February 28, 2024 | | | |

On some Semi, the RH frame harness may rub against the thermal hose stud, which may damage the harness over time. Harness damage may result in Anti-Lock Braking System (ABS), traction control, and stability control alerts.

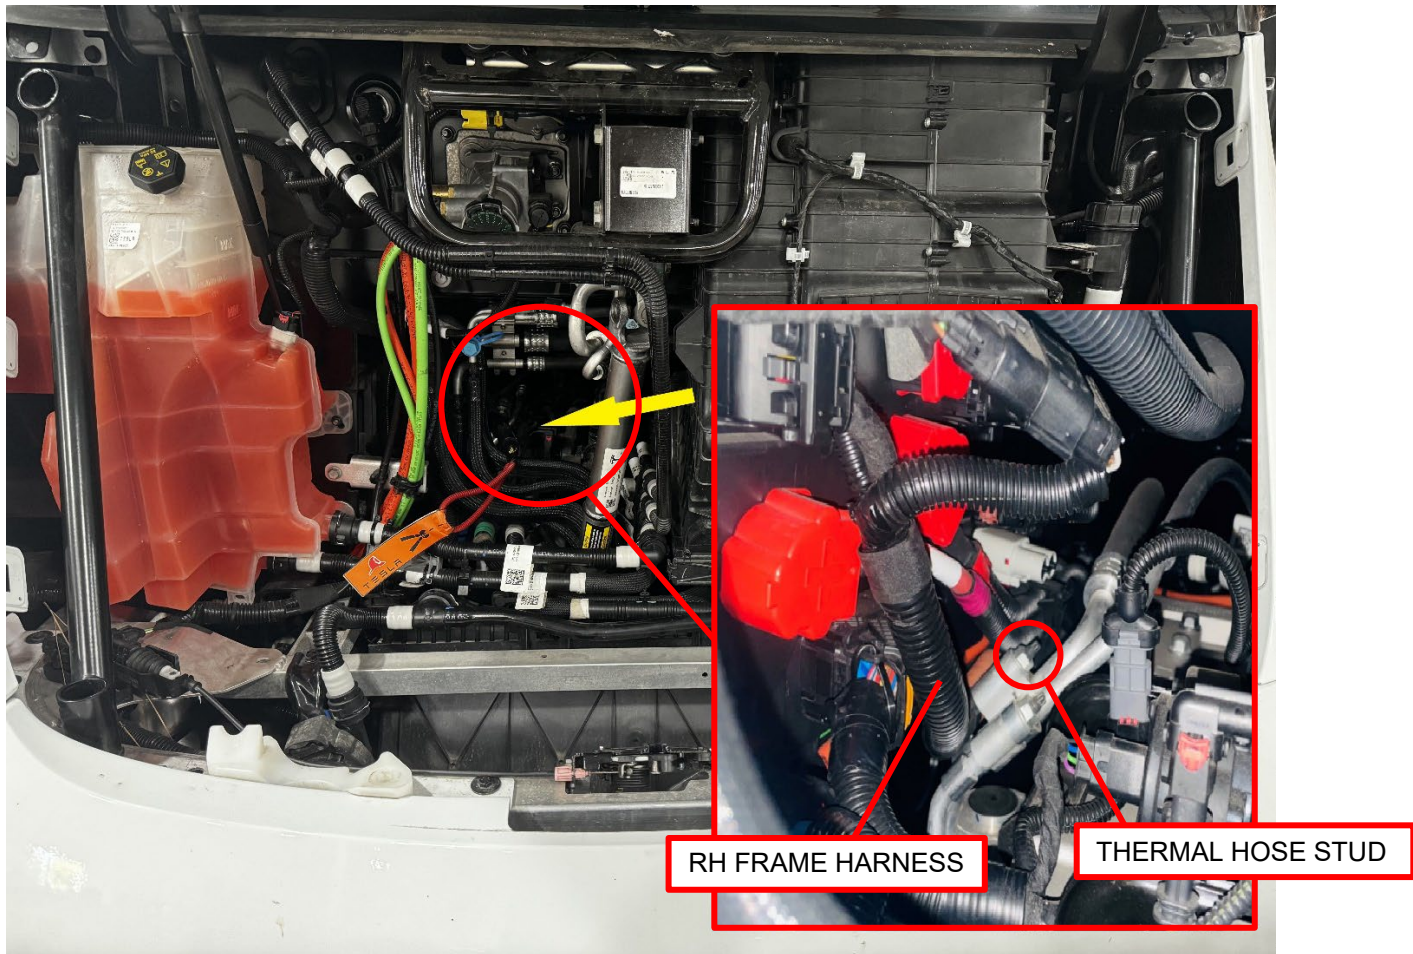
Figure 10 – RH frame harness inspection area

5. Inspect the RH frame harness for indications of damage or rubbing against the thermal hose (Figure 10).

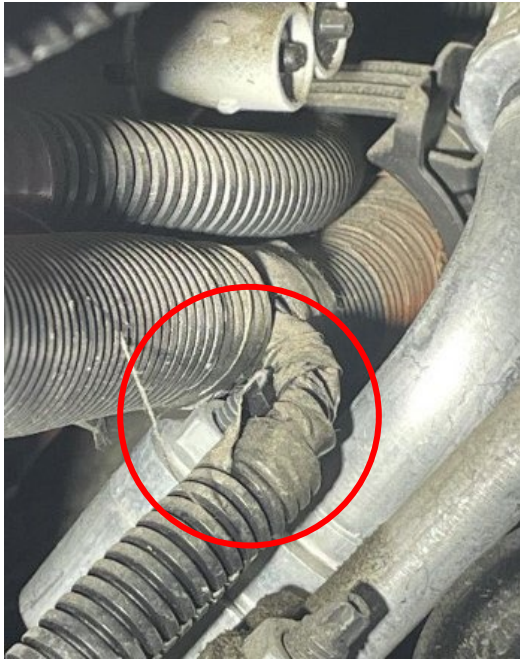
Figure 11 – Evidence of rubbing observed (1 of 2)

- Create a Toolbox session.
- Record the harness in question and description(s) of the rubbing or damage observed to the Toolbox session. Escalate the Toolbox session, wait for additional support, and then continue to step 6.

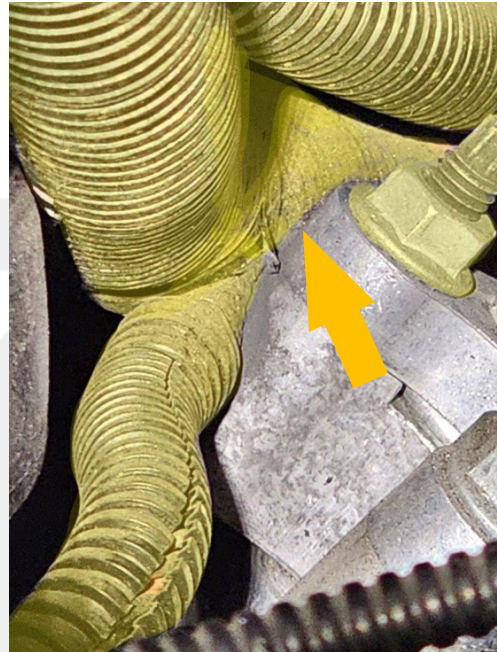
Figure 12 – Evidence of rubbing observed (2 of 2)

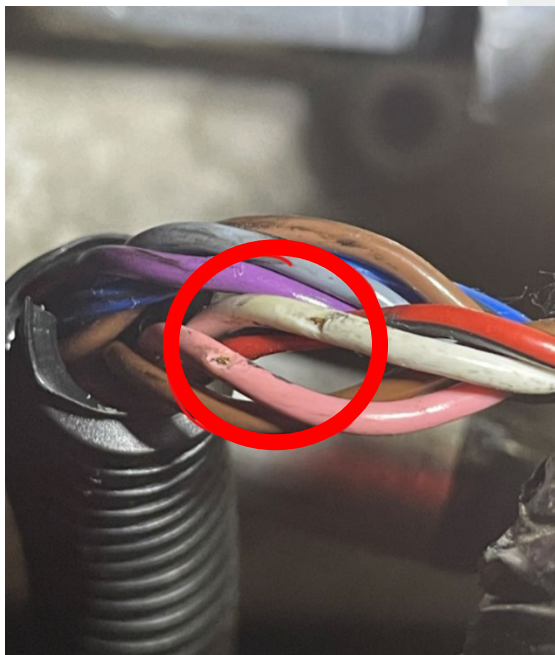
Figure 13 – Evidence of damage observed (1 of 2)

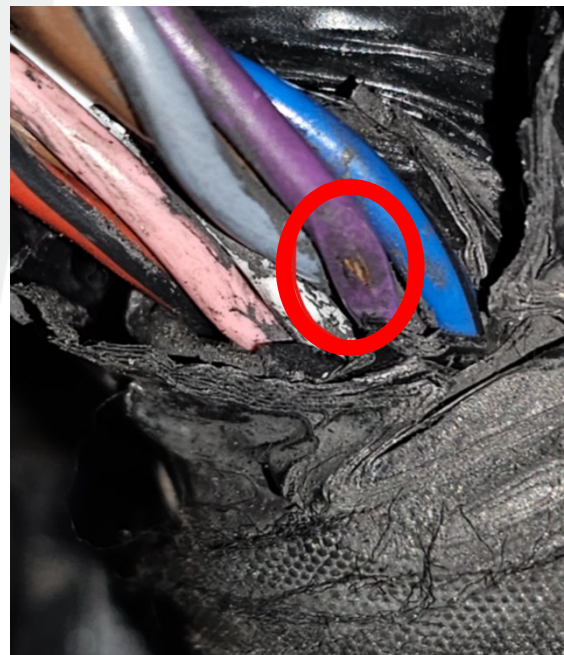
Figure 14 – Evidence of damage observed (2 of 2)
