# Service Bulletin

Bulletin No.: 24-NA-065

**Subject:** Chirp Noise from Center Stack/Radio Control

| Brand: | Model: | Model Year: | | VIN: | | Engine: | Transmission: |
|---|---|---|---|---|---|---|---|
| BrightDrop | Zevo 600 | 2023 | 2023 | - | - | All | All |

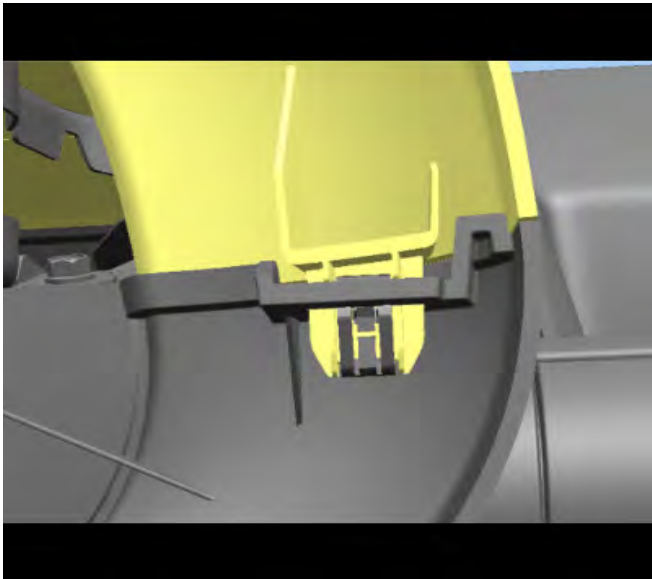
6596309

The radio control top cover is affixed using clips and can be popped off using trim stick.

**Note:** Not pictured is the ICS screen, screen does not need to be removed to complete repair.
