GROUP	MODEL
TRA	2020-2022MY Multiple Models
NUMBER	DATE
105 (Rev 1 4/08/2024)	November 2023

TECHNICAL SERVICE BULLETIN

4WD COUPLING NOISE INSPECTION AND SNAP RING REPLACEMENT

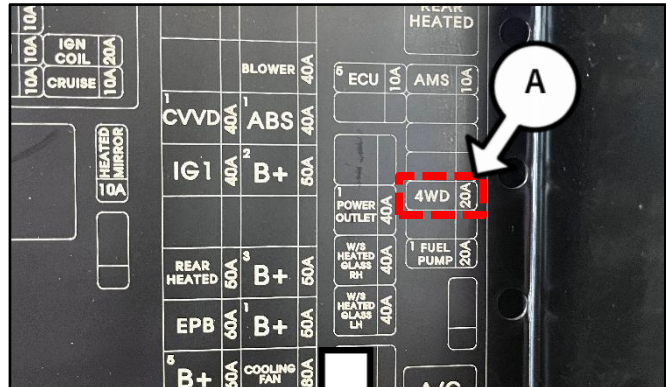
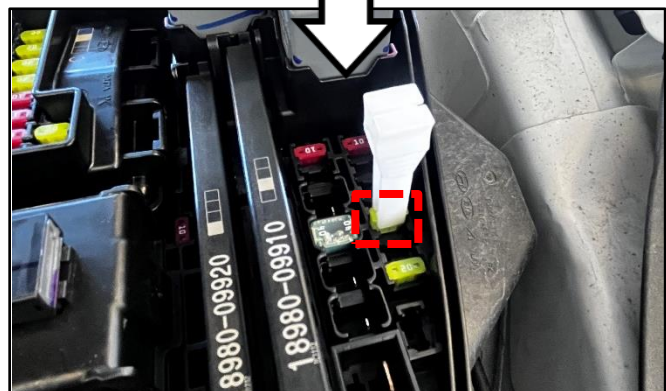
2.
 - If the noise is present and it resembles the noise in the referenced videos, remove the '20A' 4WD fuse (A) located in the engine room junction block and test drive vehicle again at speeds of 25MPH or less.
 - If a noise is present and does NOT resemble the noise in the referenced videos, **this TSB does not apply.**

DL3a junction block shown. ON, MQ4a, and MQ4 P/HEV junction block fuse orientation may be different.

3.
 - If the noise is no longer present, then proceed to the 'Replacement Procedure' on page 3.
 - If the noise is still present (other condition), refer to KGIS for troubleshooting procedures. **This TSB does not apply.**

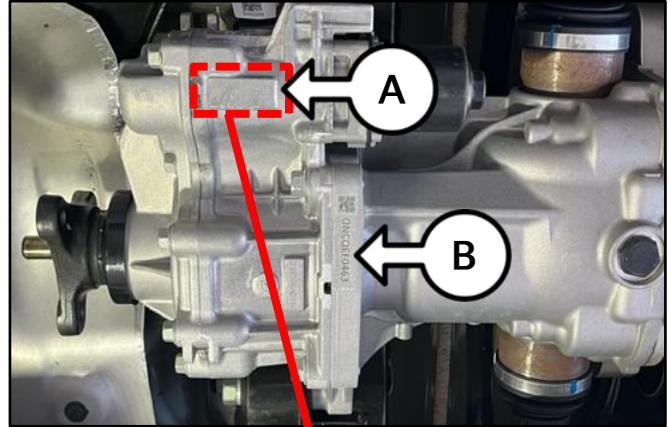
1. Raise vehicle on lift.
2. Place the vehicle in 'Neutral' (N).
3. Identify the nine (9) digit serial number (A) located on the 4WD Coupling (B).

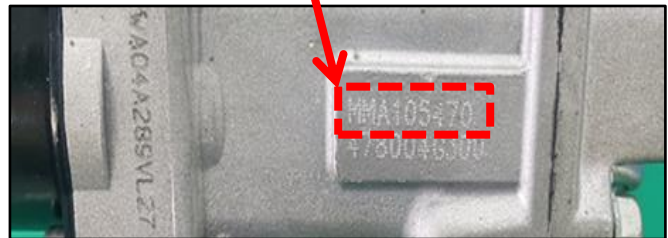
4. Notate the nine (9) digit serial number (A).

Note: If the serial number is illegible, replace the coupling assembly with DPSM approval. (DSA-A dealers do not require DPSM approval.)

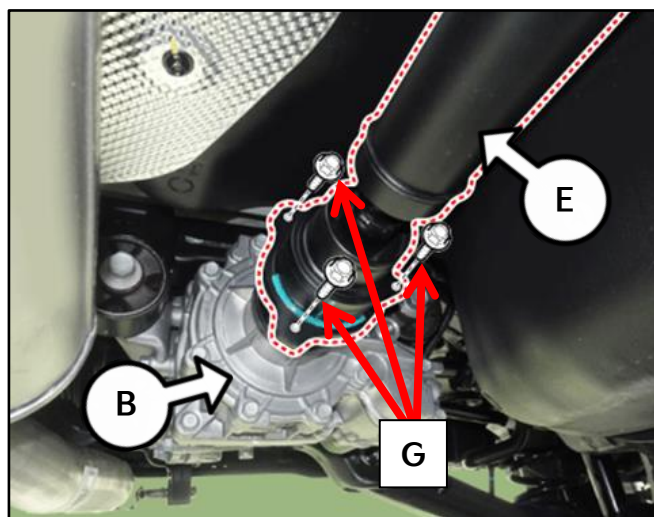
9. Loosen the three (3) propeller shaft retaining bolts (G) from the 4WD coupling (B).

Tightening torque for bolts (C):
 Telluride (ON)
 42.0 - 47.7 lb.ft (56.9 - 64.7 N.m)
 K5 (DL3a)
 36.1 - 50.6 lb.ft (49.0 - 68.6 N.m)
 MQ4a & MQ4 P/HEV
 39.8 - 50.6 lb.ft (53.9 - 68.6 N.m)

DO NOT reuse the propeller shaft mounting bolts.

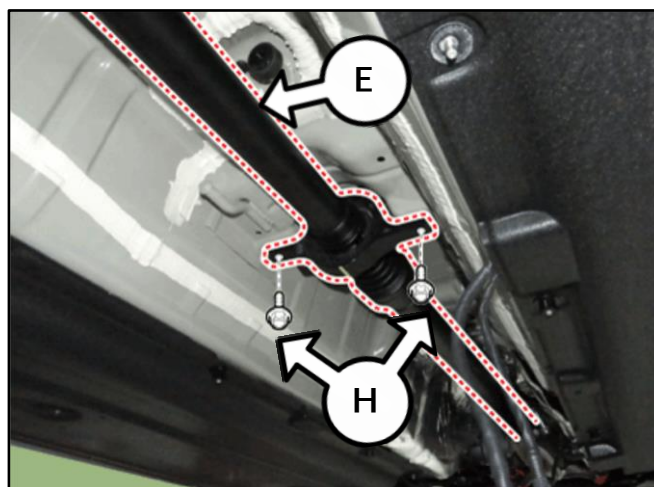
10. Loosen the two (2) center bearing bracket bolts (H) and lower propeller shaft (E).

Tightening torque for bolts (E):
 Telluride (ON)
 36.1 - 50.6 lb.ft (49.0 - 68.6 N.m)

Use a cable tie/strap to hold/secure the propeller shaft. It is not necessary to completely remove the propeller shaft.

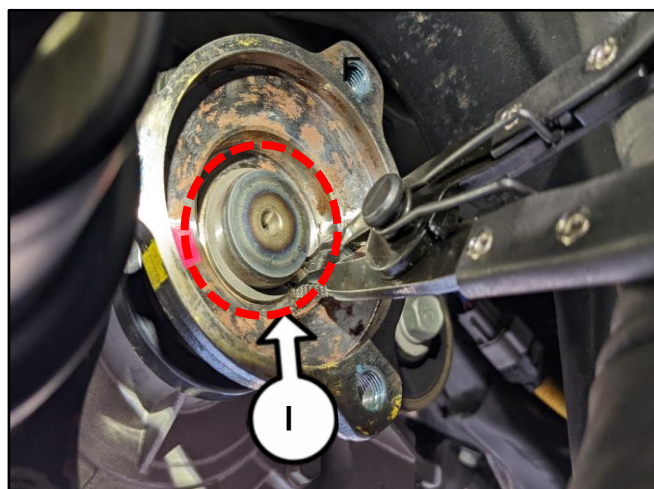
11. Using a snap ring plier, remove the snap ring (I).

The 4WD coupling does NOT need to be removed from the vehicle. Removing the coupling from the vehicle can cause fluid to leak, which cannot be replenished. If fluid leaks from the coupling, the coupling will need to be replaced.

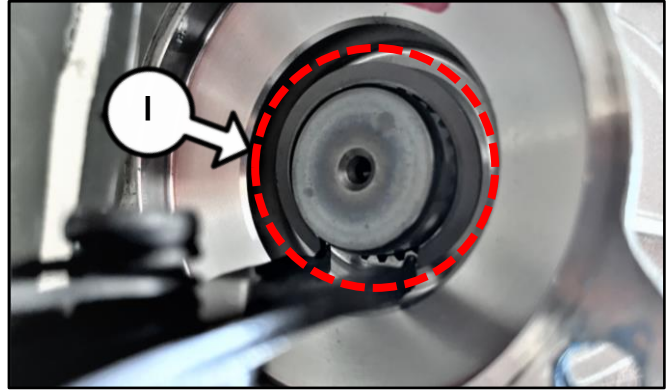
12. Install the new snap ring (I).

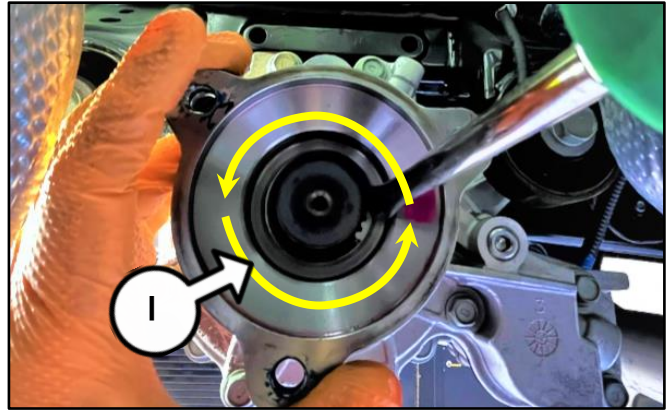
13. Using the snap ring plier or a flathead screwdriver, confirm the newly installed snap ring (I) rotates properly.

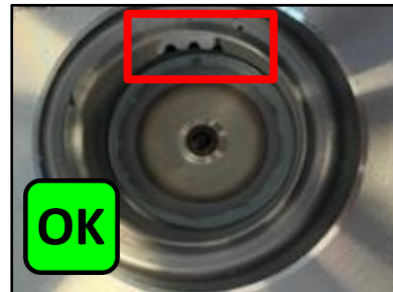
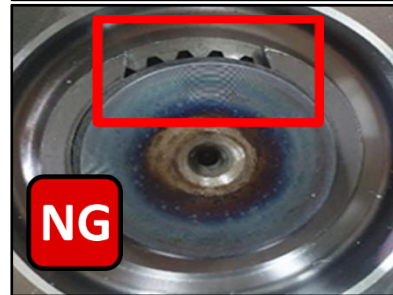
- 14.
- If the number of visible splines is 2.5 - 3 splines (OK), proceed to step 15.
 - If the number of visible splines is 4 - 5 splines (NG), the snap ring will need to be replaced with a new one.

15. Install all removed parts in the reverse order of removal.

Make sure to reassemble the propeller shaft retaining bolts (G) in the same position they were removed from. Failure to do so may cause an imbalance in the propeller shaft which may lead to a vibration at high speeds.
