CADILLAC
DCS6853
URGENT - DISTRIBUTE IMMEDIATELY

Subject: UPDATE: N232428540 - Customer Satisfaction Program
Multiple Module Reprogramming
Population Expansion

Models: 2023 Cadillac LYRIQ

N232428540 Multiple Module Reprogramming

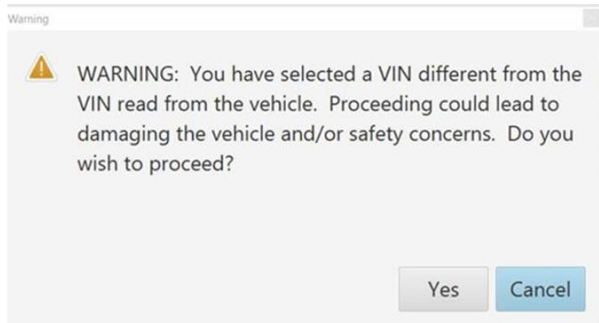
Important: If the vehicle VIN DOES NOT match, the message below will be shown.

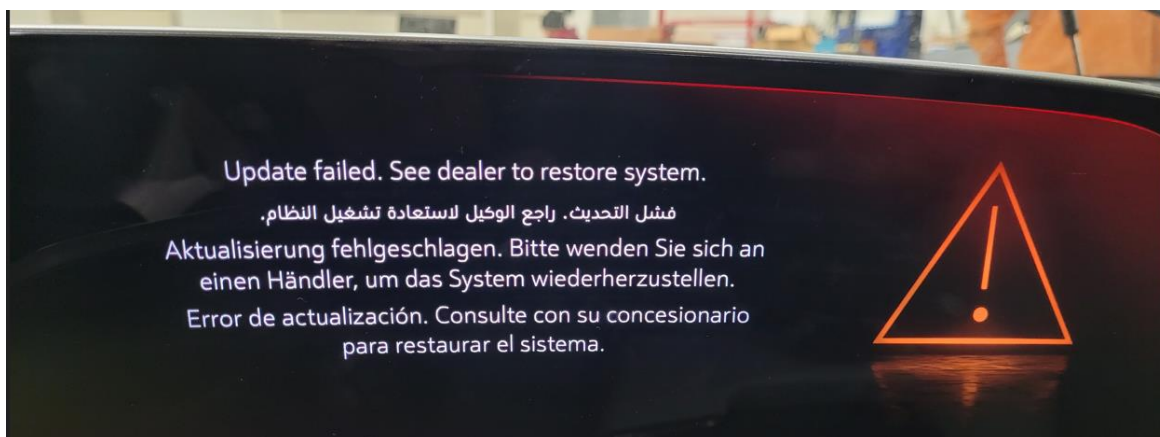
1. There is a chance for an error to be encountered during the USB update portion of the procedure right around 60% completed.
 - 1.1. This happens once the USB is in the vehicle and the progress bar can be seen on screen.
2. If the error occurs the screen will look like below

3. In this case pull the USB from the vehicle and reformat again as shown in step 7 under service procedure.
4. Access the Service Programming System (SPS) and follow the on-screen instructions.
5. On the SPS Supported Controllers screen, select A11 Radio – USB Copy/USB File Transfer.
6. Upon completion of the file transfer, properly eject the USB drive from the computer.
7. Connect the USB drive to the USB port in the vehicle.
 - 7.1. If the screen fails to show a progress bar once reinserted, pull out and reinsert again.
8. These steps should allow the progress bar to restart and complete successfully.
9. If you require further assistance, or would like verbal instructions in addition to this part of the service procedure please contact Techline Customer Support Center 1-800-828-6860 for English or 1-800-503-3222 for French (Canadian) for assistance.
