Preliminary Information

PIT5832L Diagnostic Tip: Unable to complete the Serial Data Authentication Configuration/ No Start Or Unable To Perform Theft Relearn After Replacing Or Programming A Module / DTC U1962

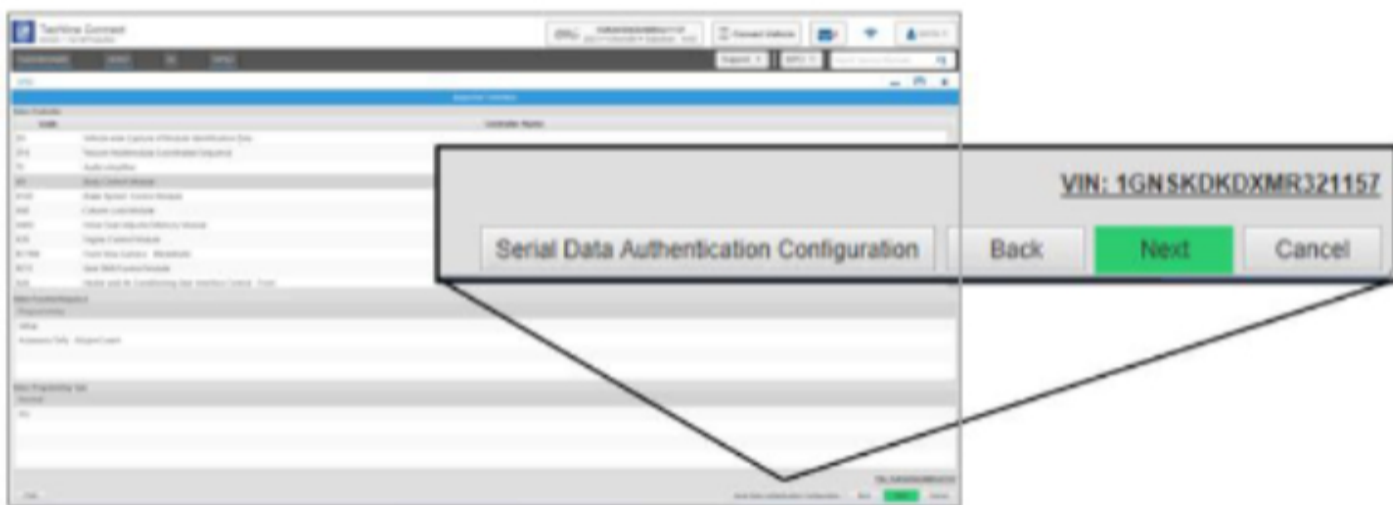
3. If a vehicle will not complete the SDAC, run the SDAC (using the Serial Data Authentication selection in Techline Connect) again. Make sure the vehicle is in the OFF position and the key fobs are more than 10 feet away from the vehicle. Select the box in SPS controller list in the lower right-hand corner labeled "Serial Data Authentication Configuration".

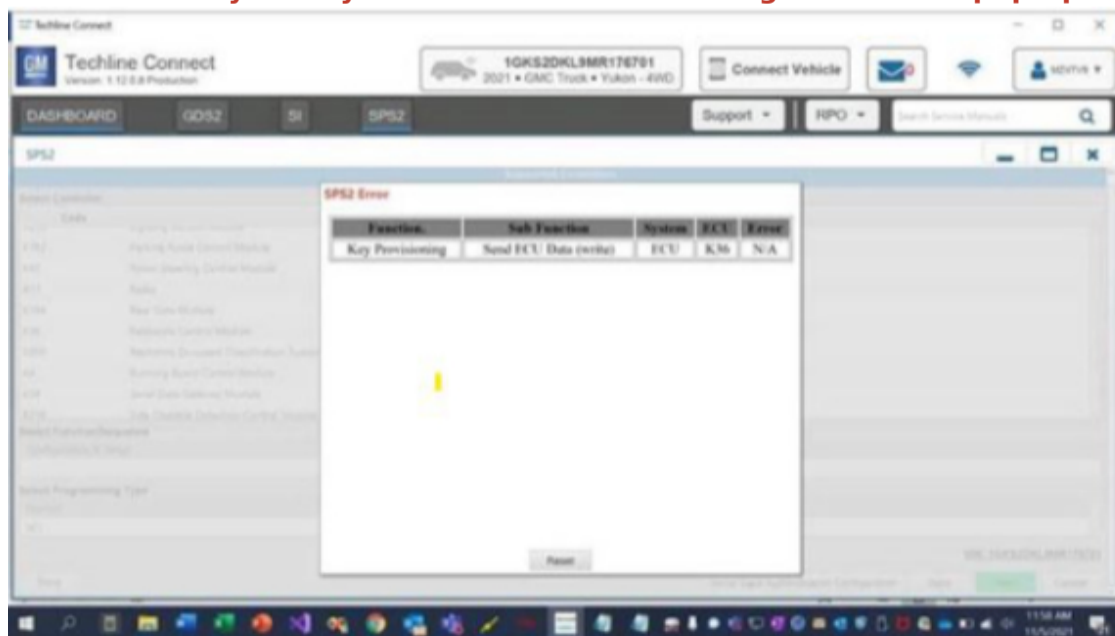
4. The SDAC will run up to 3 times before it fails. When it fails, there should be a pop box that shows up on the screen like the one below. Check and record the items listed under System and ECU. If the system box reads "Server" then the issue is related to the SPS system server or internet connection and not related to the vehicle. Attempt the SDAC again at a later time or the next day early in the morning. (If the box doesn't read "Server" continue to step 5).

5. If the system box reads "ECU", then the Global ID of the module that is causing the concern should be able to be obtained. In the example above, the Global ID is listed as K36, which is for the SDM. The module's name can be found by looking at the global codes listed under "Control Module References" document in SI for the vehicle that is being working on
6. Sometimes the pop-up box will read "ECU" but it will not give you a Module ID in the ECU box. In this case,

7. Once the module that caused the concern has been identified, attempt to SPS program the module if a update is available and then attempt to run the SDAC again.
