Bulletin No.: PIT5110D  
Published date: 03/11/2024

### PIT5110D Crank No Start (Check UBEC And Fuel Pump Connectors)

Brand:	Model:	Model Years:	VIN:		Engine:	Transmissions:
			from	to		
Chevrolet	Express	2010 - 2012	All	All	4.3L, 4.8L, or 6.0L	All
GMC	Savana	2010 - 2012	All	All	4.3L, 4.8L, or 6.0L	All

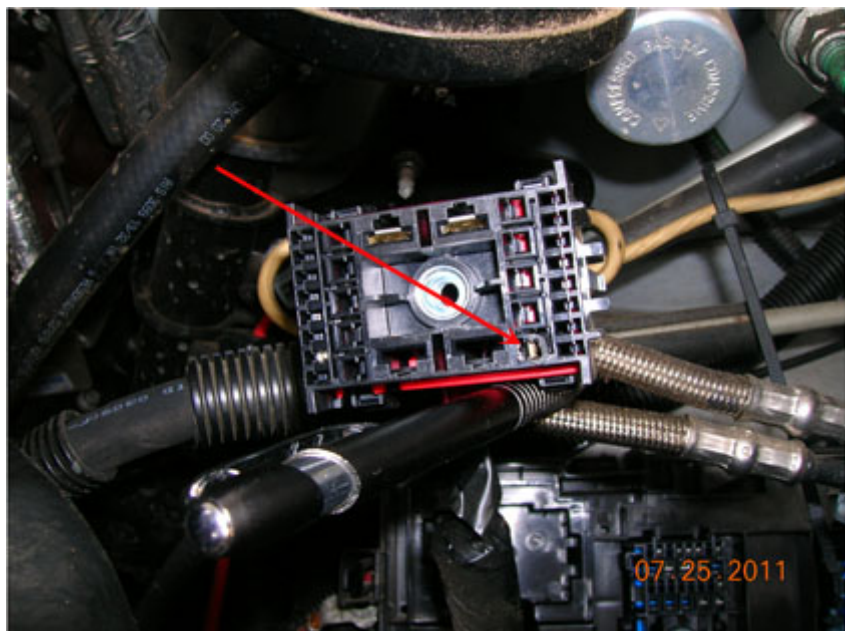
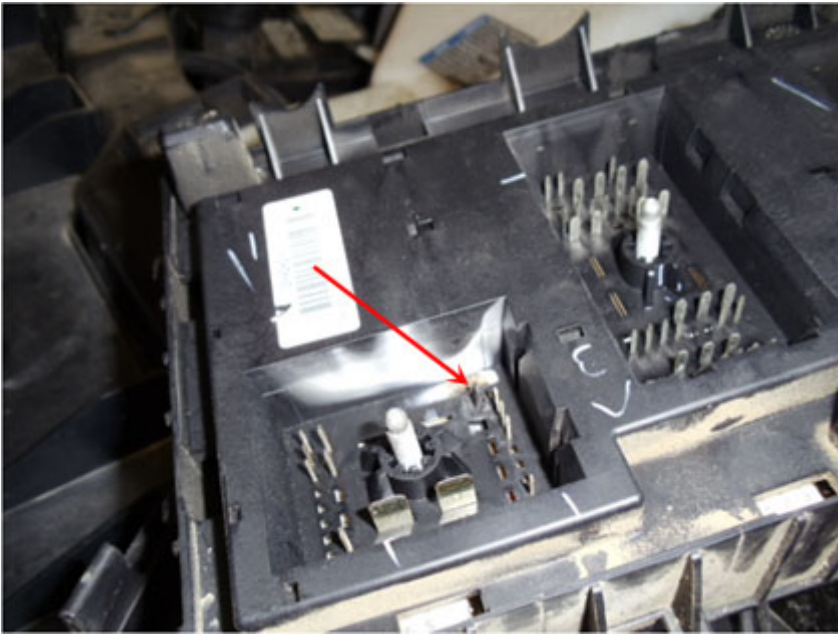
Some owners may comment on a crank no start concern. This concern may be caused by a poor connection in the fuel pump circuits. Inspect the following areas for poor connections:

1. UBEC X2 connector terminal B1, see pictures (Primary Area Of Concern).

1. **DO NOT** replace the fuel pump for a UBEC connection concern. Inspect the UBEC X2 Connector Cavity B1 for discoloring, deformation or poor terminal tension. If any issues are found, repair using the following:

-UBEC X2 Connector Body: PN 19180280.

-Terminal: PN 13525969 in Deliph Tay 4 (See SI connector end view for service tools and crimp tool Or Terminated lead p/n19303708 ordered from CCA parts.

-UBEC: See Parts Manual For Part number.
