## PIP5898B Rear Axle Leak

Product Investigation Review Required

Brand:	Model:	Model Years:	VIN:		Engine:	Transmissions:
			from	to		
Cadillac	ATS	2013 - 2019	All	All	LTG, LCV, LFX, LGX	MYA, M5T, M5N
Cadillac	CTS	2014 - 2019	All	All	LTG, LCV, LFX, LGX	MYA, MGG, M5N

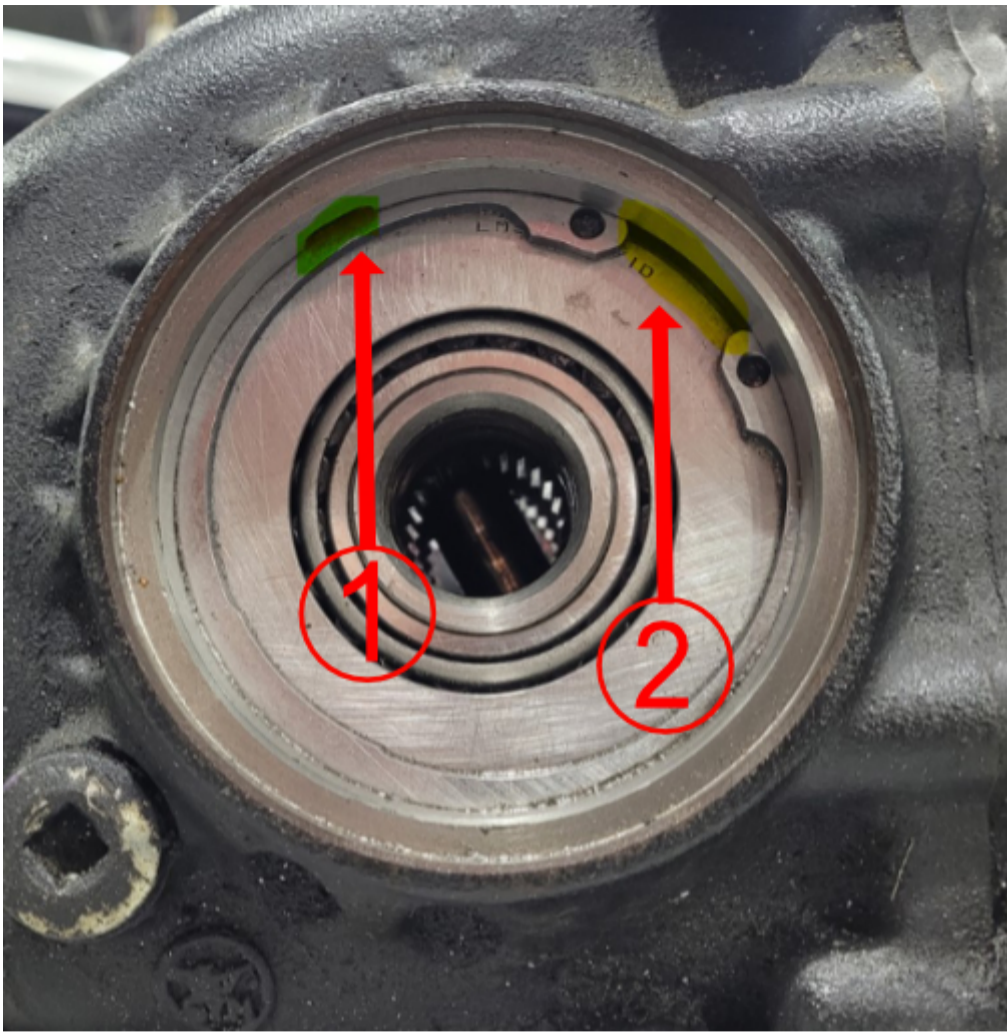
Involved Region or Country	North America
Additional Options (RPO)	195 MM Axle For ATS only with FE2
Condition	Some customers may comment that the rear differential carrier assembly is leaking.
Cause	This condition may be caused by the side bearing retaining ring on one or both sides blocking the rear axle shaft seal oil feed port. The oil feed port being blocked causes the seal to not receive proper lubrication and thus fail prematurely.

If the lube passage (1) is blocked by the snap ring as pictured below continue on to step 4. If the opening in the snap ring (2) is properly lined up with the lube passage (1) proceed to step 3.

5) If either side the snap ring is blocking the lube passage you will need to remove the differential assembly to move the snap ring to the correct orientation. Repositioning of the snap ring should NOT be attempted in vehicle. See Differential Carrier Assembly Replacement and If either snap ring is out of position then use labor operation 3087998 below.

6) Since the seals are removed put the differential on the bench on its side so the snap ring faces up. Using a pair of large snap ring pliers reposition the snap ring to unblock the oil feed port. J-45126 was used and it was easier to compress the snap ring and tap it lightly to loosen it in the groove, rotate the snap ring so that the opening in the snap ring (2) lines up with the lube passage (1) to allow lube to get to the seal. make sure the snap ring is fully seated in the groove once the proper orientation is achieved. Repeat for one or both sides as needed.

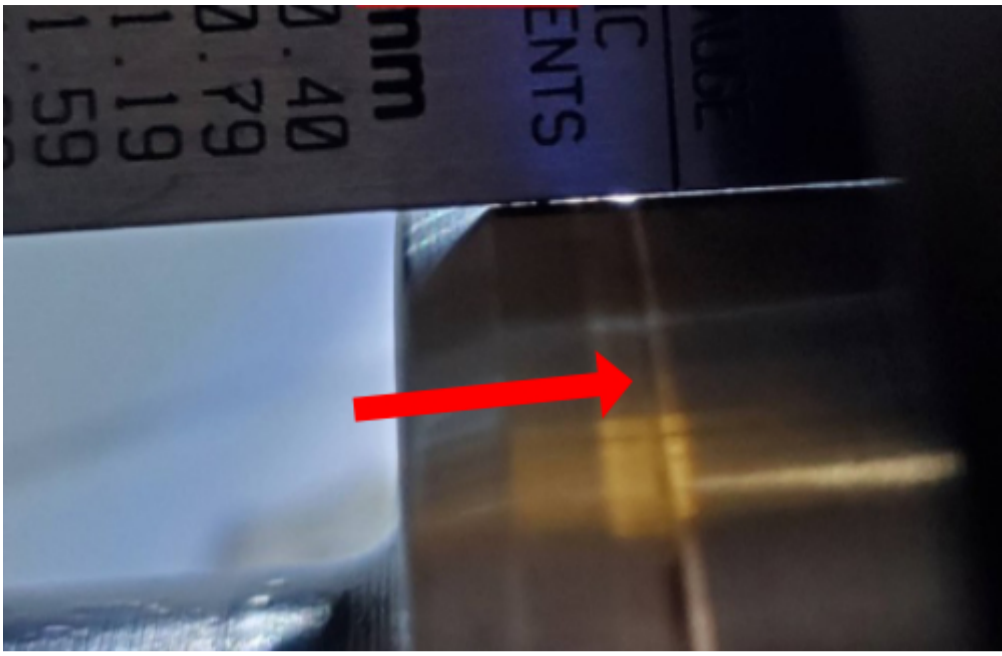
Worn

7) Inspect the shaft of the wheel drive shaft flange for any damage caused by the seal. Top is a flange needing replacement, Bottom is a flange that is showing normal wear.

8) Replace the wheel drive shaft flange as necessary.
