### PIP5932A Information on Malfunction Indicator Lamp (MIL) Illuminated with Any Combination of DTCs P0521, P06DD or P06DE Setting

Brand:	Model:	Model Years:	VIN:		Engine:	Transmissions:
			from	to		
Chevrolet	Trax	2024	All	All	1.2L LIH	All

Involved Region or Country	North America
Condition	MIL on with P0521 and/or P06DD, P06DE stored.
Cause	Several potential causes - oil pump debris - engine wiring harness issue.

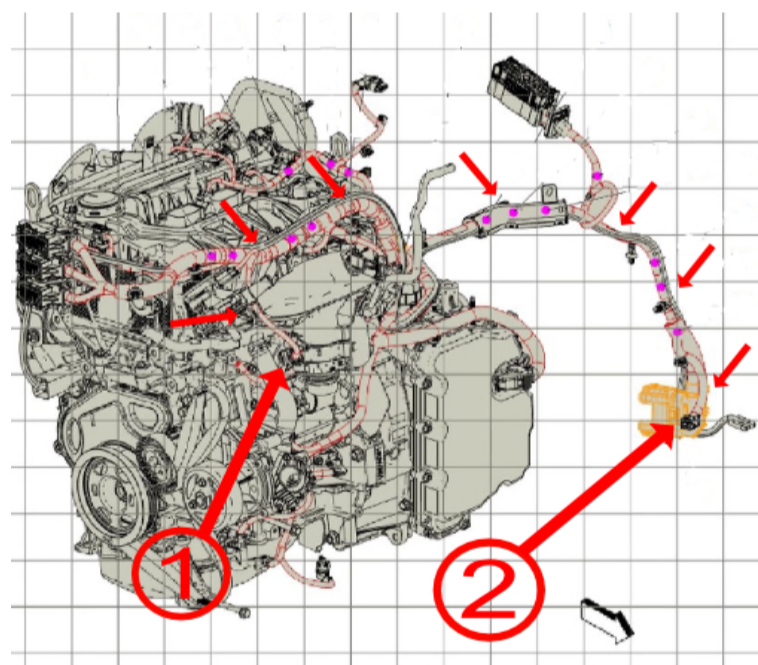
If the resistance is within range, tap and manipulate the engine wiring harness between the oil pressure sensor (1) and X125 (2) shown below, while monitoring for a change in the resistance reading.

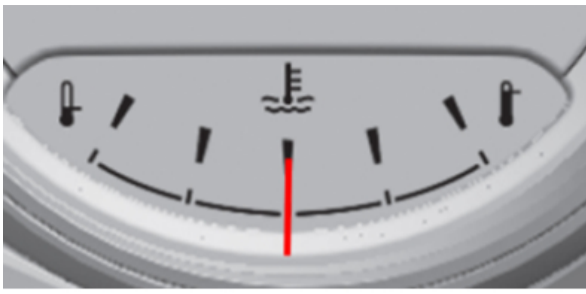
Start and run engine for minimum 15 minutes until the coolant temperature gauge needle is centered in the gauge.
