# Preliminary Information

## PIT6105B LCDD Data Provisioning Message On Replacement Radio

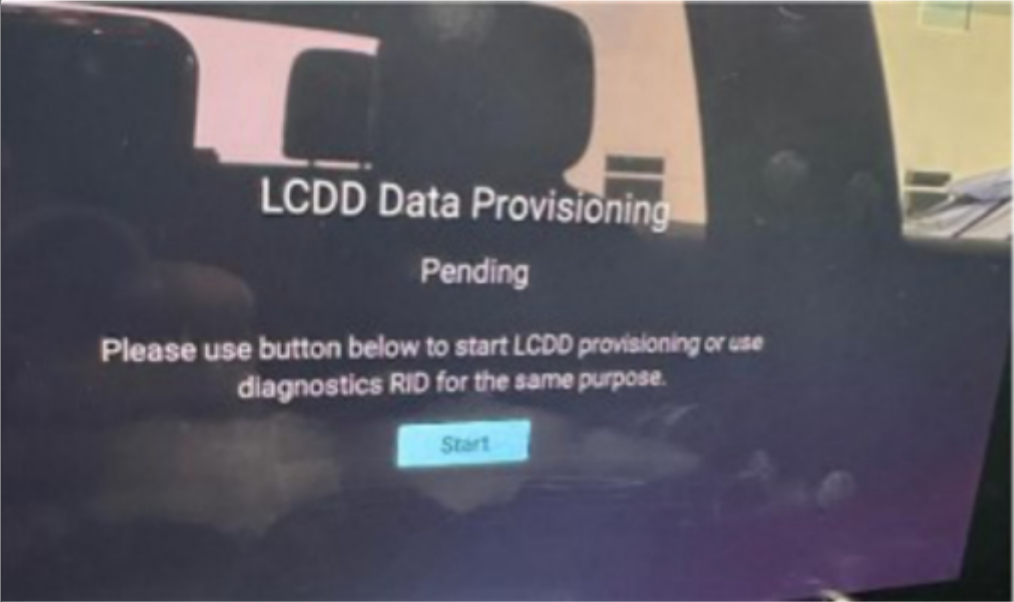
Involved Region or Country	North America
Additional Options (RPO)	IVD and IVE
Condition	<p>When installing a replacement radio, the technician may notice the LCDD Data Provisioning message.</p>

Cause	Radio software anomaly

**Correction:**

Before performing USB programming and SPS programming, press "Start" on the radio display.

After it completes, proceed with published Service Information programming for the A11 Radio.
