Bulletin No.: PIT6136  
Published date: 03/20/2024

### PIT6136 Diagnostic Tip: Antilock Brake System (ABS) Lamp Illuminated, Diagnostic Trouble Code (DTC) C0513, C0514, C0515, C0516

Brand:	Model:	Model Years:	VIN:		Engine:	Transmissions:
			from	to		
Chevrolet	Silverado EV	2024	All	All	All	All

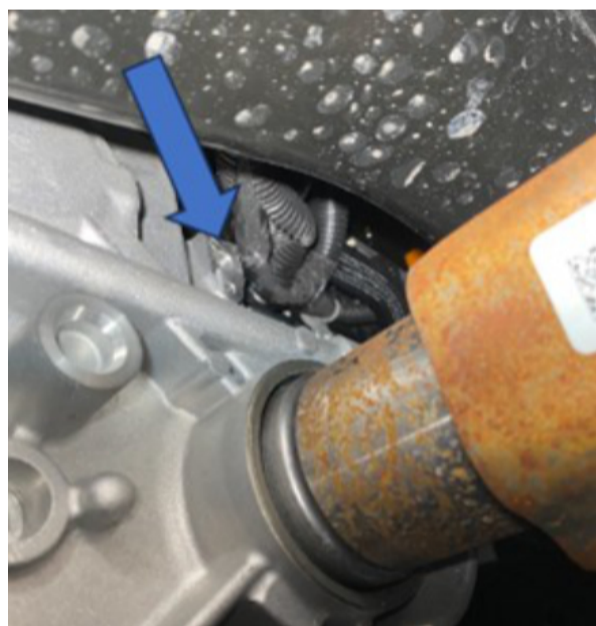
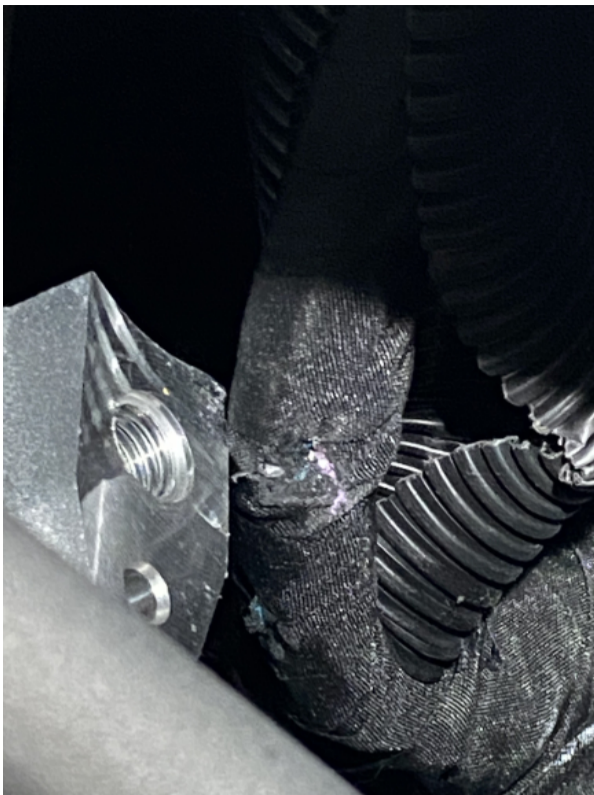
Involved Region or Country	North America
Condition	A customer/driver may comment of a ABS light illuminated followed with a "Service Stability " message.
Cause	This may be due to the ABS wiring harness making contact with the top edge of the rear drive unit (DU) above the right rear axle.  See Photos Below.

Inspect the location show above the right rear axle and repair wiring and re-route harness as needed.
