## PIT6141 Check Ball and Cap Location When Replacing Power Brake Booster or Power Brake Booster Pump

| Brand: | Model: | Model Years: | VIN: | | Engine: | Transmissions: |
|---|---|---|---|---|---|---|
| Chevrolet | Silverado 4500HD, 5500HD, 6500HD | 2019 - 2023 | All | All | All | All |

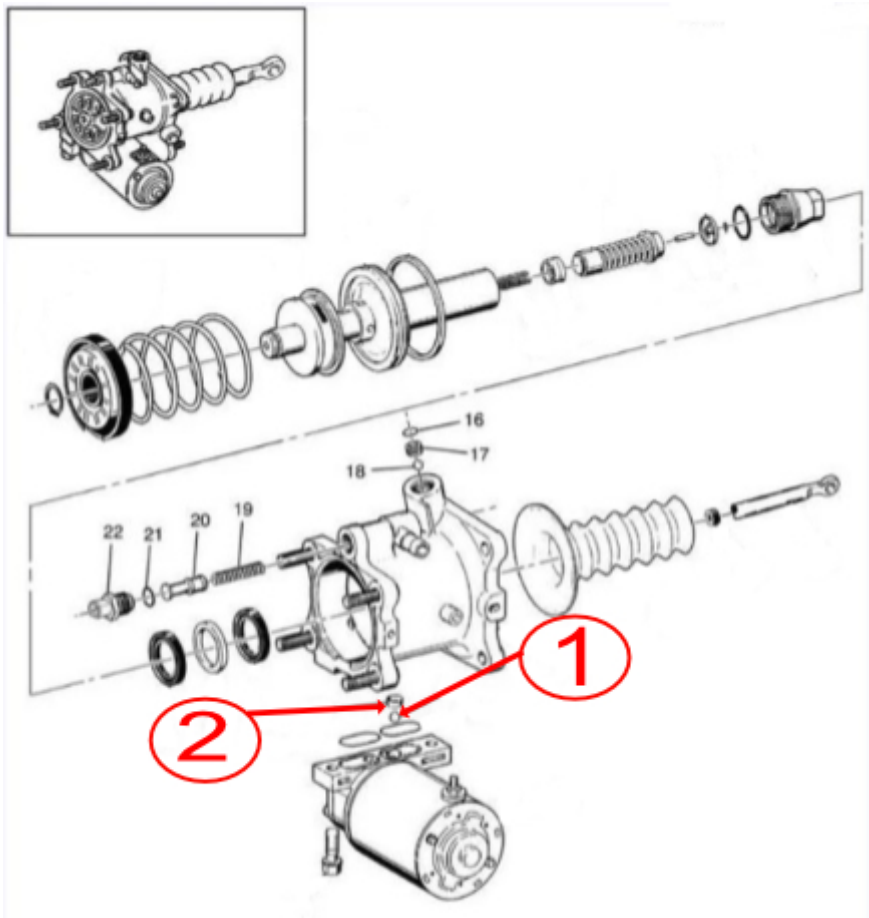
| Condition | A technician may find a check ball and plastic cap that separated from the brake booster pump motor when the pump is separated from the booster. |
| Cause | The cap and check ball may have pulled out of the pump motor when it was separated from the brake booster (possibly falling on the ground.) |

Insert check ball (1) and cap (2) into rear most port (towards brake pedal push rod on brake booster) as shown below:
