TECHNICAL INSTRUCTIONS
FOR
CUSTOMER SUPPORT PROGRAM 23LE05
HV FLOOR UNDER WIRE HARNESS AND REAR TRACTION MOTOR CABLE
CORROSION
CERTAIN 2022 - 2023 MODEL YEAR NX350 HYBRID

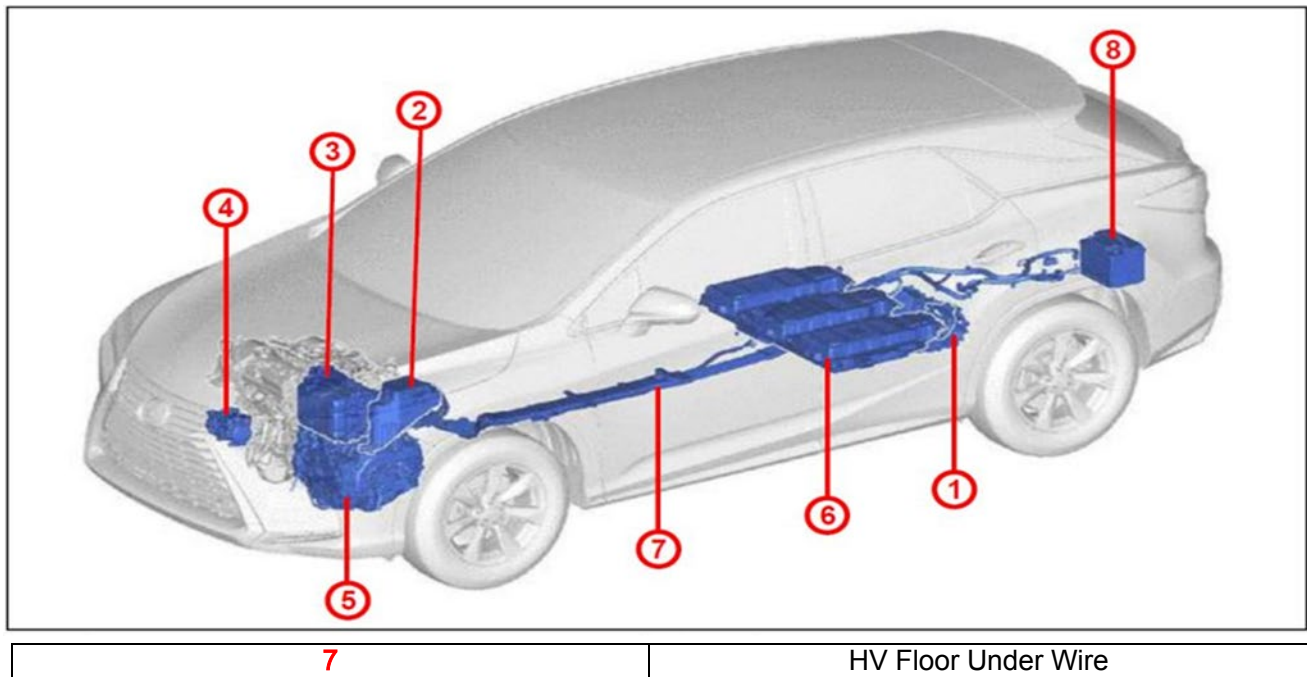
Although the HV Floor Under Wire Harness and Rear Traction Motor Cable is covered by Lexus New Vehicle Limited Warranty for 4 years or 50,000 miles (whichever comes first), we at Lexus care about the customers' ownership experience. Lexus is providing coverage for repairs related to excessive corrosion to the wire harness connections at the Rear Motor Generator. Excessive corrosion can cause AM Radio Static during certain drive cycles or the vehicle may not start.

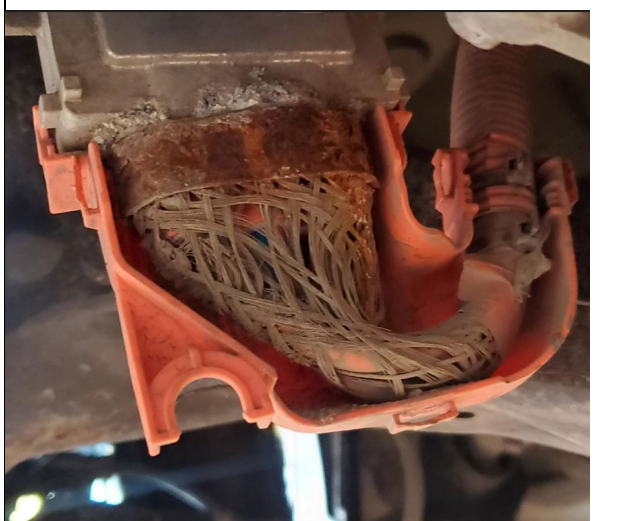
Y6 connector under vehicle at MGR

- 5) **Inspect the Y6 connection for corrosion**
- Disconnect the Y6 connector at the MGR and inspect for corrosion, dirt, or debris.

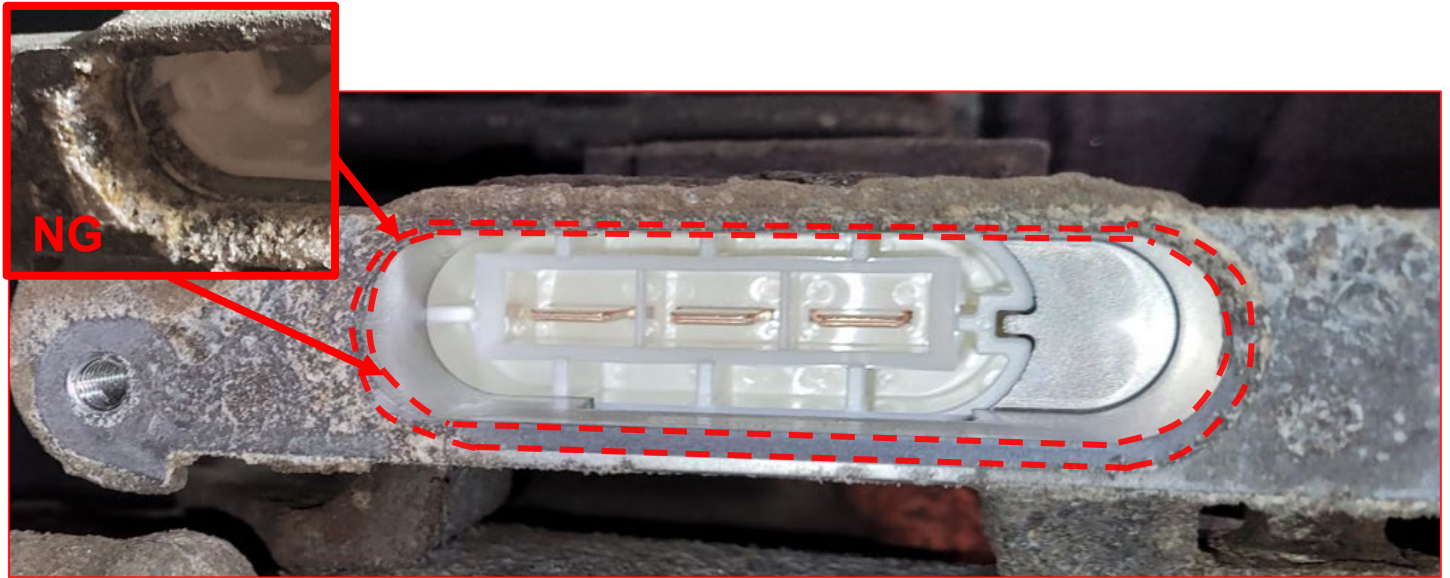
- a) Inspect the chamfer of the MGR connector housing for pitting and corrosion on the sealing surface. Corrosion in this area will cause the seal to leak. Are pitting and corrosion present?

YES – Rear Traction Motor Cable requires replacement, continue to Section VI.
