**TECHNICAL INSTRUCTIONS**

**CUSTOMER SUPPORT PROGRAM 22TE09**

**HV FLOOR UNDER WIRE HARNESS AND REAR TRACTION MOTOR CABLE  
CORROSION**

**CERTAIN 2022 MODEL YEAR NX450H+**

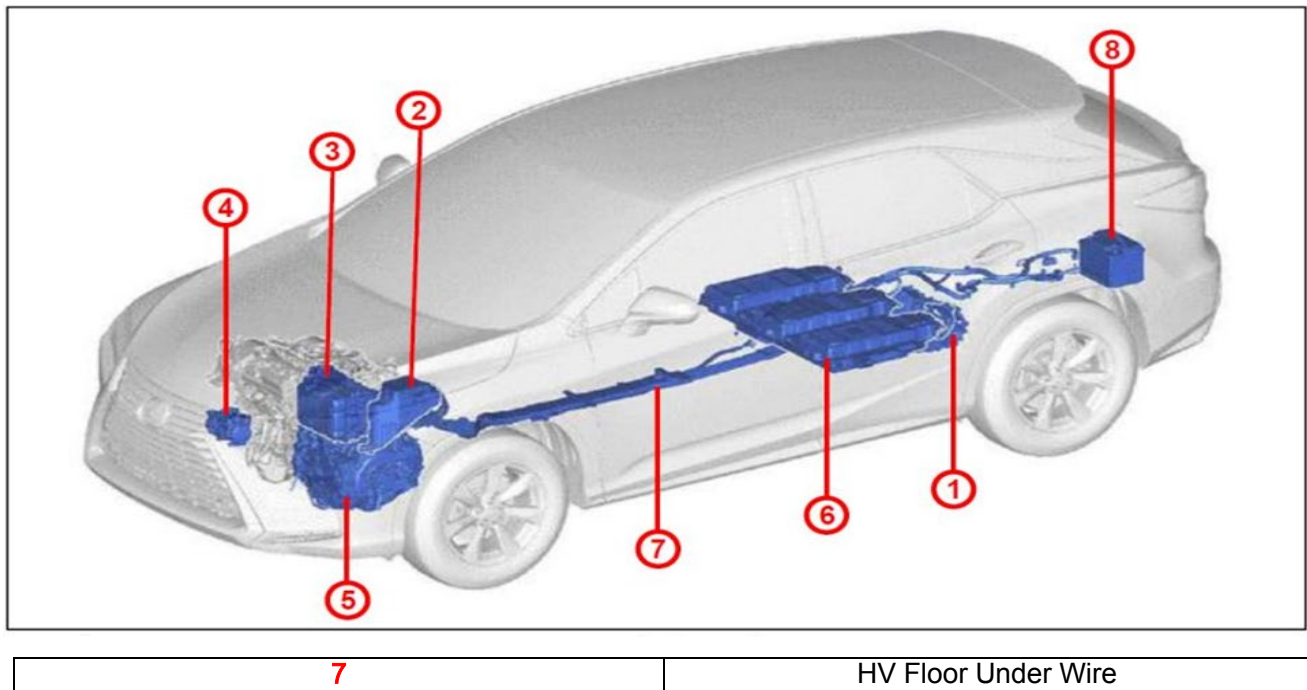
Although the HV Floor Under Wire Harness and Rear Traction Motor Cable is covered by Lexus's New Vehicle Limited Warranty for 4 years or 50,000 miles (whichever comes first), we at Lexus care about the customers' ownership experience. Lexus is providing coverage for repairs related to excessive corrosion to the wire harness connections at the Rear Motor Generator. Excessive corrosion can cause AM Radio Static during certain drive cycles, or the vehicle may not start.

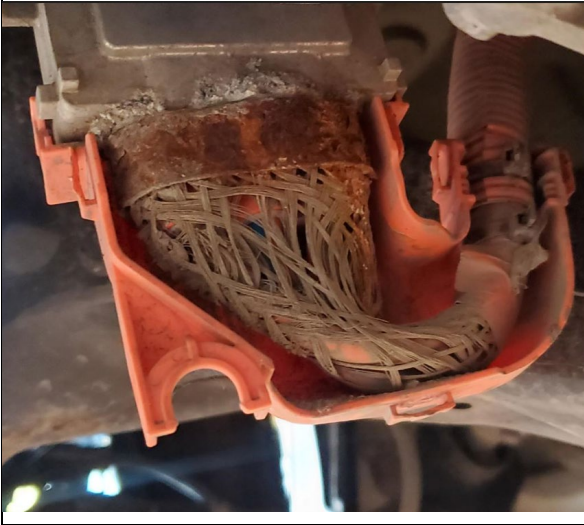
**Y6 connector under the vehicle at MGR**

- 5) **Inspect the Y6 connection for corrosion**  
f) Disconnect the Y6 connector at the MGR and inspect for corrosion, dirt, or debris.

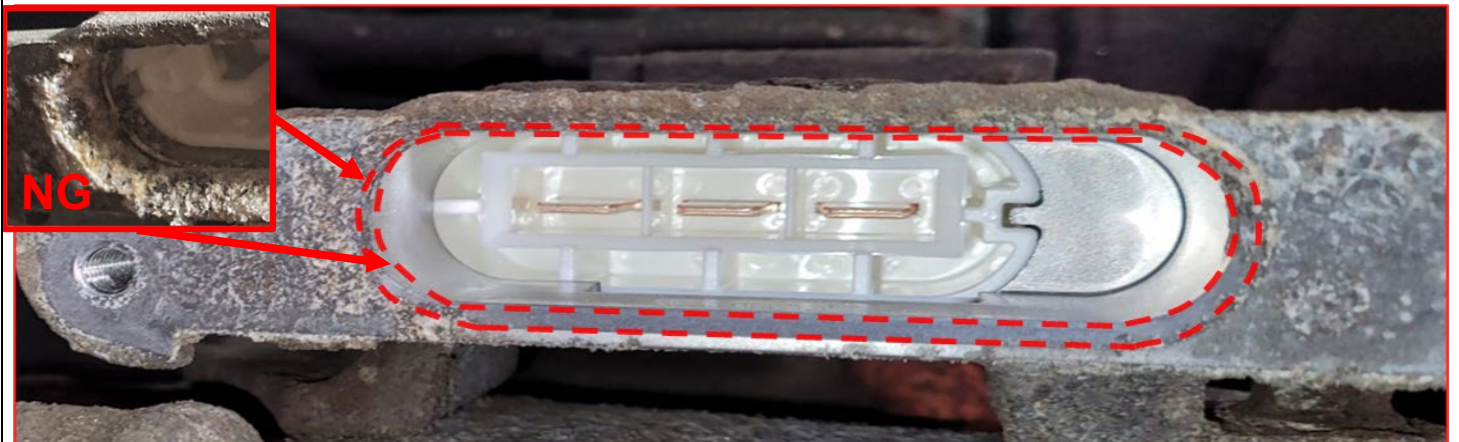
6) **Inspect the connector housing of the MGR**

- a) Inspect the chamfer of the MGR connector housing for pitting and corrosion on the sealing surface. Corrosion in this area will cause the seal to leak. Are pitting and corrosion present?

**YES** – Rear Traction Motor Cable requires replacement continue to Section VI.
