# Gap Between Soft Top and A-Pillar on the Passenger Side

**Service Category** Vehicle Exterior

**Section** Sliding Roof/Convertible

| YEAR(S) | MODEL(S) | ADDITIONAL INFORMATION |
|---|---|---|
| 2022 - 2024 | LC500C | |

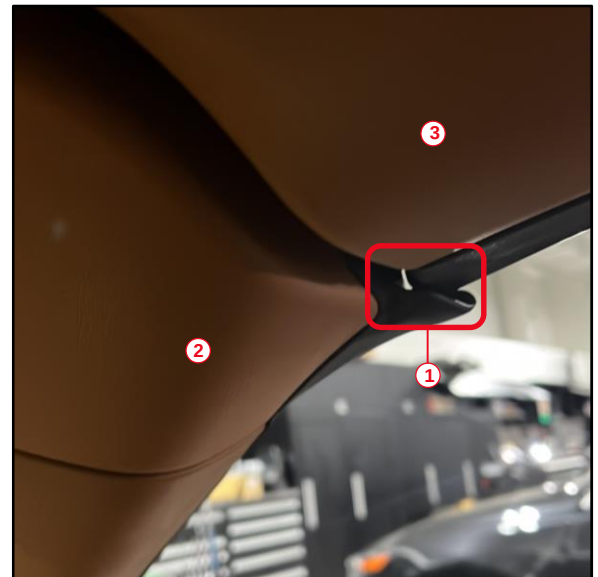
**Figure 1.**

Does the vehicle exhibit a gap on the passenger side at the A-pillar and soft top joint as shown on Figure 1?

| 1 | Gap |
| 2 | A-pillar |
| 3 | Soft Top |

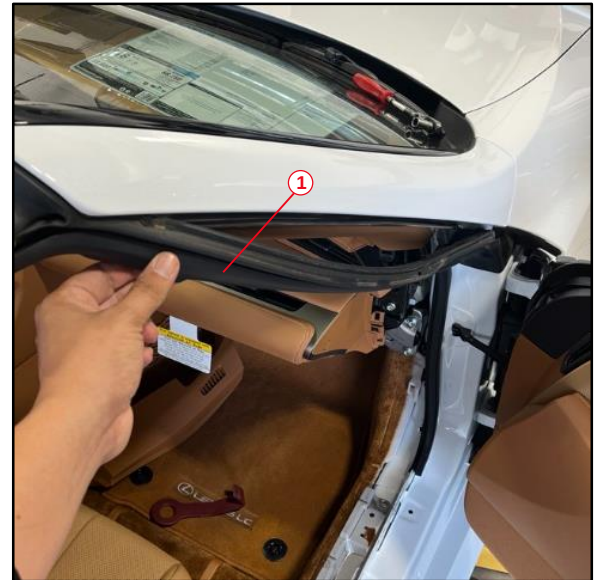
**Figure 2.**

| <b>1</b> | <b>Weatherstrip</b> |

3. Pull the weatherstrip out of the track along the A-pillar.

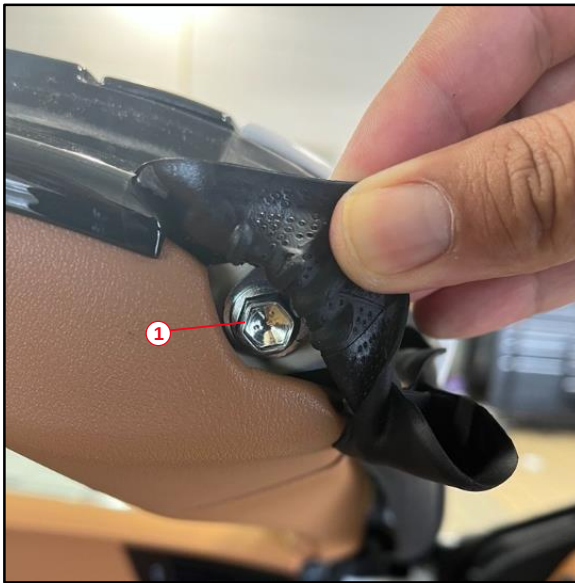
**Figure 5.**

**1 Bolt at top of the Weatherstrip**

5. Remove the bolt at top of the weatherstrip. Note that there is no shim between the threaded hole and the weatherstrip bracket as shown in Figure 6.

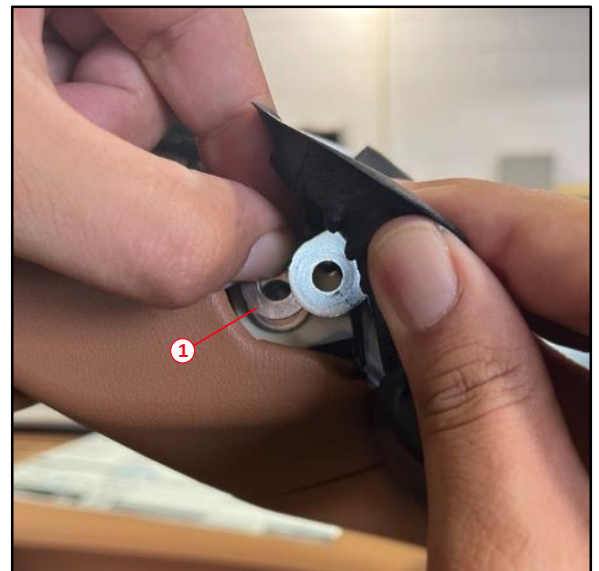
**Figure 7.**

**1 Shim**

6. Place a shim (1/4 in. diameter and 1.5 mm thick stainless-steel washer) between A-pillar base and the weatherstrip bracket.
