Torque Converter Installation Precaution

23-24Sequoia HV 22-24Tundra/Tundra HV

2022-2024	Tundra	2023-2024	Sequoia HV
2022-2024	Tundra HV

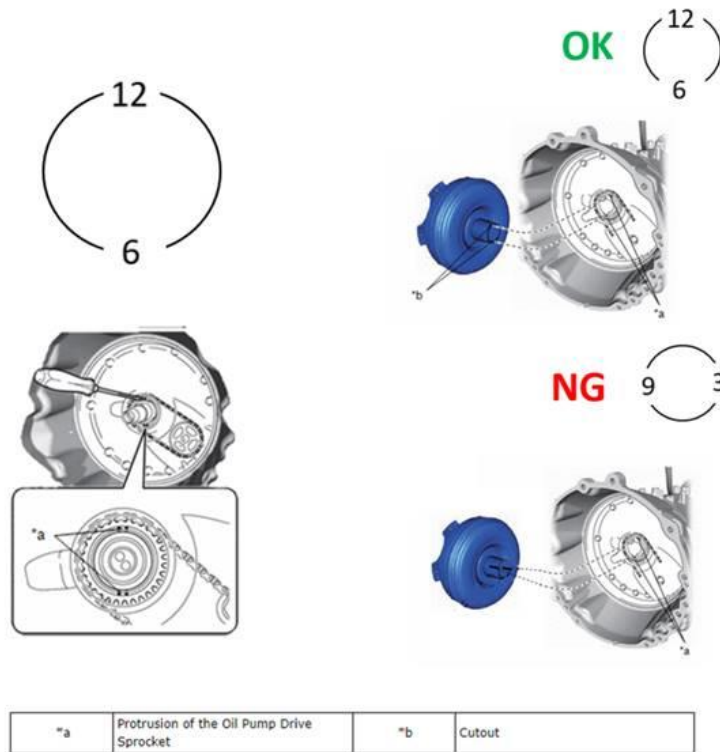
During repairs such as those listed below, damage may occur if the Torque Converter Assembly is not properly installed.

Referring to the appropriate Repair Manual Installation instructions, pay close attention to step #2 for Torque Converter Assembly Installation. It is critical to align the oil pump drive sprocket at the "12-6" o'clock position as indicated in the diagram below **before** installing the Torque Converter cutout to the protrusion on the oil pump.
