Technical Service Bulletin

27 48V Reference: Charging 48V Battery with 12V Charger DTC P0A7D00 / P0B2900

27 24 71 2067906/5 April 4, 2024. Supersedes Technical Service Bulletin Group 27 number 23-61 dated October 23, 2023 for reasons listed below.

Model(s)	Year	VIN Range	Vehicle-Specific Equipment
All Audi Vehicles	2017 - 2024	All	Not Applicable

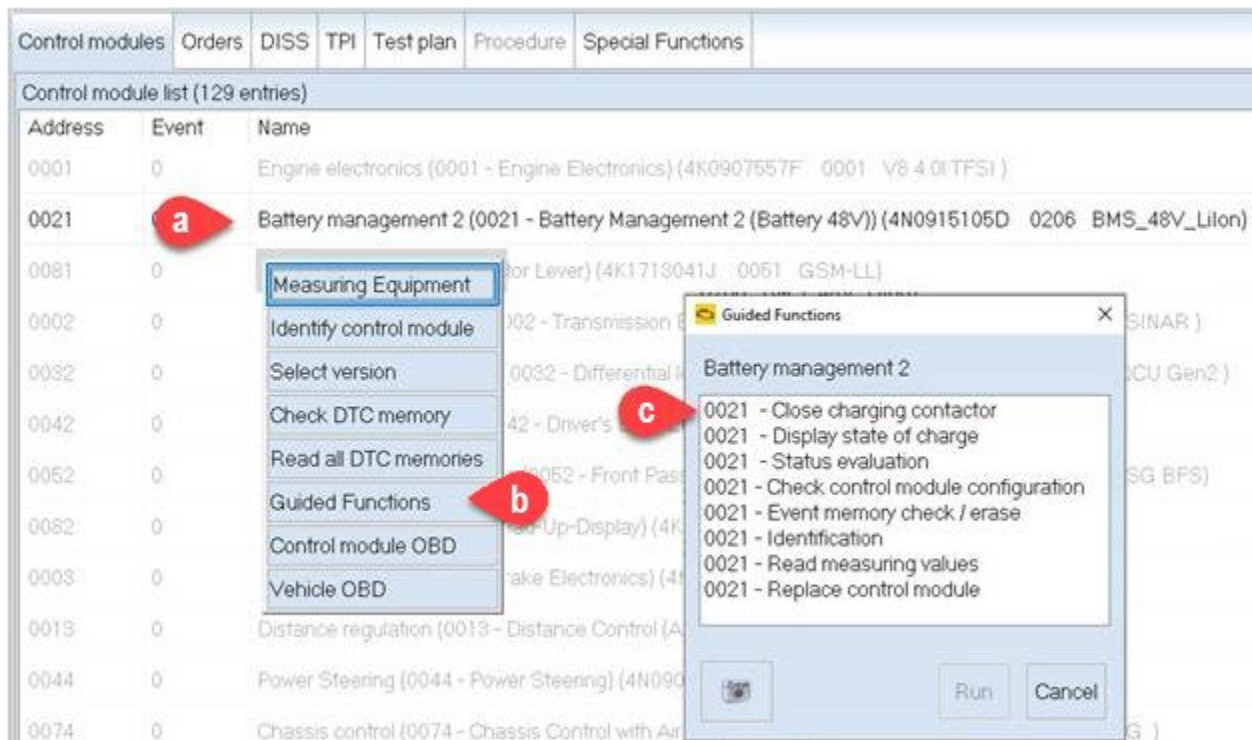
Figure 1: Use the steps below to access the test plan.

2. Shut off all non-essential electrical consumers in the vehicle.
3. In ODIS GFF run test plan "0021 – Close charging contactor" (Figure 1) to set the adaptation for protection relay closed, **do not exit the test plan** once the adaptation has been set.

- a. Right click on 0021 - Battery Management 2.
- b. Select “Guided Functions”.
- c. Select “0021 – close charging contactor”.
