93-24-02 - Service Information, ID.4 Charging Socket Emergency Release Cable Routing

Release date: 4/4/2024

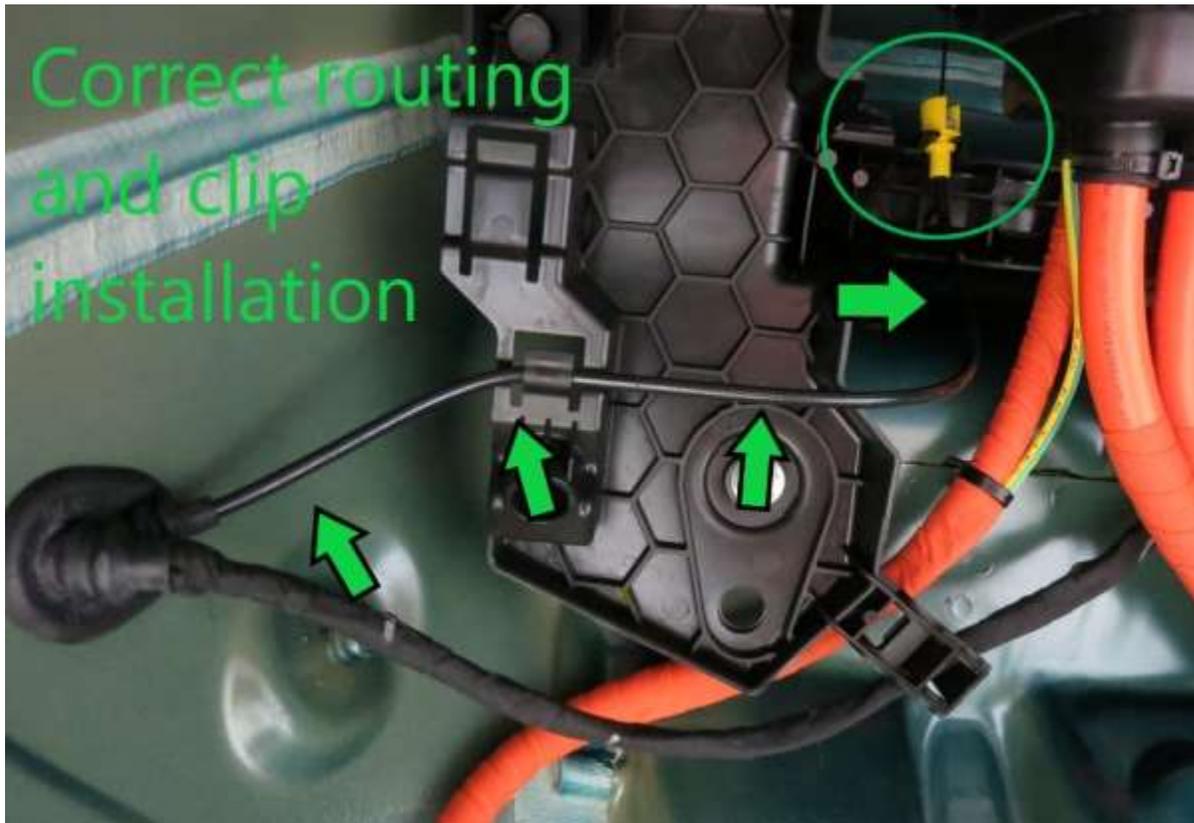
Figure 1. OK - correct routing of the emergency release cable and installation of the yellow clip.

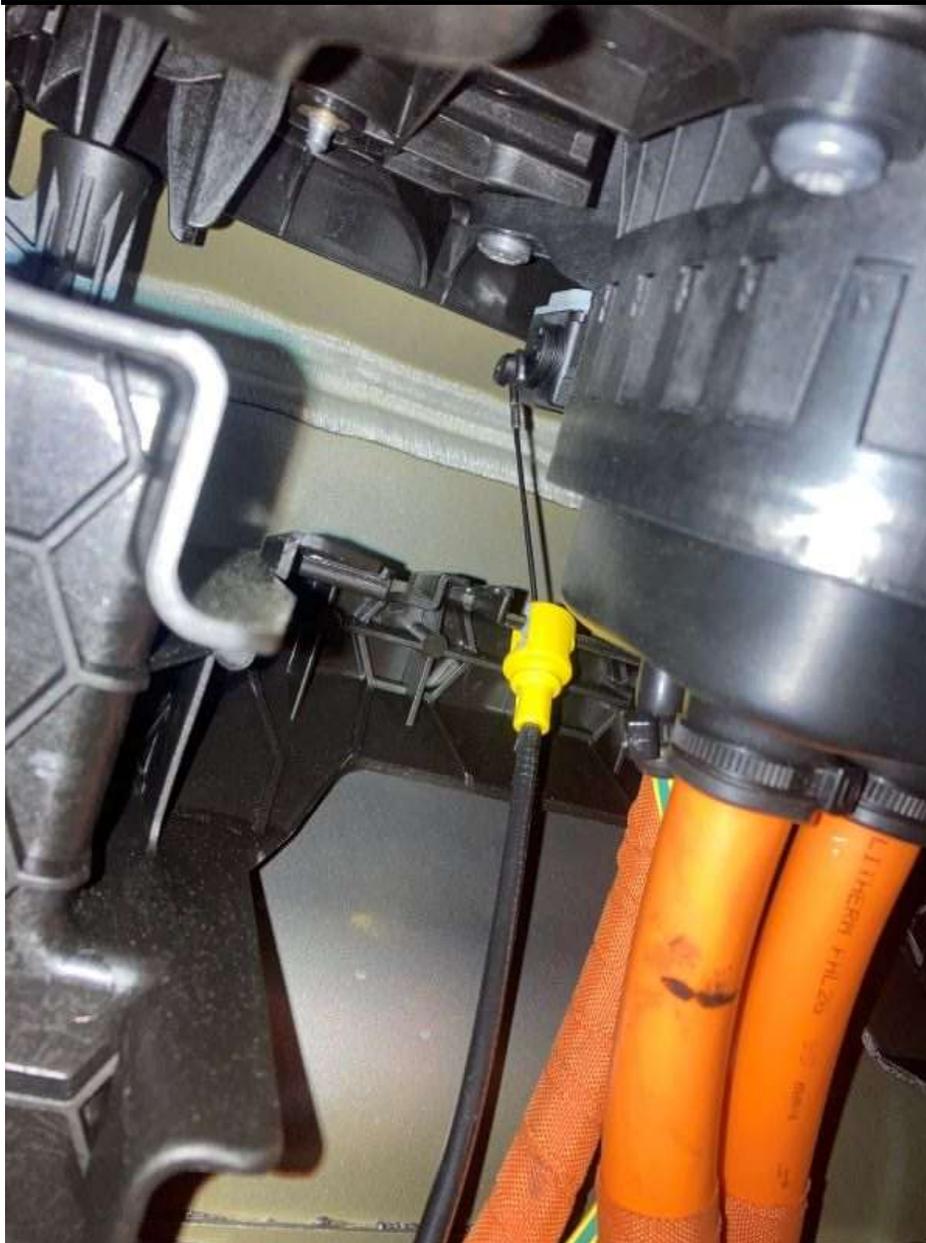
Figure 2. NOK - yellow clip out of bracket, cable pulled taut against actuator lever.

Correct routing of the emergency release cable is required for its function as well as for the charging capability of the vehicle. If such a concern is identified, repair the concern only by routing the cable correctly and then testing the charging function to verify the repair.

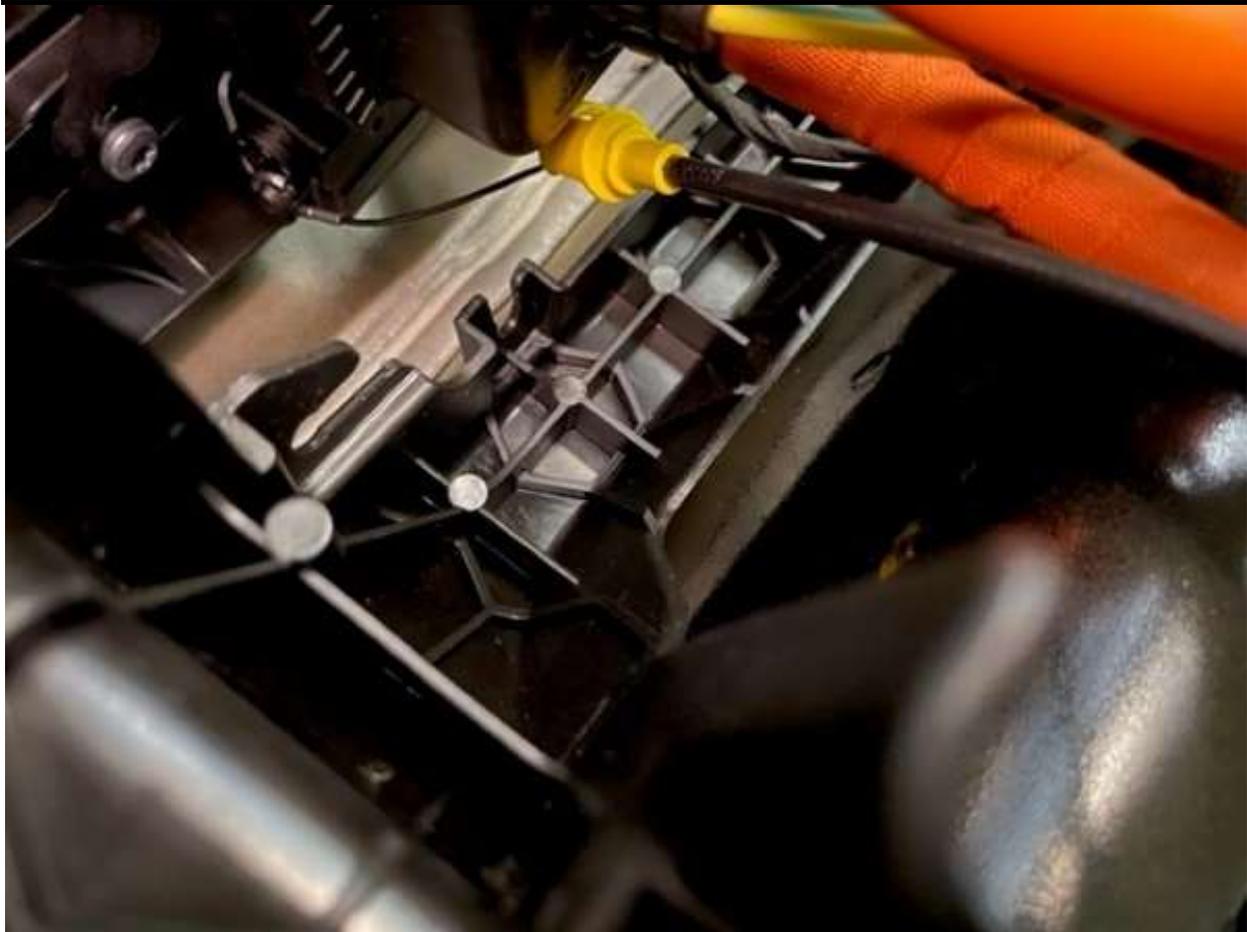
Figure 3. NOK - yellow clip out of bracket, loose.

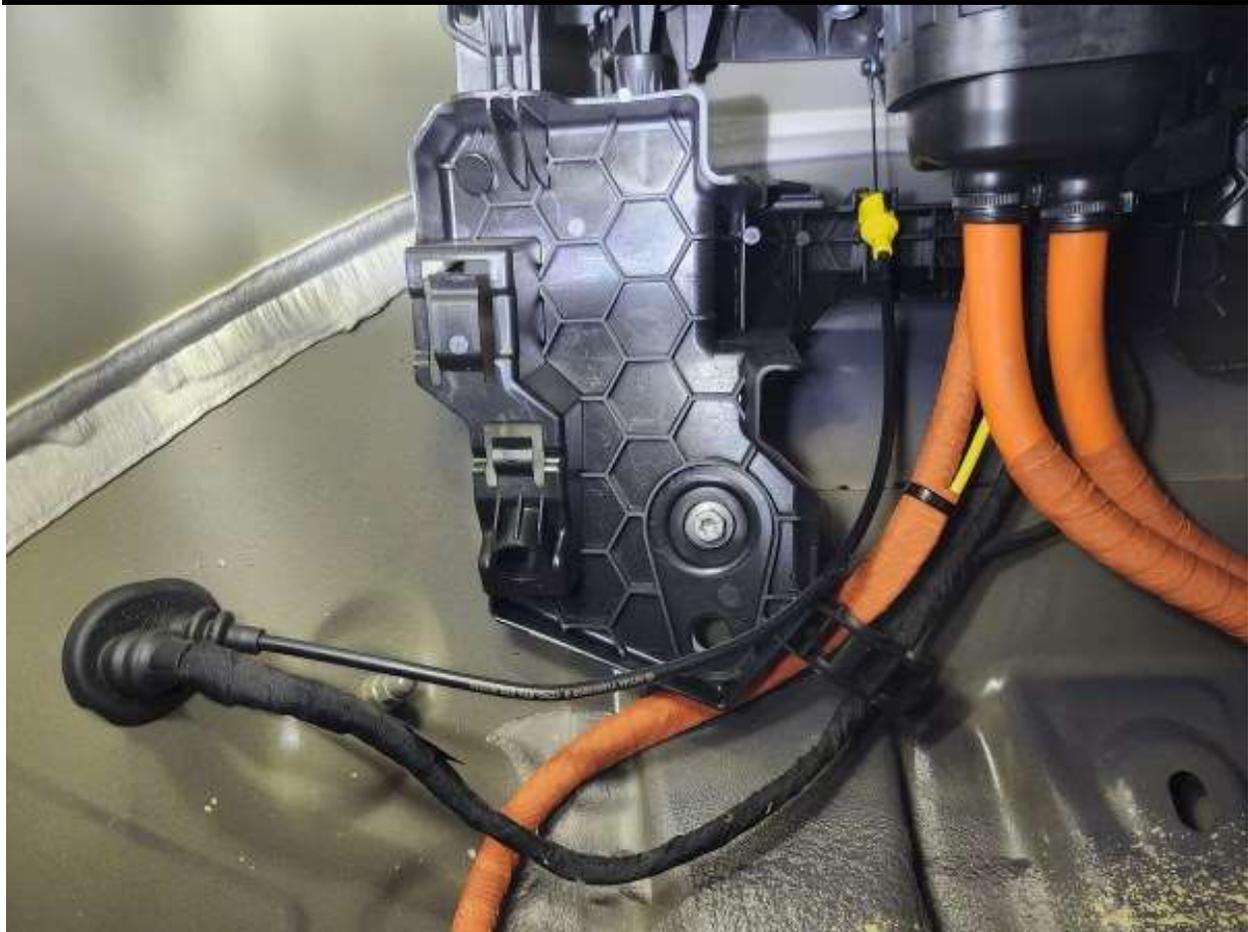
Figure 4. NOK - cable and yellow clip out of bracket, cable pulled taut against actuator lever.

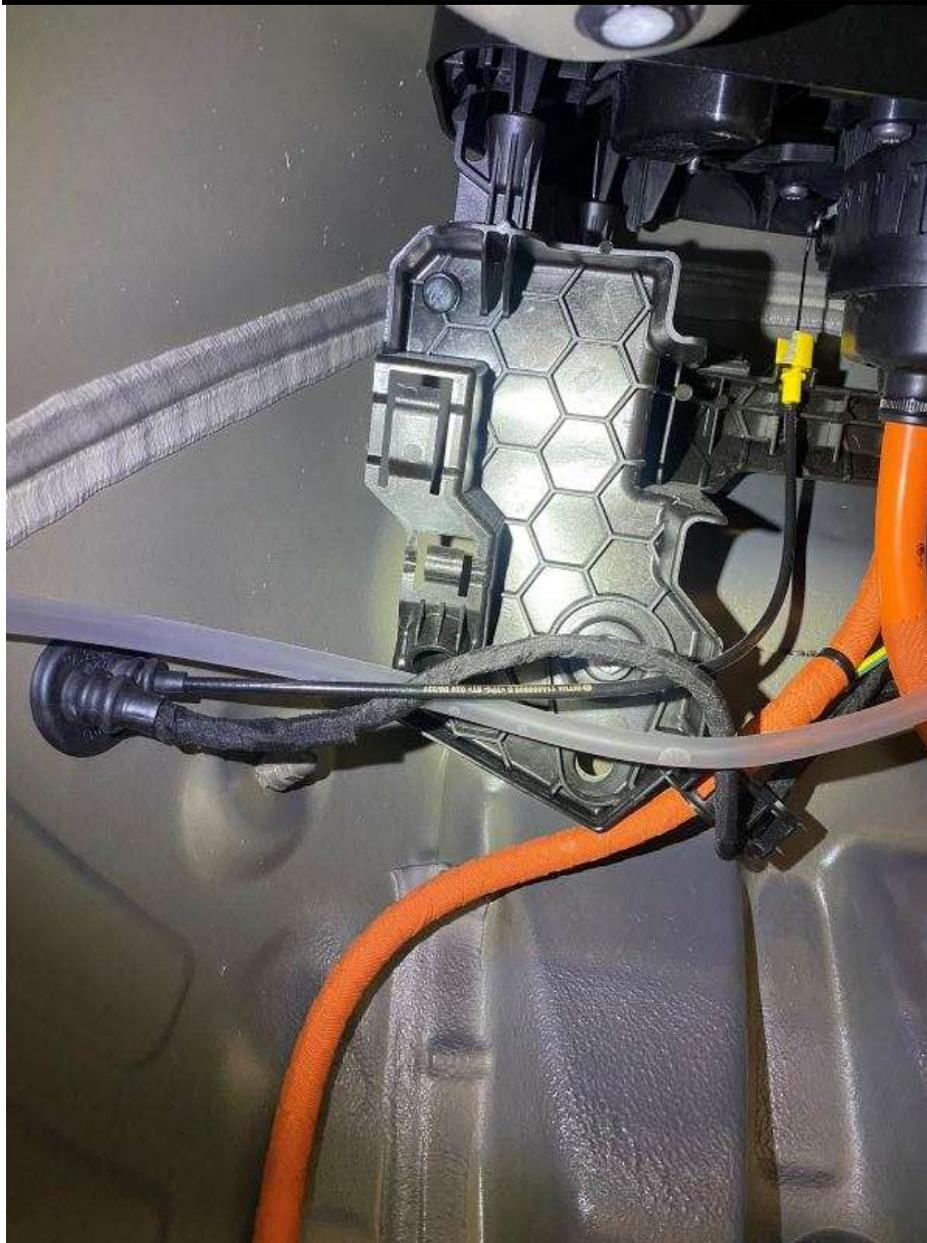
Figure 5. NOK - cable out of bracket, yellow clip installed correctly.

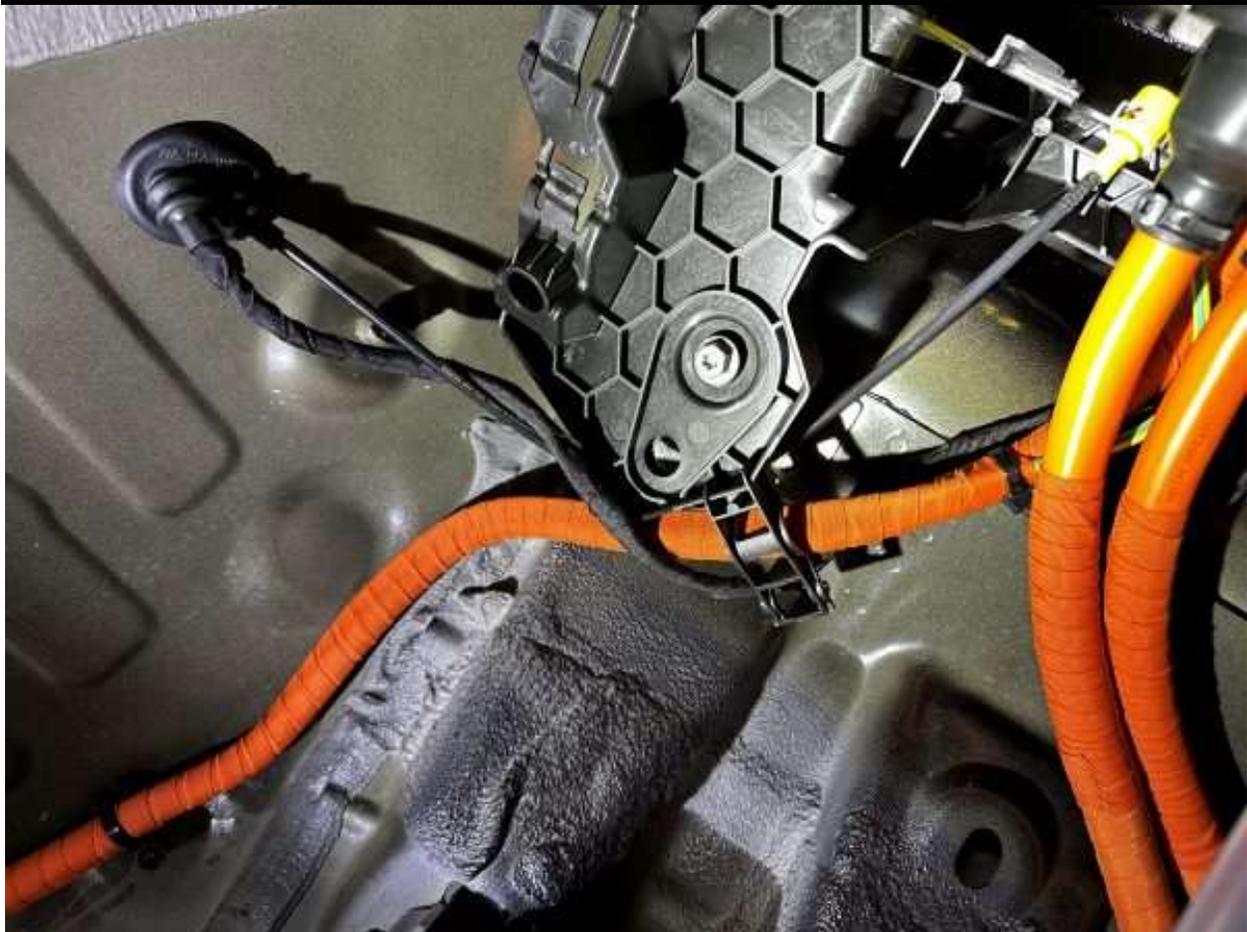
Figure 6. NOK - cable routed behind bracket, cable pulled taut against actuator lever.

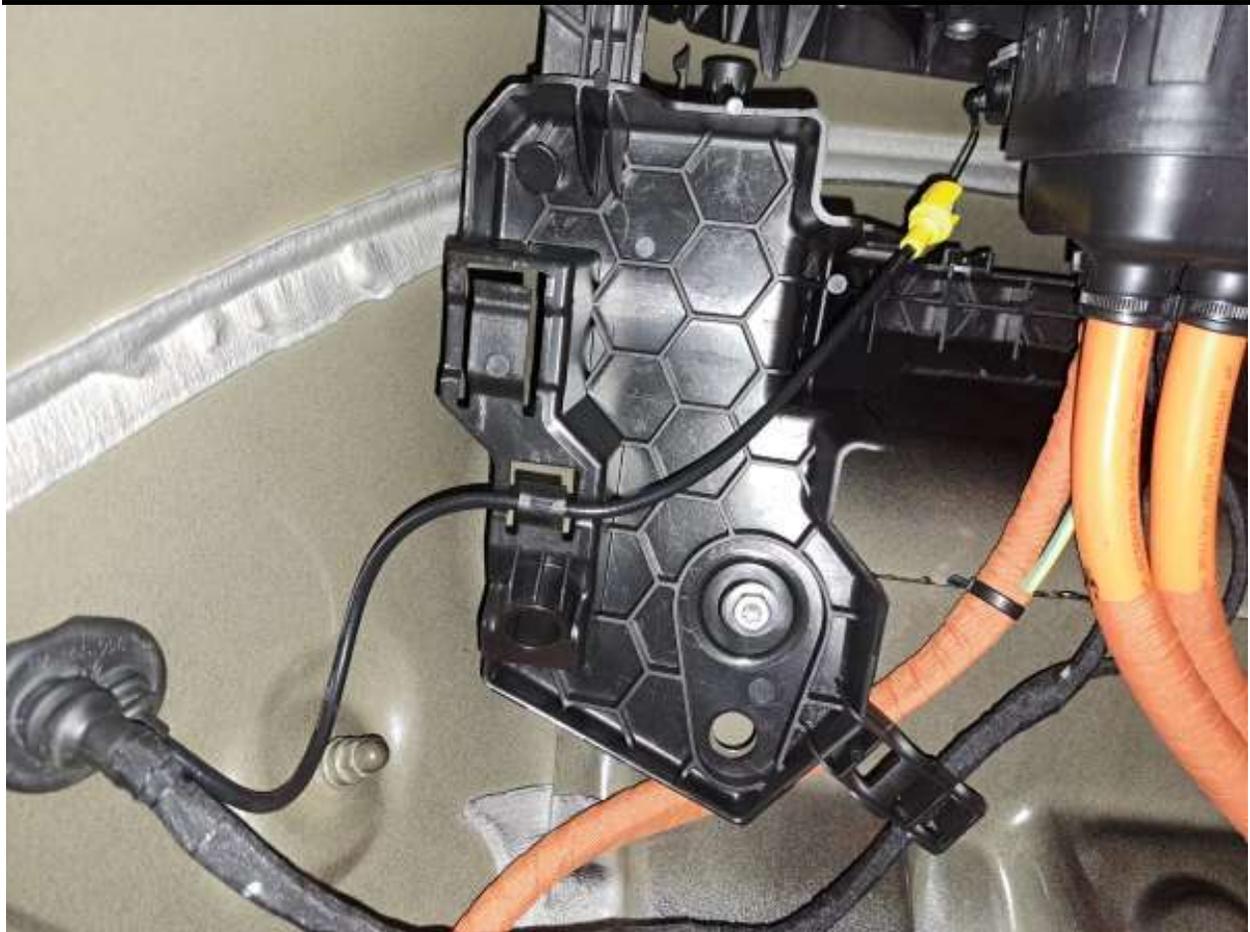
Figure 7. NOK - cable routed correctly, yellow clip out of bracket.
