Technical Service Bulletin

80 Poor, uneven or no cabin heating output

80 24 15 2073370/2 April 5, 2024. Supersedes Technical Service Bulletin Group 80 number 24-14 dated March 12, 2024 for reasons listed below.

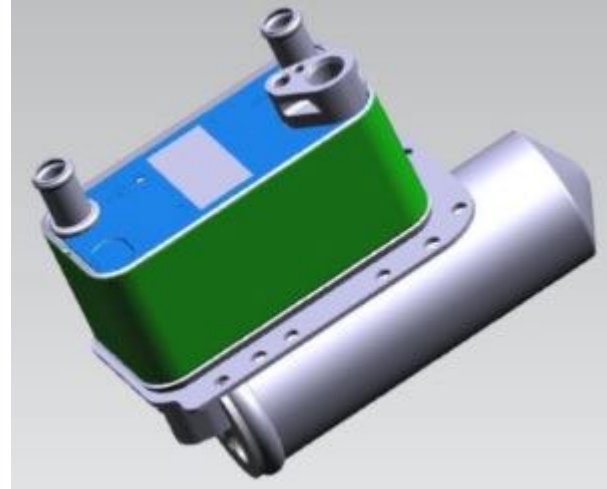
The complaint can be reproduced. Diagnosis finds obstructed or blocked coolant flow through the heat exchanger (4M0816413A).

Deposits in the cooling system can accumulate in the heat exchanger and obstruct coolant flow. The quality of the cabin heating is then compromised.

Figure 1. Heat exchanger 4M0816413A.

Before replacing the heat exchanger flush the component with water in the opposite flow direction in attempt to clear the deposits. If the flushing process is not successful and deposits remain in the component replace the heat exchanger. Refer to the cooling system flushing procedures in ElsaPro or TSB 2062583 “80 The interior vehicle heating is insufficient, and the engine coolant is discolored” if additional guidance is required.

Please exercise care not to contaminate the refrigerant side of the heat exchanger with water, coolant, moisture, etc. Thoroughly seal off the refrigerant side of the heat exchanger to avoid any intrusion of moisture or contaminants during the cleaning procedure.
