Technical Service Bulletin

91 ConBox: Wireless Audi Smartphone Interface (CarPlay / AndroidAuto) inop

91 24 95 2073333/3 April 4, 2024. Supersedes Technical Service Bulletin Group 91 number 24-88 dated March 22, 2024 for reasons listed below.

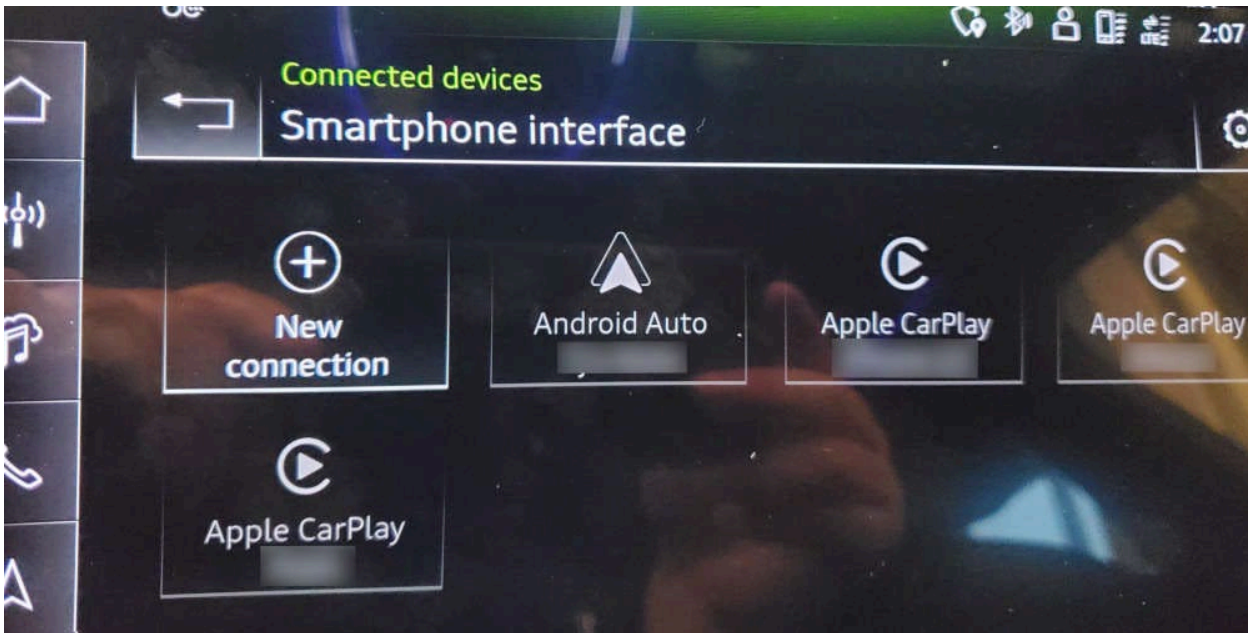
- The Audi Smartphone Interface [ASI] (Apple CarPlay [ACP] / AndroidAuto [AA]) cannot be paired to the phone wirelessly.
- The phone tiles under the ASI menu are grayed out (see Figure 1).

Figure 1: wASI connections grayed out.

Due to a configuration issue, the 5GHz Wi-Fi may not be available in some vehicles, preventing wASI from functioning.

1. Please execute the “*Check control module configuration*” test plan under Guided Functions for the Emergency Call Module and Communication Unit (ConBox) -J949- (address word 0075).

2. Delete all Audi Smartphone Interface (ASI) connections from the vehicle.
3. After a bus sleep cycle, the correct functionality should be reestablished.
