April 12, 2024

Version 4

Warranty Extension: 2017-18 CR-V: Software Update with A/C Control Unit Replacement; DTC P0300, P0301, P0302, P0303, P0304, or P0172; Whirling Noise from Engine

Supersedes 19-032, dated June 18, 2019, to revise the information.

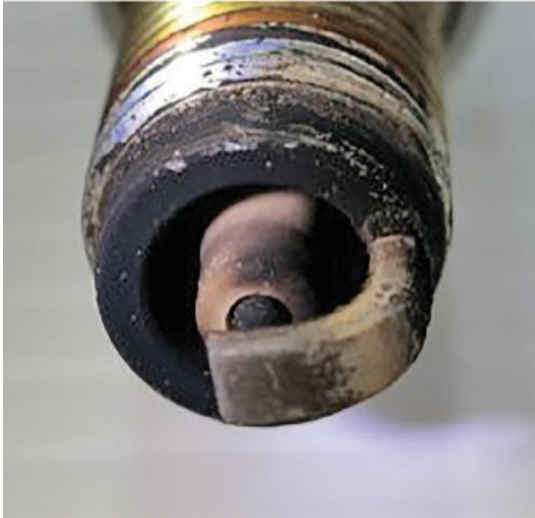
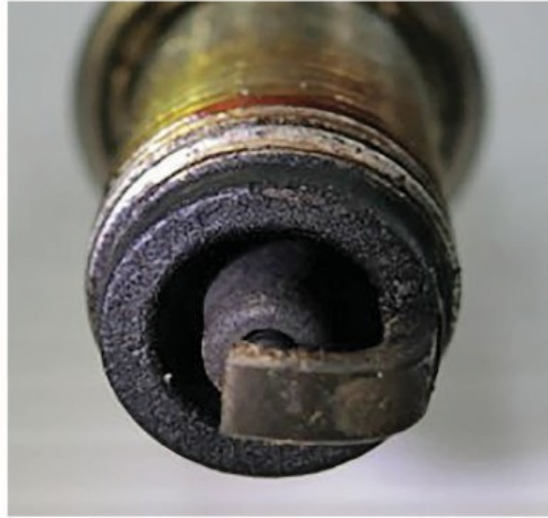
1. In some cases, the DTCs may return. If this happens, inspect the spark plugs.

- If the spark plugs are OK, the procedure is complete. Continue with normal troubleshooting.
 - If the spark plugs are fouled, go to step 2.
2. Replace the spark plugs per service information and check for stored DTCs.

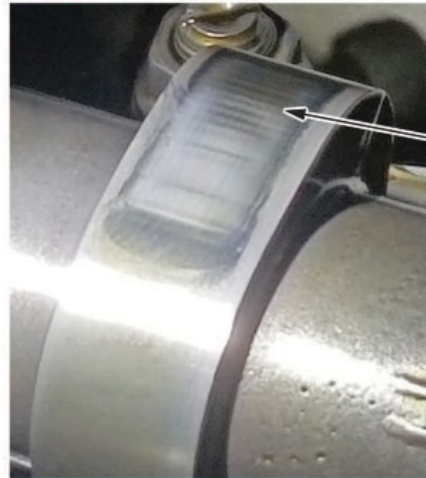
**NO GOOD**

The cam surface has ridges and a "cloudy" appearance.

- If the camshafts appear similar to the no good photo, go to step 8.
 - If the camshafts appear similar to the good photo, this bulletin does not apply. Continue with normal system troubleshooting.
8. Take a photo of the cam lobe, then follow the directions in the parts catalog when ordering the necessary parts.

Please send photos of failed camshafts to PART_RELEASE@AHM.HONDA.COM to receive approval and release parts.
