GROUP	MODEL
ELE	2024MY EV9 (MV)
NUMBER	DATE
336	April 2024

TECHNICAL SERVICE BULLETIN

SERVICE ACTION: INTEGRATED LED HEADLAMP CONTROL UNIT OPERATION LOGIC IMPROVEMENT (SA567)

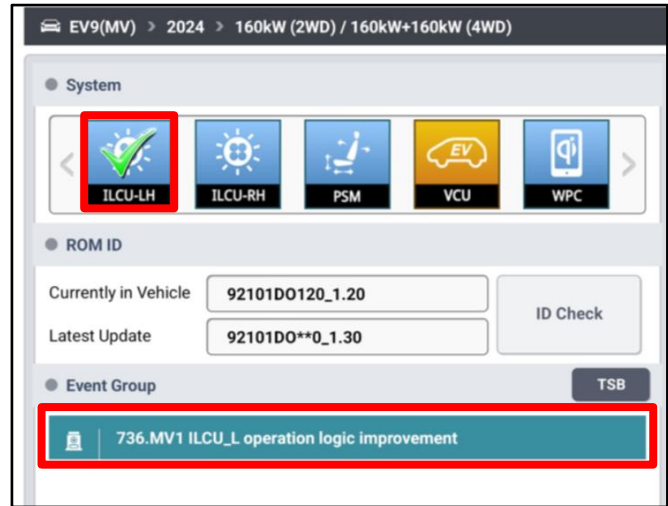
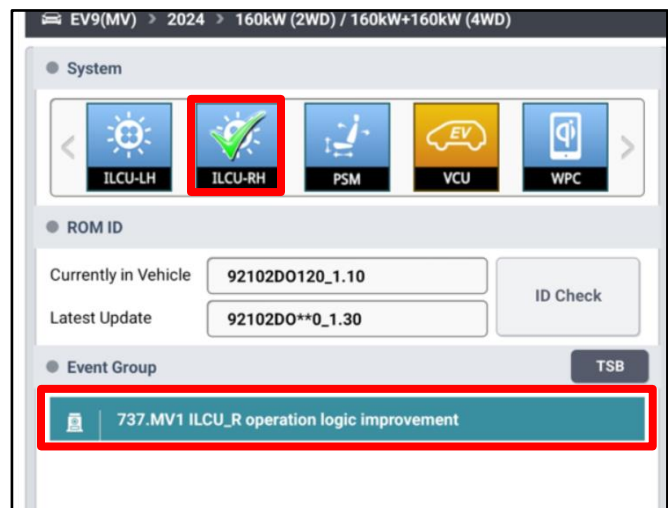
736.MV1 ILCU_L Operation Logic Improvement

737.MV1 ILCU_R Operation Logic Improvement

Refer to [TSB SST081](#) for instructions to upgrade the 'ILCU' system:

Both events 736 **and** 737 **MUST** be completed. 'Fault Code Searching' is not required after events 736 and 737 have successfully completed.
