GENERAL MOTORS  
DCS6859  
URGENT - DISTRIBUTE IMMEDIATELY

Subject: N242440290 - Service Update  
Liftgate Water Intrusion

Models: 2024 Cadillac LYRIQ

## N242440290 Liftgate Water Intrusion

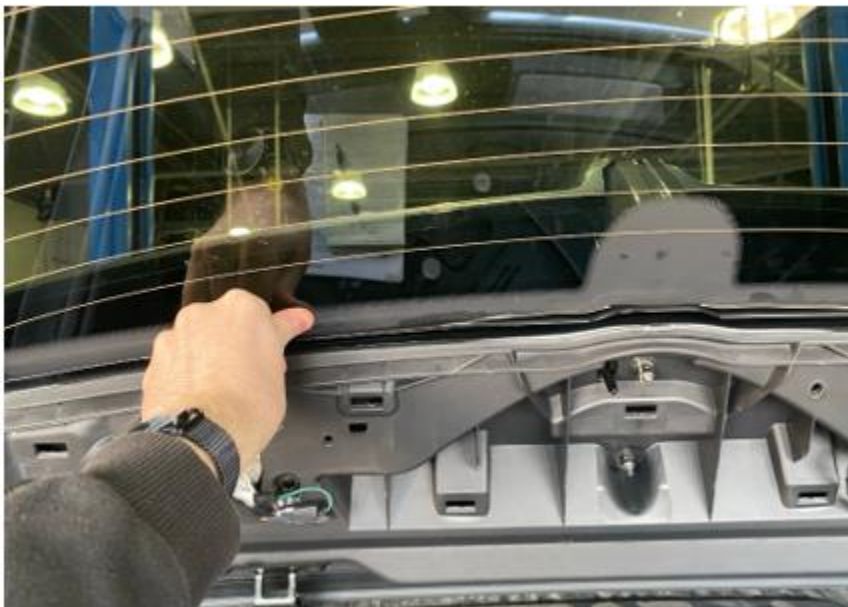
6615586

1. Inspect the Rear Window for water leaks by firmly pressing on the inside of the glass and checking for separation between the Liftgate Glass and the Liftgate.
  - If the Rear Window separates from the Liftgate, proceed to Step 2.
  - If the Rear Window does not separate from the Liftgate, no further action is required.

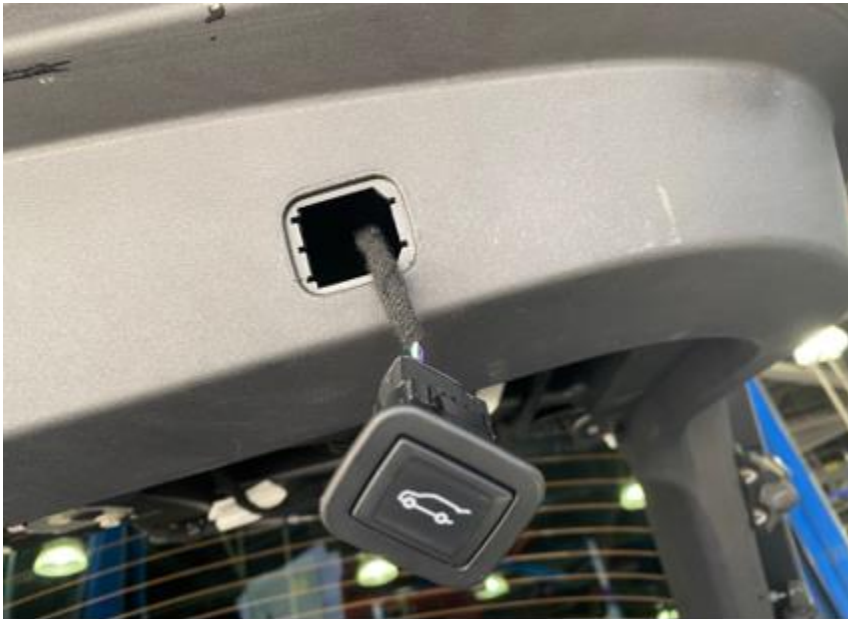
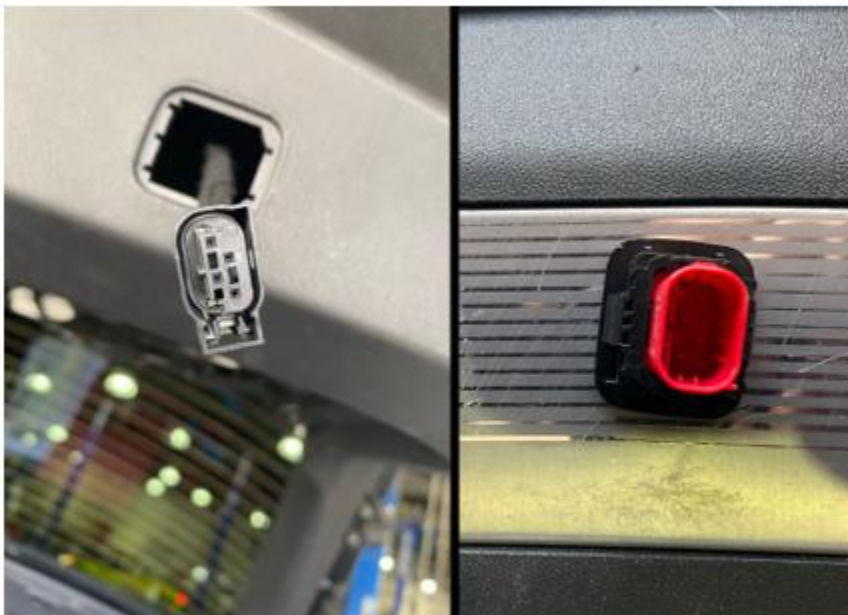
5. Remove and Inspect the Liftgate Close Switch and electrical connector for corrosion.
  - If the Liftgate Close Switch or the electrical connector has signs of corrosion, proceed to Step 6.

- If the Liftgate Close Switch and electrical connector do not show signs of corrosion, proceed to Step 8.
6. Replace the Liftgate Close Switch. Refer to *Liftgate Close Switch Replacement* in SI.
  7. Replace the Liftgate Close Switch Harness Connector. Refer to *Wire to Wire Repair* in SI.

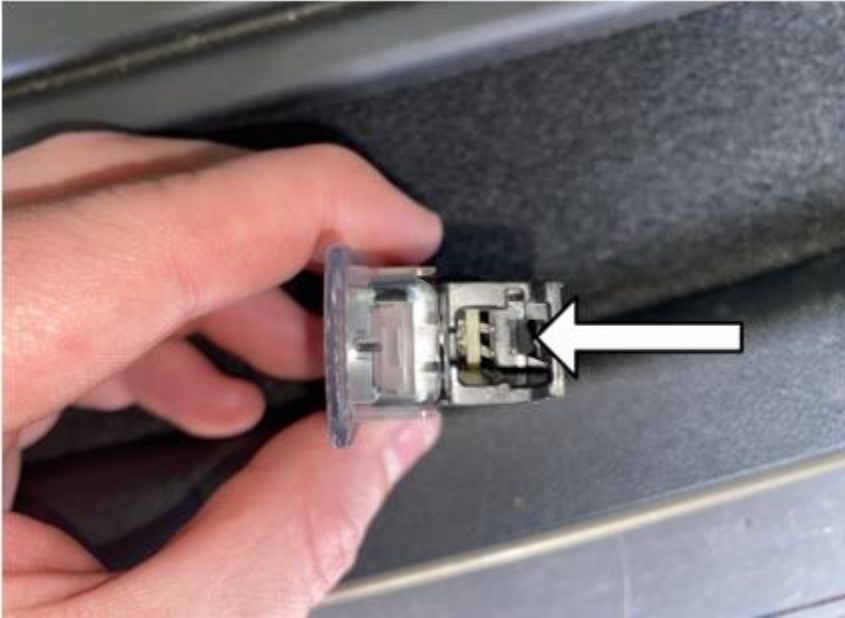
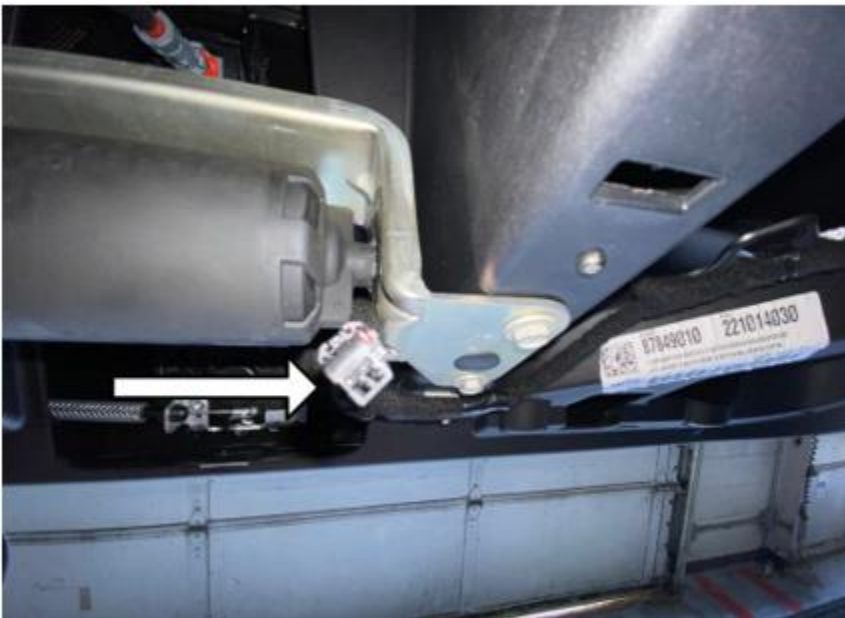
8. Remove and inspect the Liftgate Courtesy Lamp and its electrical connector for corrosion.
  - If the Liftgate Courtesy Lamp or the electrical connector has signs of corrosion, Proceed to Step 9.
  - If the Liftgate Courtesy Lamp and electrical connector does not show signs of corrosion, Proceed to Step 11.
9. Replace the Liftgate Courtesy Lamp. Refer to *Liftgate Courtesy Lamp Replacement* in SI.
10. Replace the Liftgate Courtesy Lamp electrical Connector. Refer to *Wire to Wire Repair* in SI.

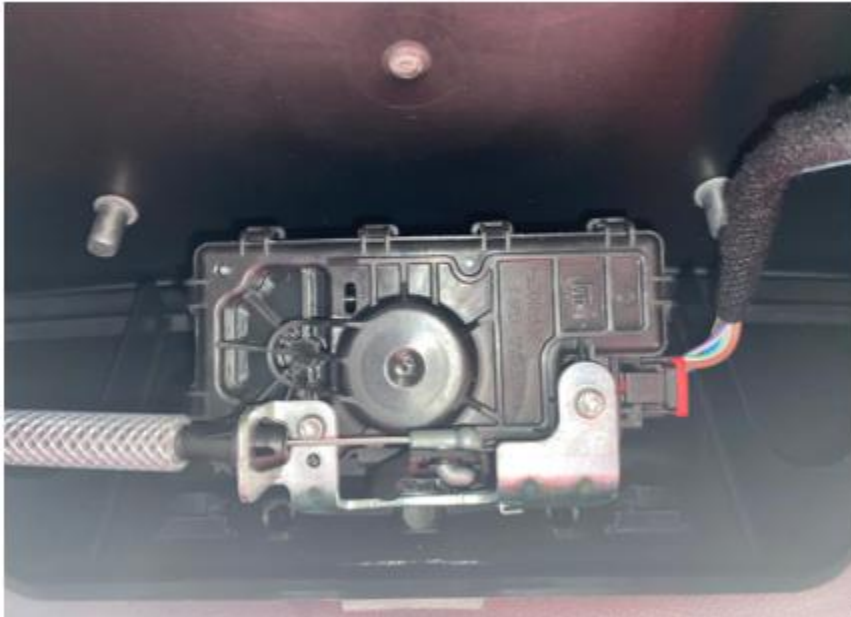
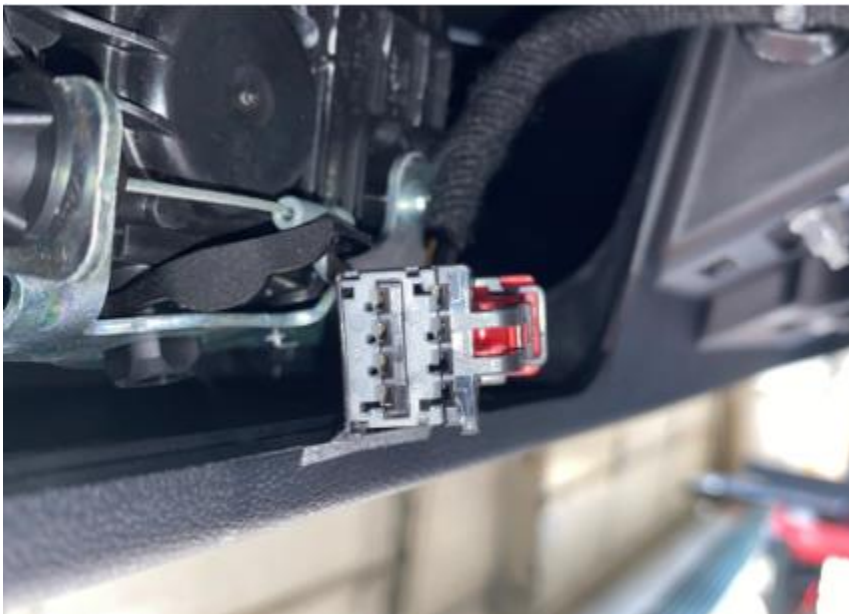
11. Inspect the Liftgate Latch and its electrical connector for signs of corrosion.
  - If the Liftgate Latch or its electrical connector has signs of corrosion, proceed to Step 12.
  - If the Liftgate Latch and its electrical connector do not show signs of corrosion, Proceed to Step 14.
12. Replace the Liftgate Latch. Refer to *Liftgate Latch Replacement* in SI.
13. Replace the Liftgate Latch electrical connector. Refer to *Wire to Wire Repair* in SI.
14. Reinstall all removed trim and components. Refer to the installation steps in *Rear Window Replacement* in SI.
