Subject: N242435430 - Customer Satisfaction Program  
Multiple Module Reprogramming

Models: 2024 Chevrolet Silverado EV

# Customer Satisfaction Program

## N242435430 Multiple Module Reprogramming

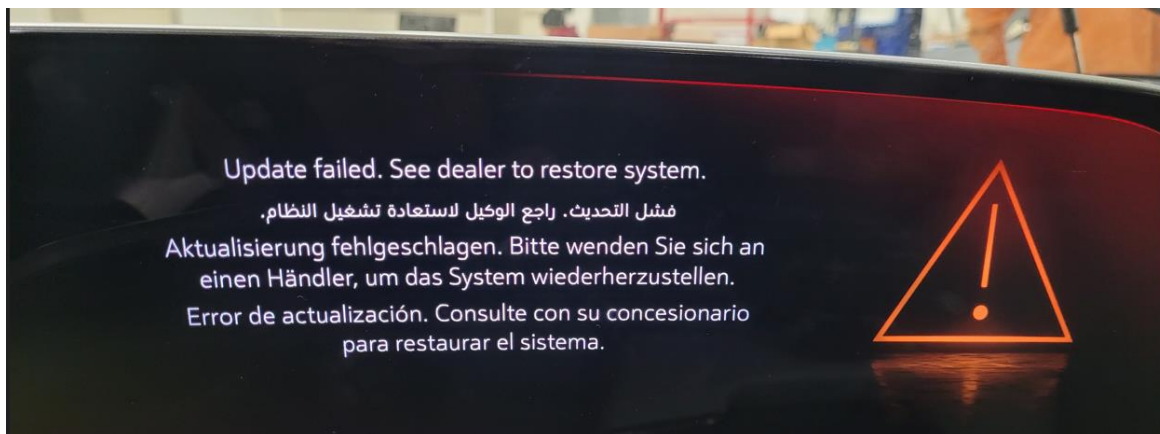
6554772

1. There is a chance for an error to be encountered during the USB update portion of the procedure right around 60% completed.
  - 1.1. This happens once the USB is in the vehicle and the progress bar can be seen on screen.
2. If the error occurs the screen will look similar to the screen below:

3. In this case pull the USB from the vehicle and reformat again as shown in step 7 under service procedure.
4. Access the Service Programming System (SPS) and follow the on-screen instructions.
5. On the SPS Supported Controllers screen, select A11 Radio – USB Copy/USB File Transfer.
6. Upon completion of the file transfer, properly eject the USB drive from the computer.
7. Connect the USB drive to the USB port in the vehicle.
  - 7.1. If the screen fails to show a progress bar once reinserted, pull out and reinsert again.
8. These steps should allow the progress bar to restart and complete successfully.
