SIB 41 01 24

## GROANING SOUND BETWEEN THE HOOD AND THE HOOD HINGES

E-Series	Model Description
i20	iX Sports Activity Vehicle

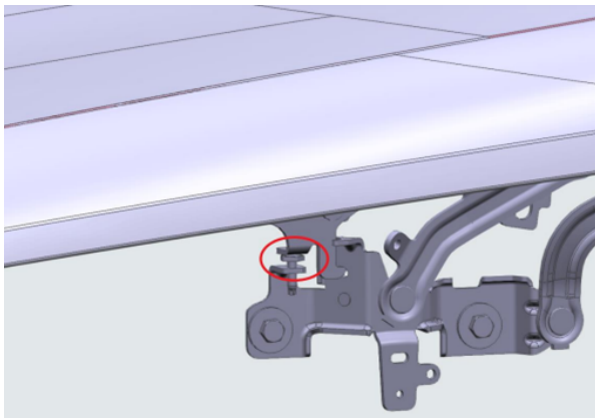
A groaning sound from the front of the vehicle while driving can be heard, particularly while cornering.

Tight clearance (circled) between the hood and the hood hinges.

Lubricate the head of the adjusting screw on the hinges.
