SIB 41 07 22

2024-04-04

CRACKING SOUND FROM THE TOP OF B-PILLAR

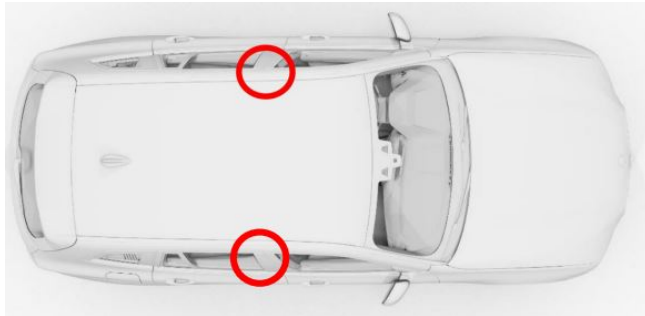
While driving the vehicle on normal roads at 10mph and above, a "cracking" sound from the top of the B-pillar(s) is heard.

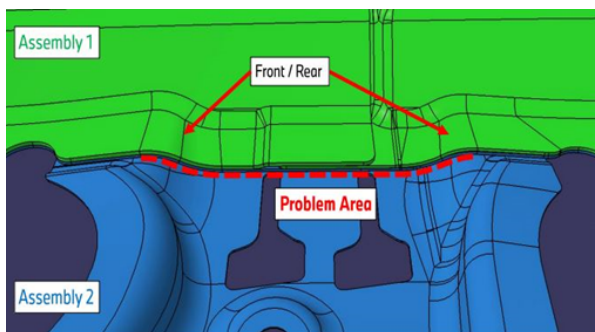
Movement of the sheet metal layers at the B-pillar(s).

Drill a 6-8 mm hole through the first three sheet metal layers.

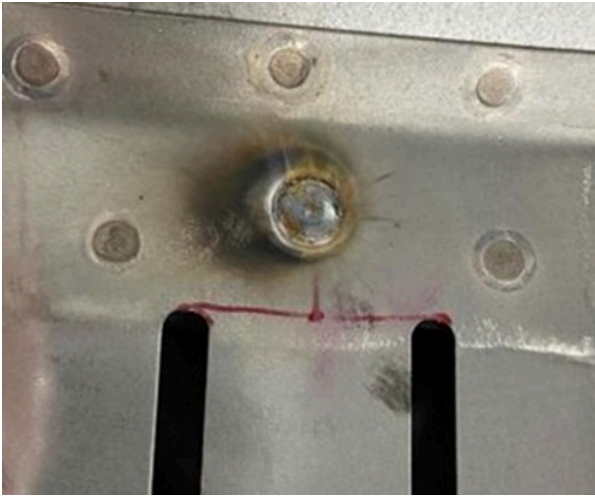
Note: The rework might not be effective if the bore hole is not deep enough.

Drilling the bore hole to deep might weaken the structure excessively (should be avoided).

6. Measure the depth of the bore hole to ensure that all three sheet metal layers have been drilled through correctly.
