SIB 51 08 24

FOGGING IN THE INSIDE OF THE WINDSHIELD IN THE AREA OF THE  
ADCAM

E-Series	Model Description
U11	X1 Sports Activity Vehicle

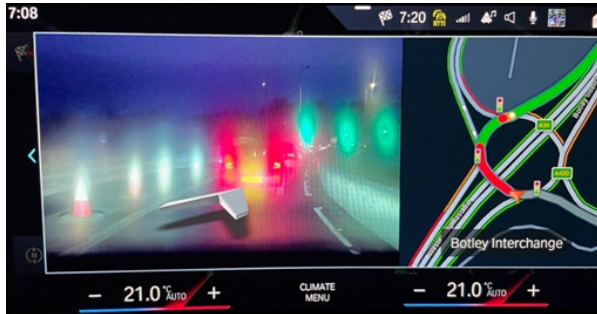
The Augmented Reality Camera (ARCAM) shows up blurry when activated.

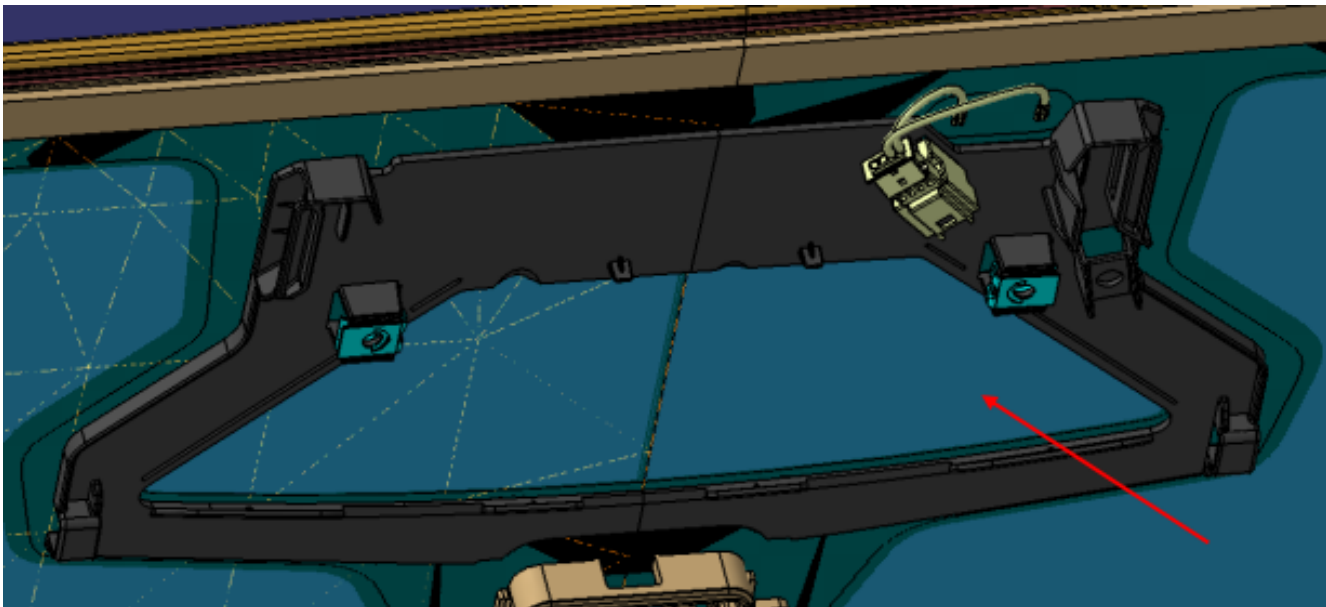
Contamination on the inside of the windshield in front of the Autonomous Driving Camera (ADCAM; arrow).

Using a clean and dry microfiber cloth, clean the affected area of the inner windshield and ADCAM lenses using BMW glass cleaner.

1. Remove the ADCAM camera per the repair instructions listed in ISTA/AIR 66 51 541 or 66 51 590.
2. Spray the glass cleaner onto a clean/dry microfiber cloth.

3. Clean the inner section of windshield where the ADCAM sits and clean the ADCAM lenses.
4. Reinstalled the ADCAM and reassess the vehicle.
