SIB 51 11 23

2024-04-11

CRACKING SOUND IN D-PILLAR TRIM PANEL AND/OR CARGO AREA CAPPING TRIM PANEL

E-Series	Model Description	Production Date
i20	iX Sports Activity Vehicle	SOP (Start of Production) – up to and including August 31, 2023

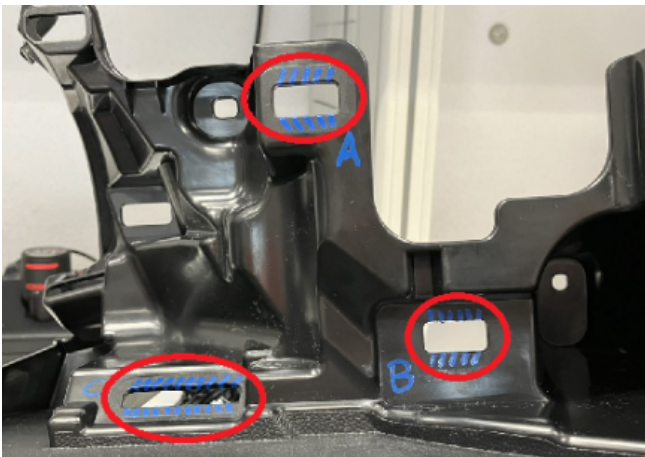
1. The alignment hole is too large on the right-side luggage compartment capping trim panel causing excessive play.
2. Unfavorable friction between the D-pillar trim panel and the headliner.

2. Apply adhesive tape to the marked alignment holes as shown in the photo.
