SIB 51 11 24

INTERFERENCE BUZZING NOISE FROM THE CENTER AUDIO SPEAKER IN THE DASHBOARD

E-Series	Model Description
U10	X2 Sports Activity Coupe
U11	X1 Sports Activity Vehicle

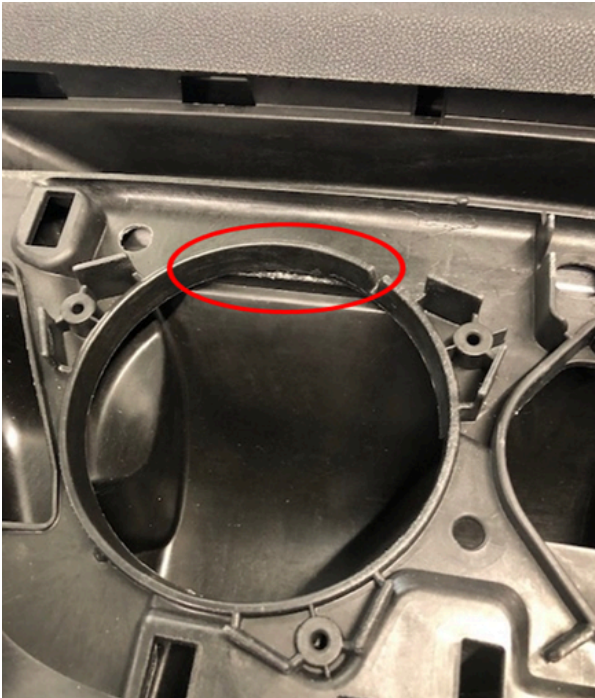
Protruding plastic weld below the holder of the center speaker.

Apply a felt strip between the center speaker holder and the air duct.

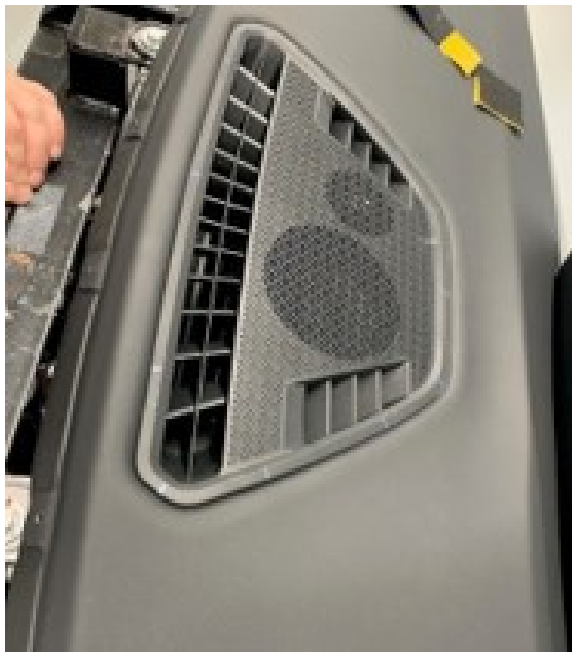
Verify that the buzzing sound is present from the center speaker when the audio is on. If so, continue to step 1.

1. Remove the center speaker trim and speaker following the repair instructions listed in ISTA/AIR (65 13 060).
