SIB 33 06 24 SERVICE SOLUTION: Drive Chain Noise

2024-04-08

Model	Model Description	Production Date
K81	F 900 GS	0K63

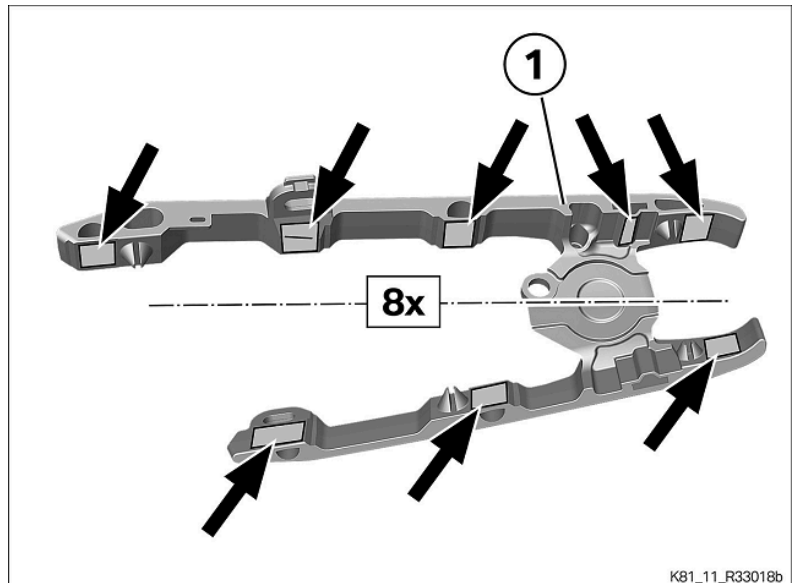
Customer hears noise coming from the drive train, due to the chain knocking against the slide rail. The acoustics are transferred through the swingarm and amplified.

In case of a complaint, you can adhere damping strips to the slide rail.

1. Remove the chain slide rail according to repair instructions 33 85 504 in AIR.
1. Clean surfaces.
1. Cut damping material (27 00 8 529 962) into 8 pieces.
1. Adhere strips to chain slide rail (see arrows in image →)
1. Install chain slide rail according to repair instruction 33 85 504 in AIR.
