SIB 61 32 23

DELIVERY STOP: ENGINE COMPARTMENT SOUNDPROOFING

E-Series	Model Description	Production Date
G70	i7 Sedan Battery Electric Vehicle	July 4, 2022 – April 24, 2023

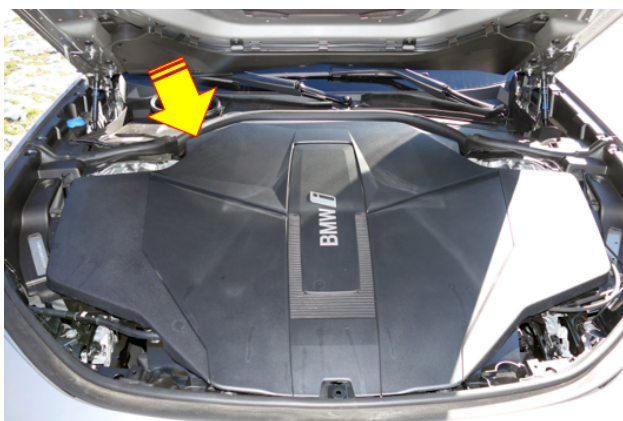
A small flap of sound insulation material may come into contact with some of the 12 V B+ cables at the remote B+ charging point terminal (general location at arrow) along the engine compartment's passenger side inner fenderwell.

If the sound insulation becomes damp and is in contact with the mounting point of the positive cable terminal or the positive battery cable, in very rare cases corrosion may occur over time.

Remove the engine compartment sound insulation on the passenger side; and, if necessary, rework the connections of the positive battery cables at the terminal.

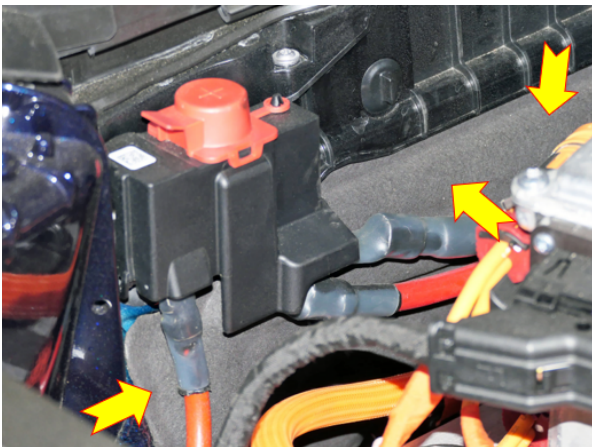
The arrows indicate the sound insulation to be removed.

Remove the B+ 12 V junction point cover.
