Maserati

Rapid Update 713

Grecale Multiple Software Updates

CVPAM – ICS – IPC – RFHM – BCM – ECM - TCM

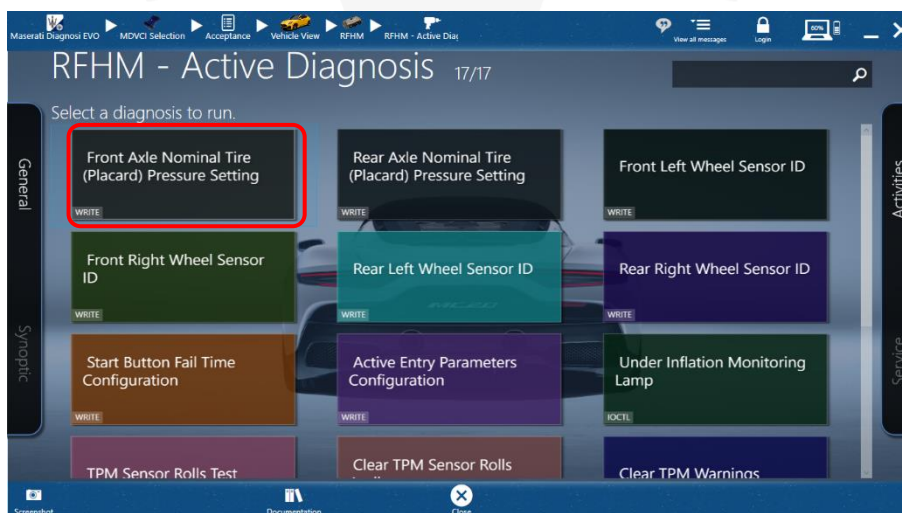
This update is essential to prevent the occurrence of a false TPMS (Tire Pressure Monitoring System) warning indication. In specific situations, the front tire pressures might erroneously appear in yellow on the cluster display, even when the actual tire pressures meet or exceed the specified values. This problem stems from an incorrect internal calculation related to the hexadecimal conversion between psi and bar. It's crucial to note that this update does not alter the tire pressure values as stated in the owner manuals and technical documentation.

IMPORTANT for 19" tires only:

- k. Select **RFHM – Active diagnosis – Front Axle Nominal Tire (Placard) Pressure Setting**:

- l. Insert **31** in the text box and click on **Execute** to set the new value.

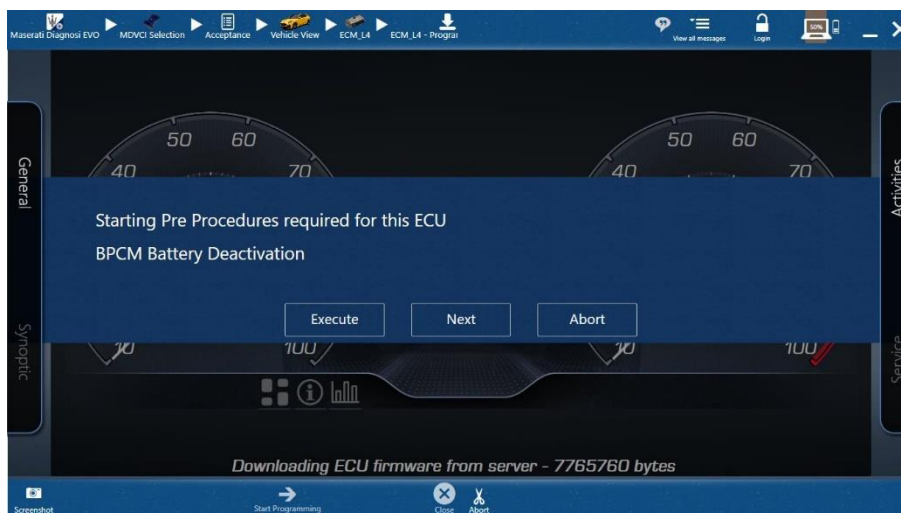
This update is essential to rectify a potential loss of CAN communication between the ECM and other ECUs (AGSM, DTMC, BSM, etc.) when the ECU temperature is high. This new software corrects this behavior avoiding multiple warning lights. No loss of torque or recovery strategy is activated for this concern. The new software also fixes a potential MIL attributed to P-codes P106A and P1066 related to the MultiAir solenoid valve. **This Software update requires the TCM to be updated as well.**

- q. From ECU View, select the **ECM – ECU programming**.
- r. Press **"Execute"** starting pre-procedures:

- s. After ECU programming, perform **BCM – Procedures – PROXI Alignment**.
- t. Clear DTCs.
