Service Bulletin

Bulletin No.: 21-NA-155

Subject: Information on Check Trailer Wiring Message and/or Service Trailer Brake Displayed on Driver Information Center (DIC) - DTC C1114 Set

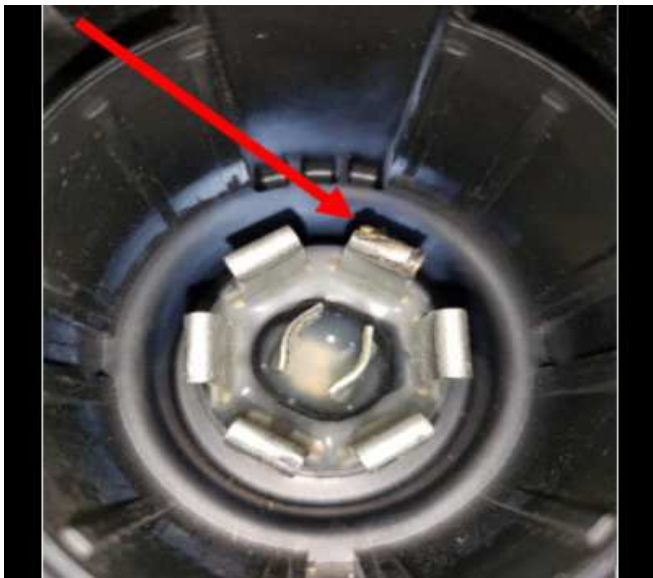
5867917

1. Short on trailer side damaged the terminal – Trailer side connector is loose/worn – **Non-Warranty Issue.**

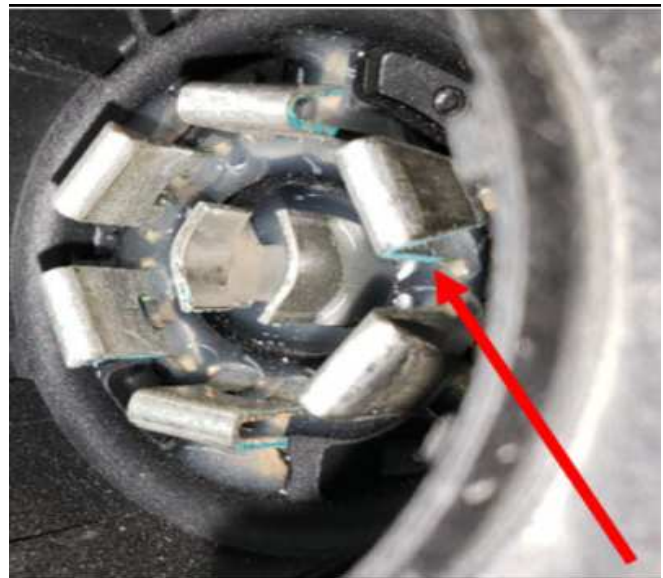
5867994

2. The blue/green is expected, and this small amount of corrosion does not impact function of connector – **Non-Warranty Issue.**

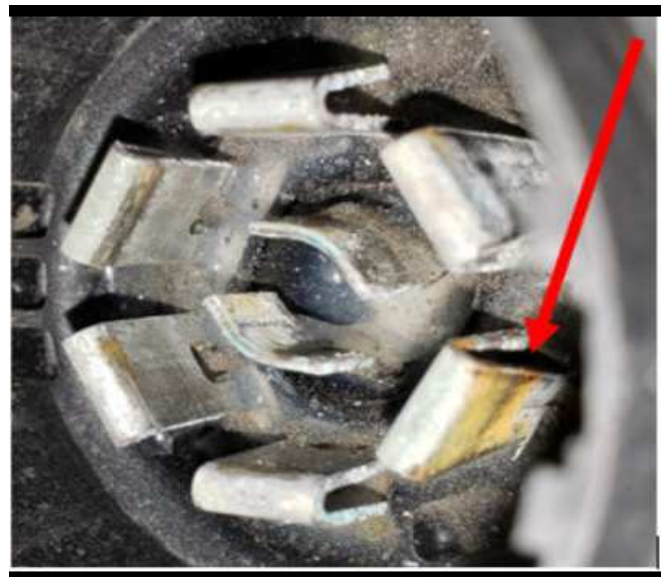
5867995

3. Trailer side connector is damaged/deformed causing removal of protective plating. This is the result of the trailer side connector is moving or bouncing when connected (excessively worn connector) – **Non-Warranty Issue.**

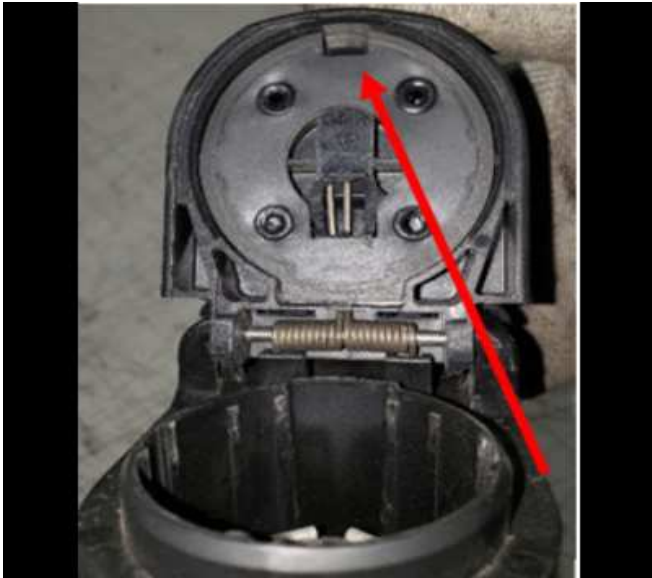
5867997

- 4. Trailer side harness retention tab has been broken off cover which is the result of customer pulling away from trailer without releasing the trailer harness – **Non-Warranty Issue.**

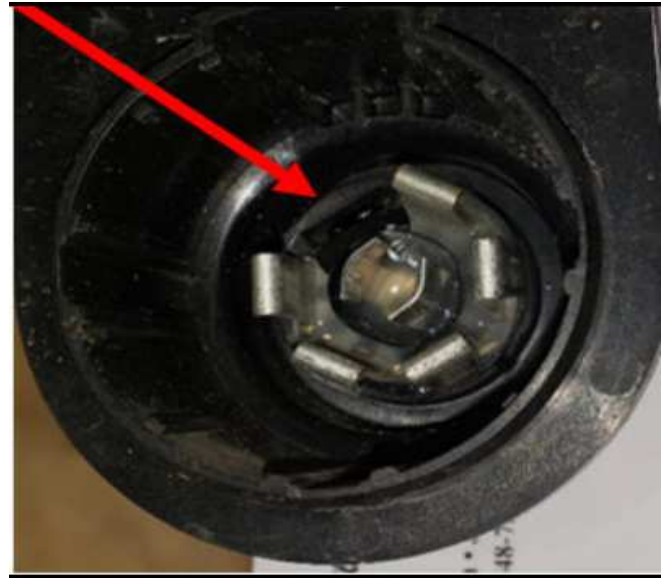
5868000

- 2. Terminal is pushed out – **Subject to terms of warranty.**

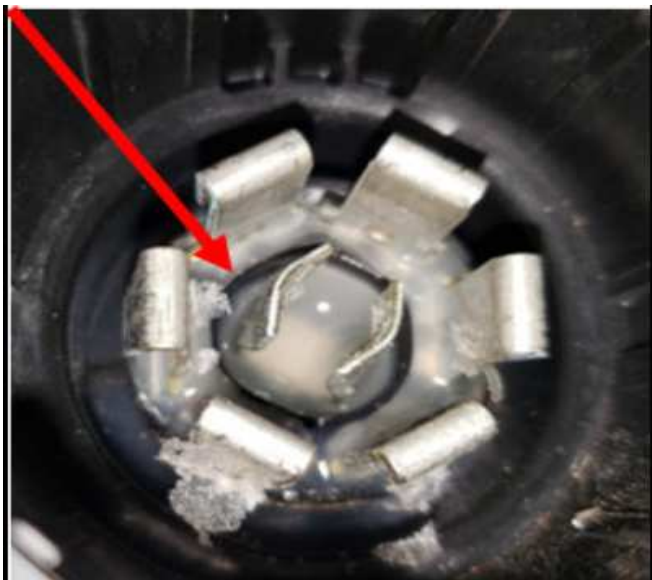
5867998

- 1. Sealant from part on terminals, would cause intermittent connection issues connecting to trailer – **Subject to terms of warranty.**

Causal Part	Description	Part Number	Qty
N/A	84056018	Truck 7-way Trailer Connector Socket	1
