GROUP	MODEL
Voluntary Service Campaign	2021-2023MY Seltos (SP2) AWD
NUMBER	DATE
SC297	April 2024

4WD ECU INSPECTION/REPLACEMENT (SC297)

This bulletin provides information to inspect and, if necessary, replace/repair the 4WD Electronic Control Unit (ECU) and wire harness and also to install a protective cover over the 4WD ECU on certain 2021-2023MY Seltos (SP2) All-Wheel Drive (AWD) vehicles produced from November 20, 2019 through March 2, 2023 that were originally sold or are currently registered in one of 36 states and the District of Columbia with significant snowfall (AK, CO, CT, DC, DE, IA, ID, IL, IN, KS, KY, MA, MD, ME, MI, MN, MO, MT, ND, NE, NH, NJ, NM, NV, NY, OR, OH, PA, RI, SD, UT, VA, VT, WA, WI, WV, and WY). In the 36 states and District of Columbia with significant snowfall, snow may be tracked into the driver's footwell area. Meltwater from this snow may enter the 4WD ECU located under the driver's seat and, over time, damage the 4WD ECU circuit board components. This can lead to the illumination of the 4WD Warning Light and deactivation of the vehicle's 4WD feature. If this occurs, the vehicle can continue to be driven in the front-wheel drive mode. This service c

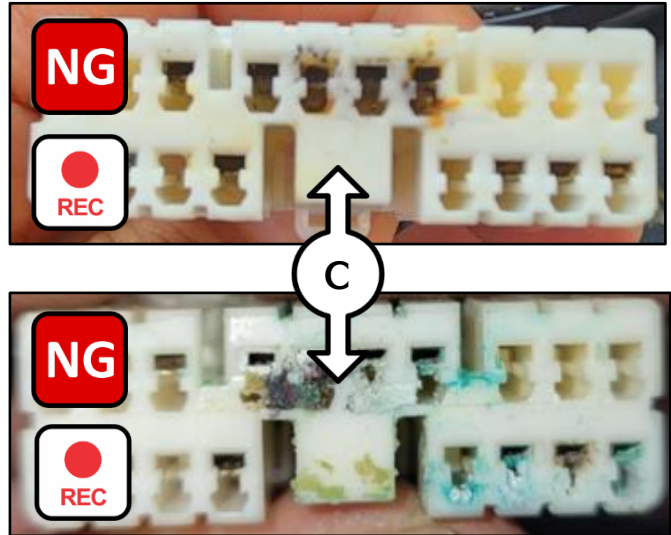
5. Inspect the 4WD ECU connector (C) for corrosion damage:

- If damage/corrosion IS found (**NG**), take a KVID video starting from the VIN label on the door and then show the (**NG**) connector, then proceed to the 'Repair Procedure' (4WD ECU Connector/Wire Harness) on page 5.

6. If corrosion damage is NOT found (**OK**), re-connect the 4WD ECU connector and proceed to the 4WD 'ECU Cover Installation' procedure below.
