Service Bulletin

Bulletin No.: 24-NA-042

Subject: Engine Misfire, Malfunction Indicator Lamp (MIL) Illuminated – DTCs P0300, P0030, P0031, P0032, P0053, P0132, P0135, P0137, P0155, P0171 and/or P0172

Brand:	Model:	Model Year:		VIN:		Engine:	Transmission:
		from	to	from	to		
Chevrolet	Silverado 2500HD/3500HD	2024	2024			6.6L (L8T)	
GMC	Sierra 2500HD/ 3500HD

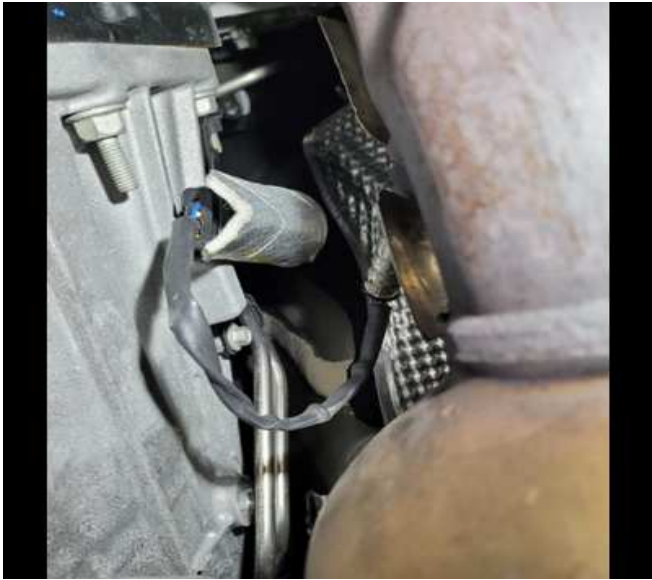
6563511

Cause	This condition may be caused by the mis-routed Bank 1 Sensor 1 oxygen sensor wiring harness, which is coming in contact with the exhaust pipe.
Correction	If you encounter a vehicle with the above concern, raise vehicle and inspect the oxygen sensor wiring. If oxygen sensor wire is contacting the exhaust pipe or heat shield, it will be necessary to replace the Bank 1 Sensor 1 oxygen sensor and ensure the sensor wiring is routed away from the exhaust.

Refer to *Heated Oxygen Sensor Replacement - Bank 1 Sensor 1* in the Service Manual.
