SIB 61 03 23

2024-04-26

GEAR SELECTOR SWITCH (GWS) BUTTONS OR INDICATOR LIGHTING MALFUNCTION

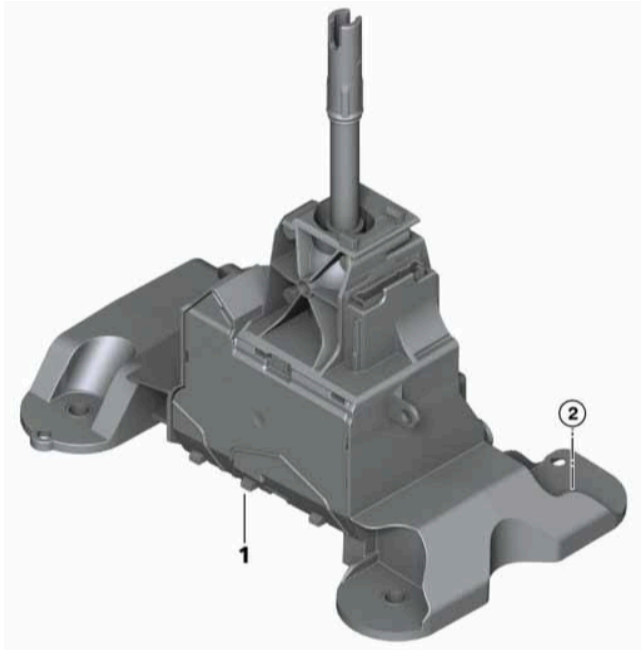
The buttons on the GWS do not work, or the function indicator lighting has failed.

Damage to the shift box (Selector Lever) ribbon cable.

1. Perform a vehicle test using ISTA, read fault memory and diagnose any relevant faults.
2. Disconnect the 12 V vehicle battery.
3. Replace the Shift box (Selector Lever), refer to repair instructions **61 31 861 “Replace the gearshift bracket for the gear selector switch (After vehicle diagnosis)”**.
4. Reconnect the 12 V vehicle battery.
5. Utilizing ISTA, clear any fault codes induced by the defective ribbon cable.
6. Perform a sleep cycle until the hazard warning switch light goes out, this can take up to 30 minutes.
7. Wake the vehicle and verify the effectiveness of the repair by testing the functionality of the GWS.

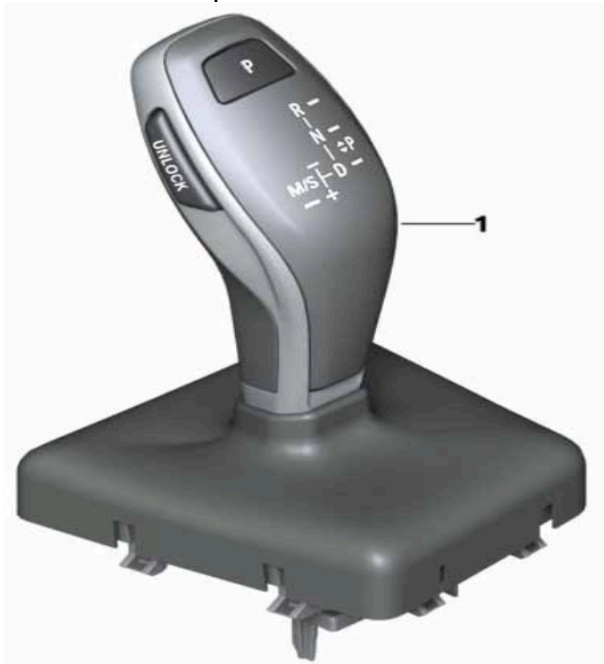
Does the GWS operate as

Yes: No further action is necessary.
No: Further diagnosis with ISTA is needed.
