Technical Journal

Technical Journal Title Difficulty to add/program remote key on T8 models		Ref. No. TJ 31698.3.3	
Issuer (Dept.) Technical Service		Issue Date 3/26/24	Status Date 4/16/24
Car Market United States and Canada	Partner 3 US 7510 Volvo Car USA	Function Group 3666	
Function Description Access (central looking & remote)		Page Page 1 of 5

If experiencing difficulties programming remote keys to a T8 vehicle, please follow the advice under Service.

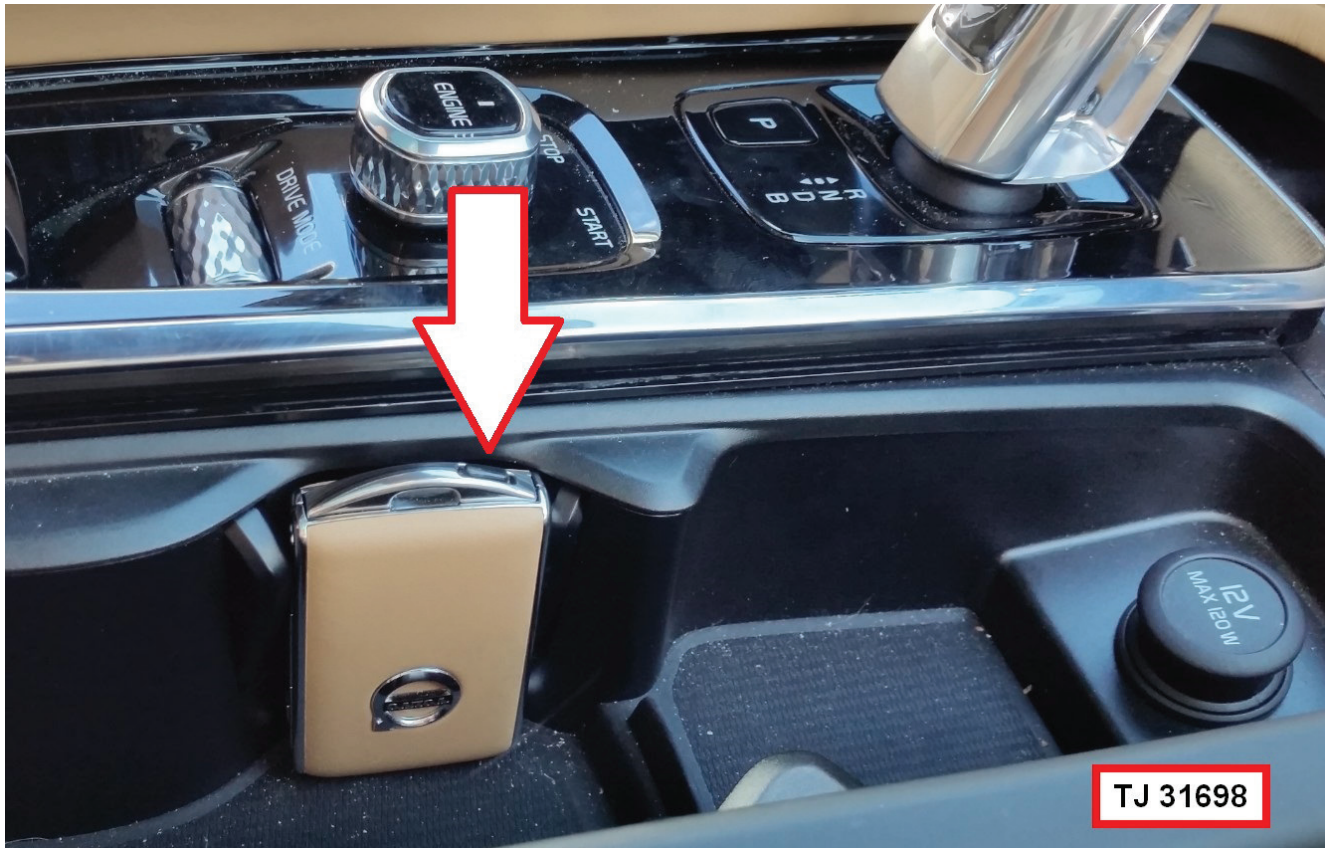
1. Download the **“Keyless vehicle key application”** SW.
2. When prompted, Place the key to be programmed in the cup holder according to picture [TJ 31698.jpg](#). **Note!** The slider button shall point upwards and to the front of the car.
3. Before clicking the **“Start Programming”** button, remove power from the SRS by removing fuse **BF52** in EJB (15/49) and fuse **DF26** in RJB (15/51).
4. Proceed with all intended key programming.
5. Re-insert the SRS fuses, and end the key programming session by clicking on the **“Close”** button.
6. If the SRS warning light is still lit after VIDA has erased the DTCs, then go to **“Software”** tab -> **“Advanced Test”** and click on the **“Reset”** button, and erase the DTCs afterwards.

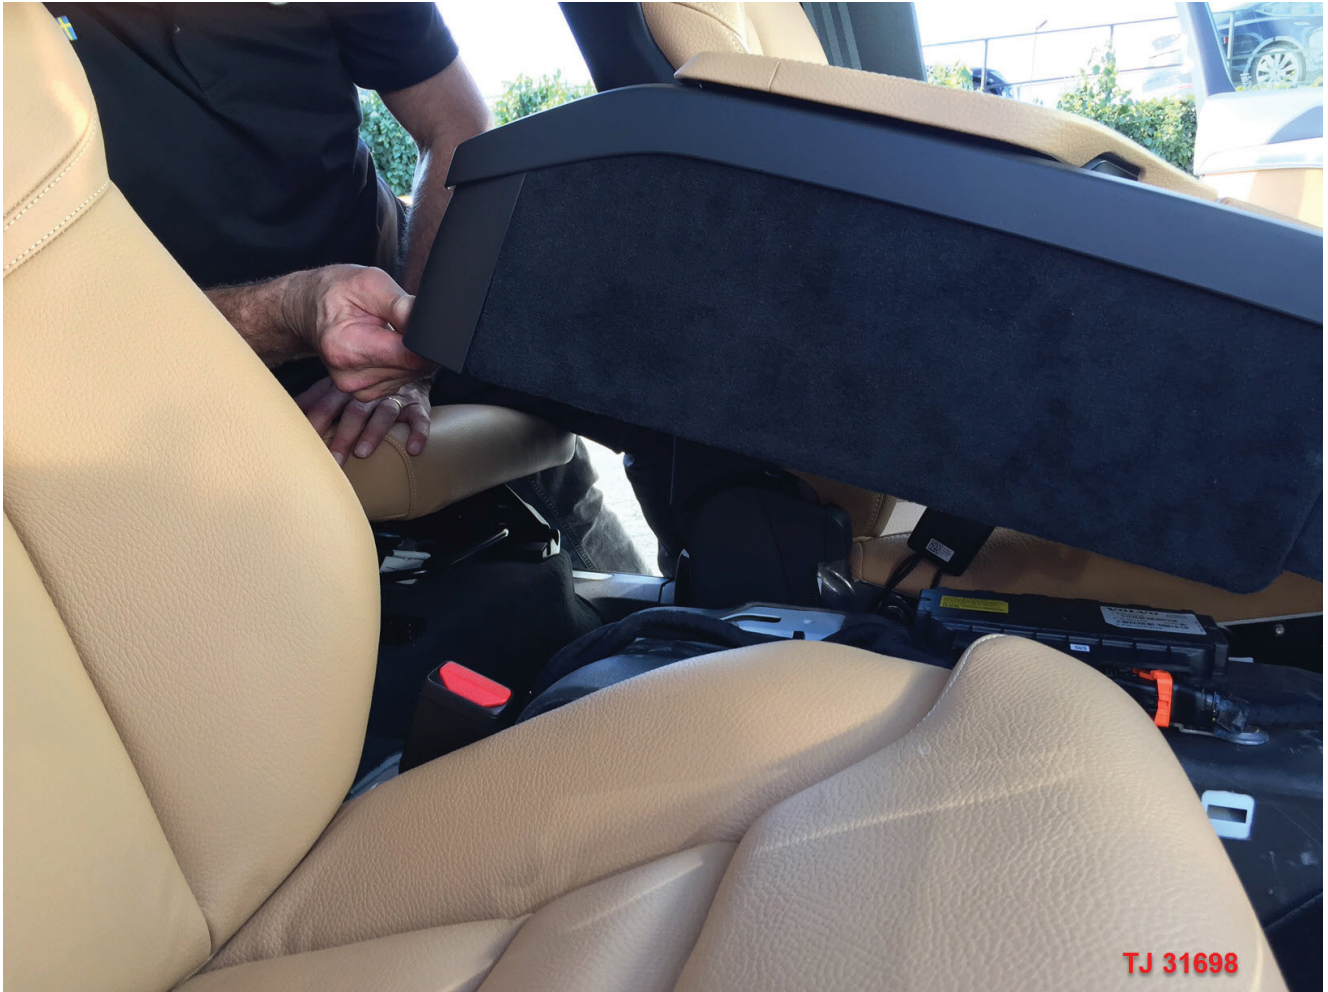
1. Unfasten the floor console from the car body (Location of the securing screws can be found in VIDA instructions for removal of Floor Console - **do not remove the console from the vehicle**).
2. Download the **“Keyless vehicle key application”** software.
3. Before clicking the **“Start Programming”** button have an assistant lift the rear of the console several inches/centimeters from the car body as shown in attachment [TJ31698_2.JPG](#)
4. When prompted, Place the key to be programmed in the cup holder according to picture [TJ 31698.jpg](#). **Note!** The slider button shall point upwards and to the front of the car.
