Volvo Car USA LLC
Technical Journal

Technical Journal Title Long Range PHEV ERAD Knocking Noise Repair Kit		Ref. No. TJ 36894.1.0	
Issuer (Dept.) Technical Service		Issue Date 3/21/24	Status Date 4/16/24
Car Market United States and Canada	Partner 3 US 7510 Volvo Car USA	Function Group 4632	
Function Description Electrical rear axis drive		Page Page 1 of 9

TJ Instruction VCC-528981-1

Title	ERAD bearing	Page	1 (7)
Action	Product fix	Operation number:	98298-2 97733-3

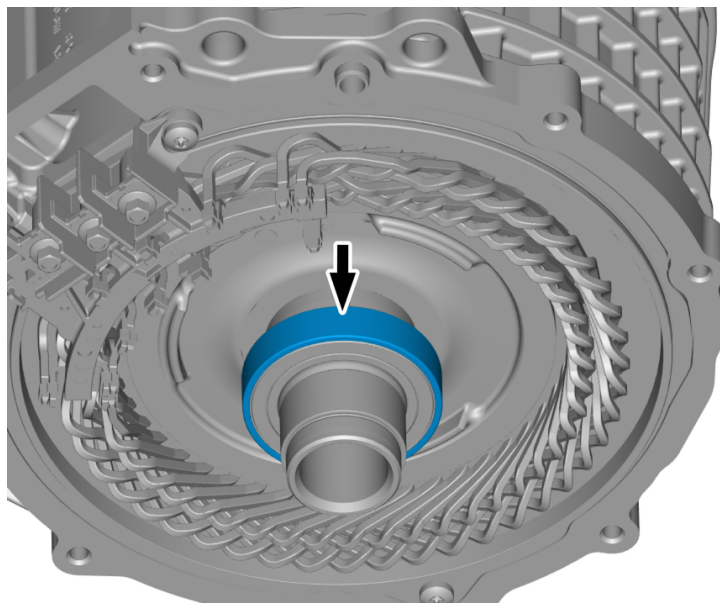
Caution! Make sure that the surface is clean and free of foreign material.

Clean the marked area.

Use: Abrasive cloth , 9511024

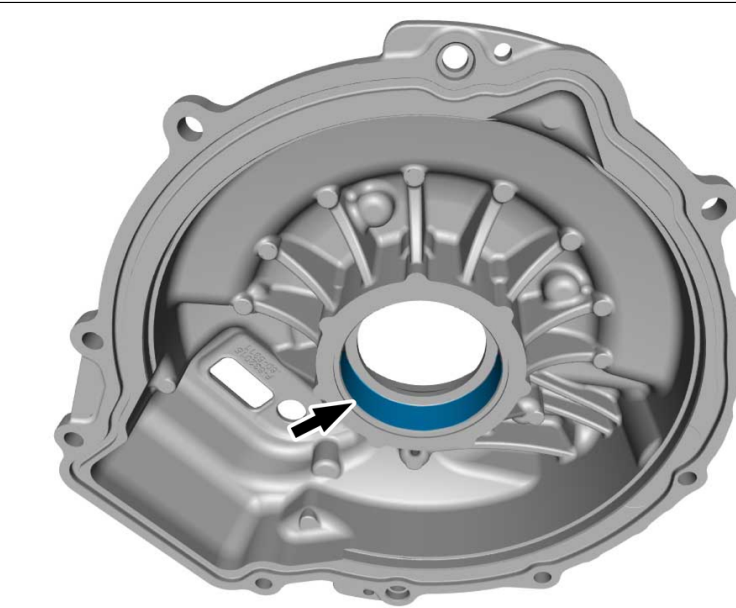
Caution! Make sure that the surface is clean and free of foreign material.

Clean the marked area.

Use: Abrasive cloth , 9511024
